Subject: EMP compliance monitoring reports for Kojjuri Embankment site (Contract Packages W-01/2016-17) and Verakhola Embankment site (Contract Package-04/2016-17)

**FRERMIP – Monitoring of EMP Implementation
Kojjuri Embankment Site
(Contact Package W-01/2016-2017)**

**FRERMIP – Monitoring of EMP Implementation
Verakhola Embankment Site
(Contact Package W-04/2016-2017)**

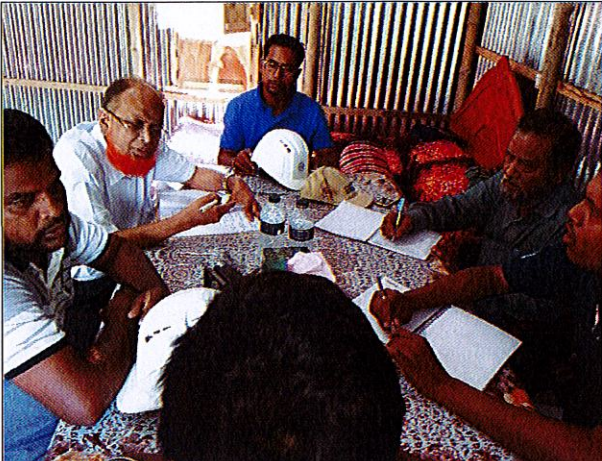
1 Meeting at site with representatives of SMO, ISPMC and Contractor

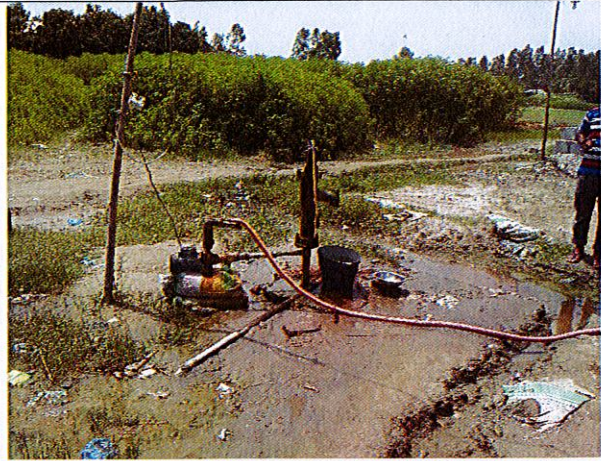
2.3	Safety Inspector		
	Employing one Safety inspector.	0	Safety inspector has not been employed yet.
2.1(iii)	Sanitation conditions & waste management		
	Water supply.	1	2 nos. tube well installed. Tube wells were seen unprotected. The used water are not discharged properly
	Sanitation (toilets etc).	2	4 nos. of pucca sanitary toilets with sock pit was installed.
	Waste management.	1	Waste bins are available; wastewater is drained in an open pit.

2. Tube well without protection

1. Contractors must step up their performance on EMP implementation, first and foremost by (i) formally assigning and/or properly instructing and supervising a full-time Environmental Inspector, (ii) by improving water supply and waste management, (iii) by monthly reporting on their on-site environmental management.

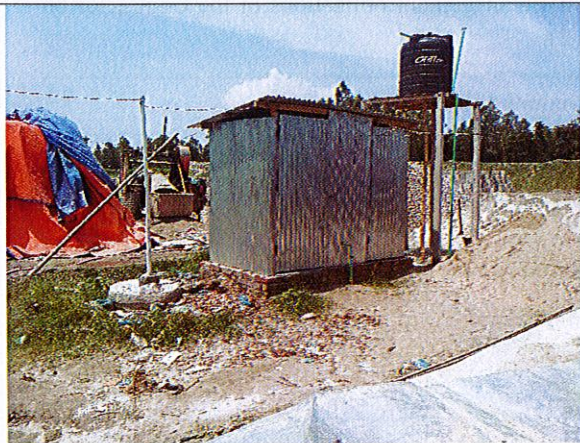
3. Sanitary toilet with sock pit

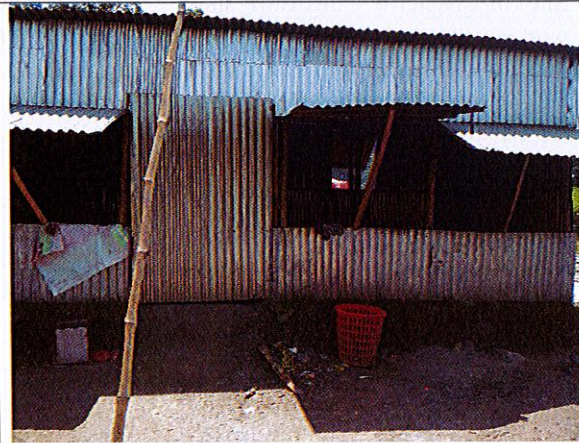
4. Waste bin are available in front of kitchen

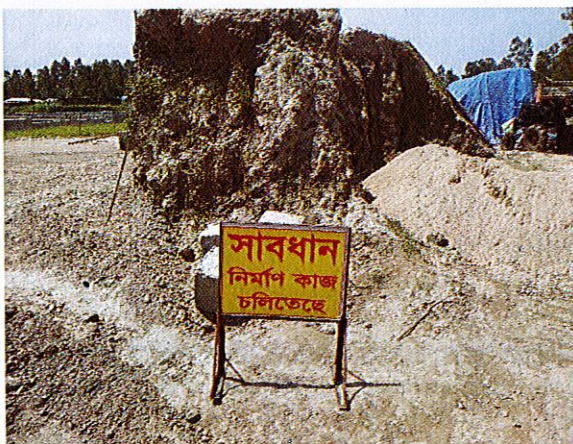
5. Safety warning sign displayed at site

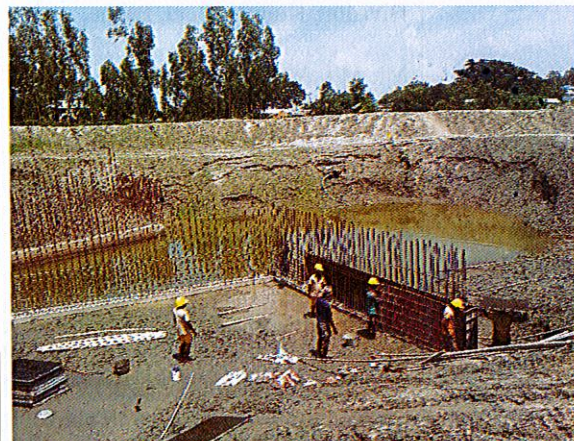
6. Labors are working wearing helmets

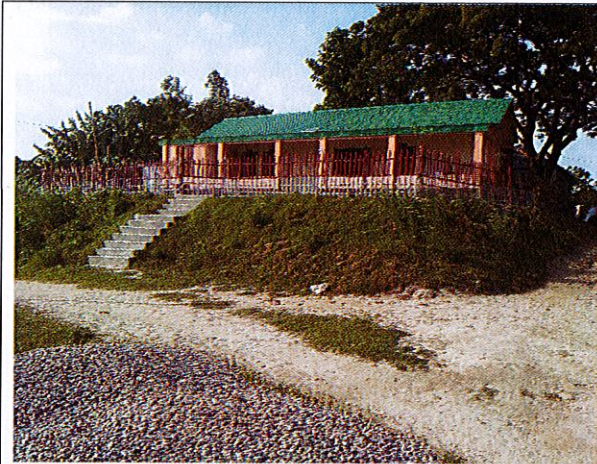
1. Well maintained site Office at Verakhola

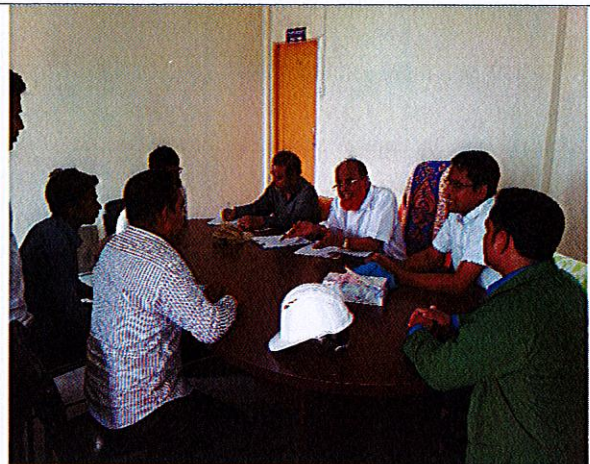
2. Meeting at site with representatives

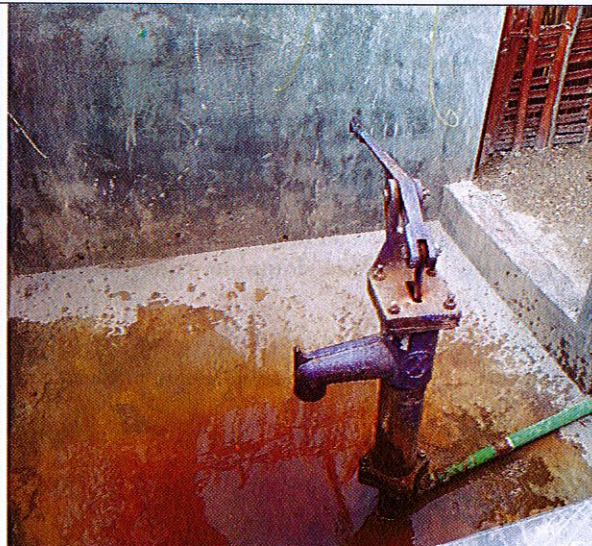
3. Tube well without protection

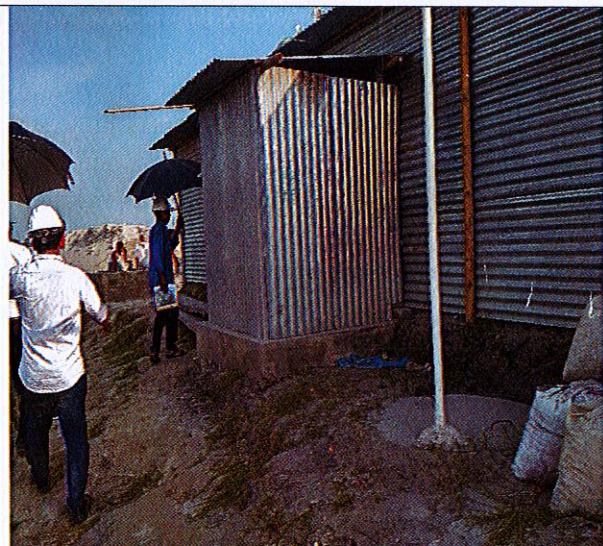
BoQ clause	Item	Score	Comment
	Sanitation (toilets etc).	3	3 nos. of pucca sanitary toilets with sock pit was installed.
	Waste management.	2	Waste bins are available. The waste water are disposed in a pit. The overall working site was seen clean

4. Sanitary toilet with sock pit

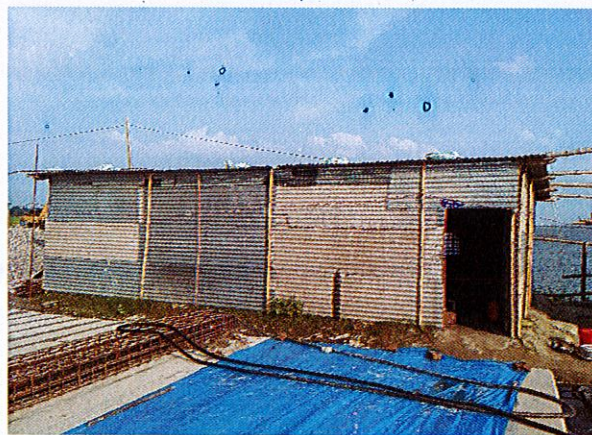
5. Labour shed

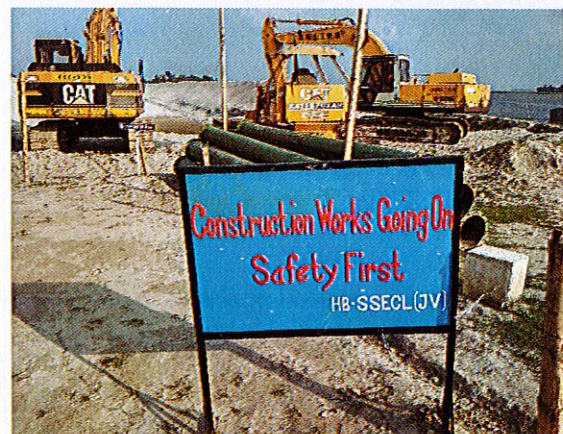
1. Safety warning sign at working site
