**Subject** **Submission of EMP Compliance Monitoring Report of 5 nos Embankment Packages.**

**FRERMIP – Monitoring of EMP Implementation**  
**Md. Moyenuddin (Bashi)- Golam Rabbani const. Ltd (JV)**  
**(Contact Package W-01/2016-2017)**

**FRERMIP – Monitoring of EMP Implementation**  
**HB-SSECL (JV)**  
**(Contact Package W-04/2016-2017)**

**FRERMIP – Monitoring of EMP Implementation**  
**Md. Moyenuddin (Bashi)-Golam Rabbani const. Ltd (JV)**  
**(Contact Package W-05/2016-2017)**

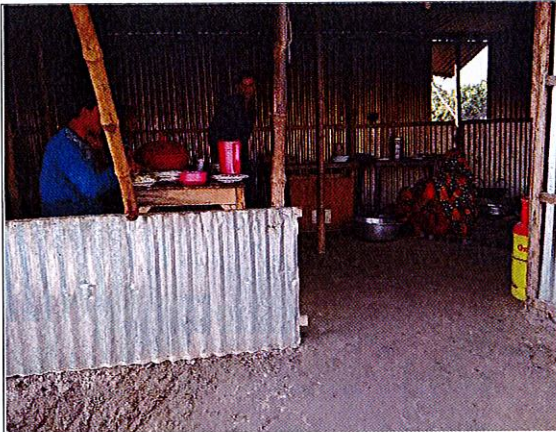
1. Well maintain Kitchen at site

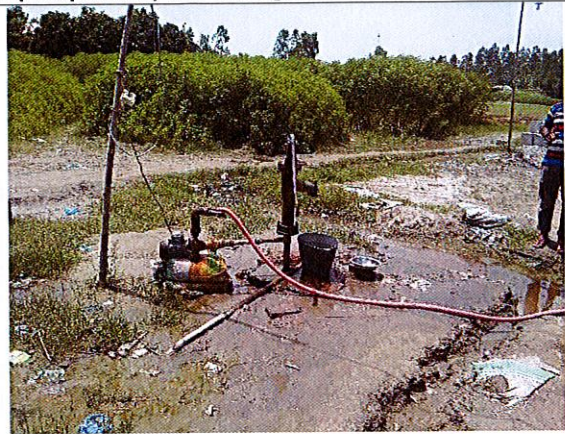
2. Tube well without protection

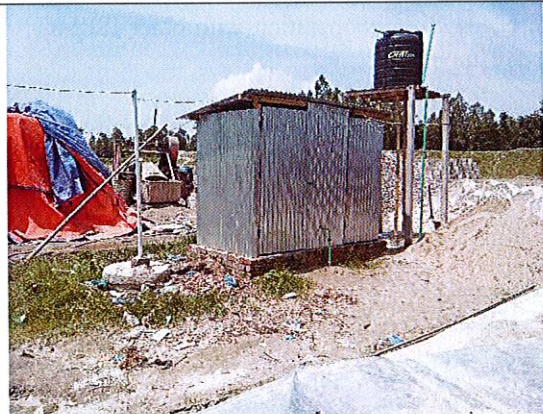
3. Sanitary toilet with sock pit

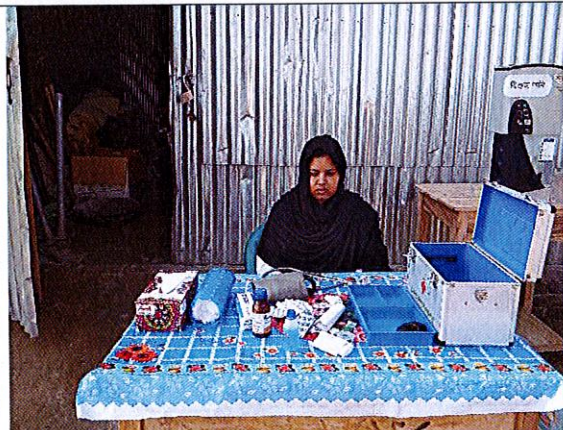
4. First aid equipment

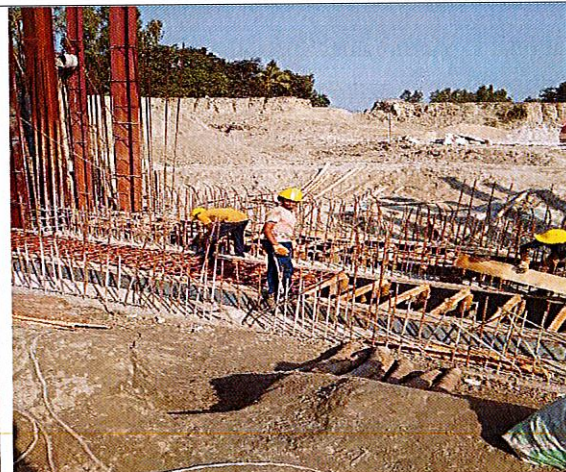
6. Labors are working wearing helmets

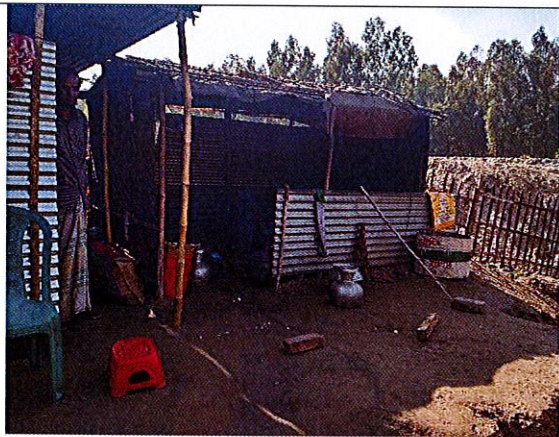
3. Kitchen with roof and wall

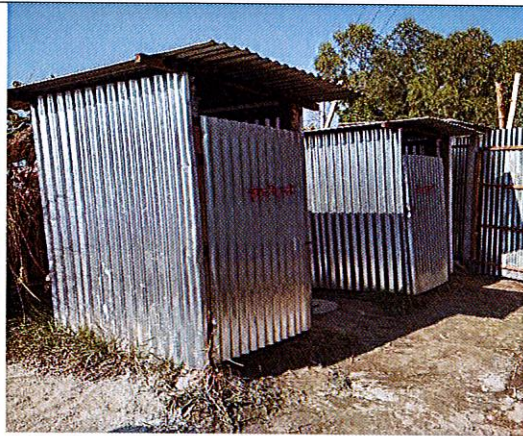
4. Sanitary toilet with sock pit

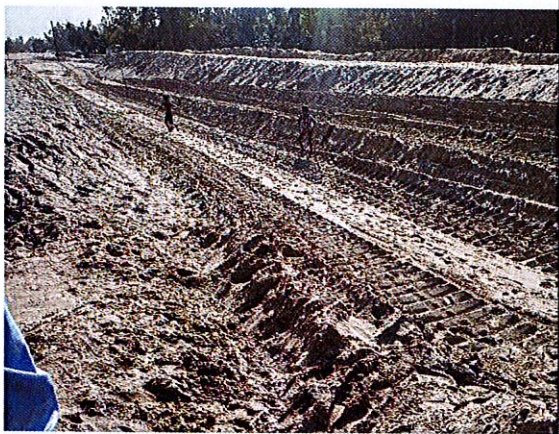
5. Construction of Embankment

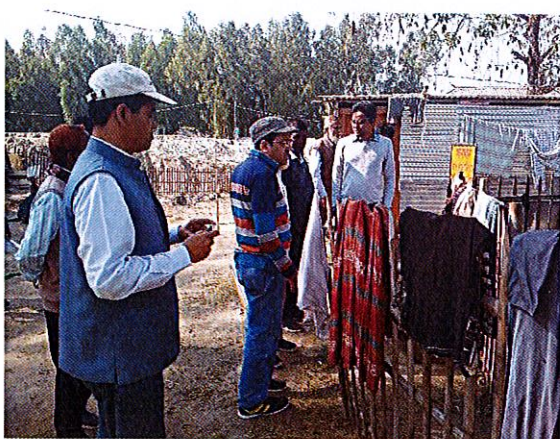
6. No action taken for dust suppression

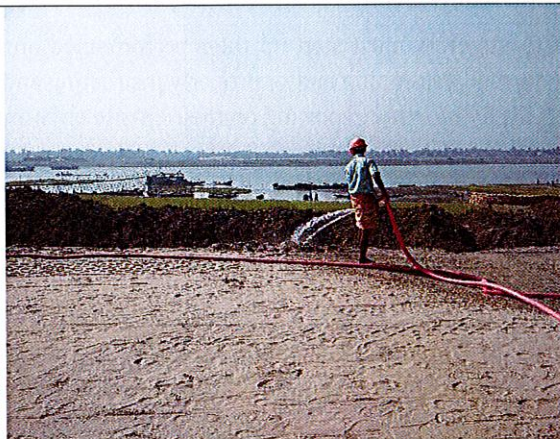
2. Water is being spraying on road for dust suppression

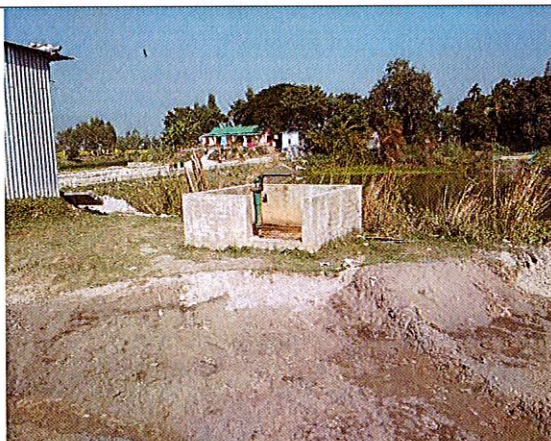
3. Tube well with protection

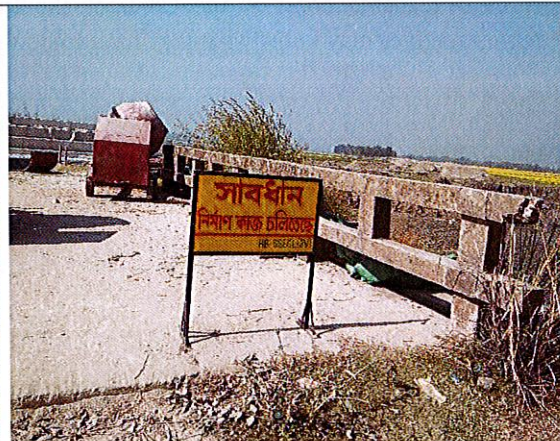
4. Safety warning signboard displayed at site

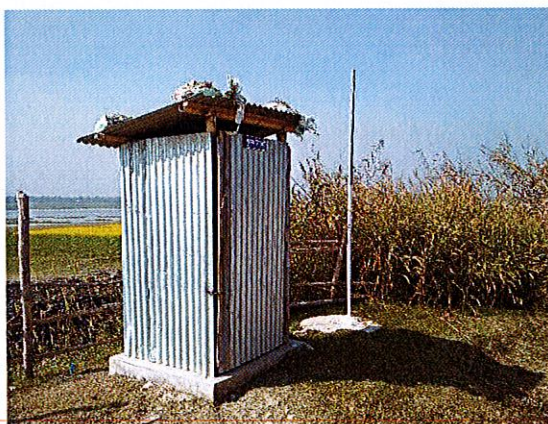
5. Sanitary toilet with sock pit

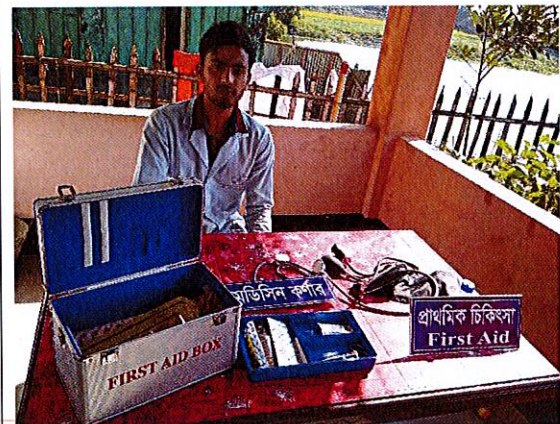
6. First-aid services

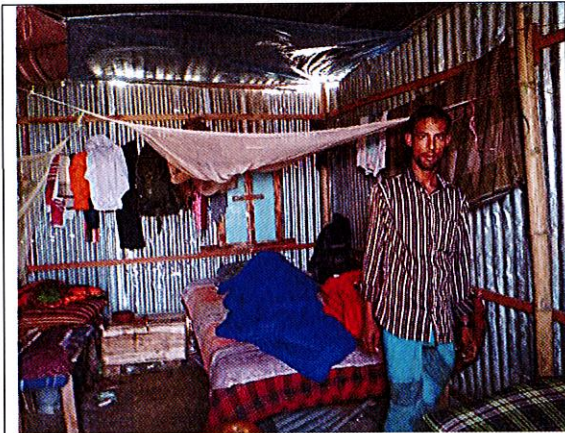
1. Labour shed at Andermanik site

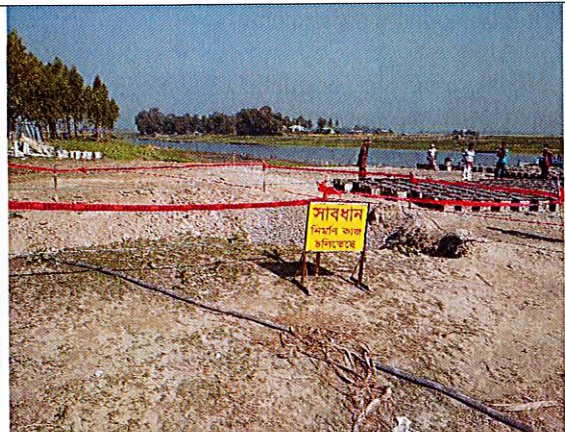
2. Safety warning sign at working site

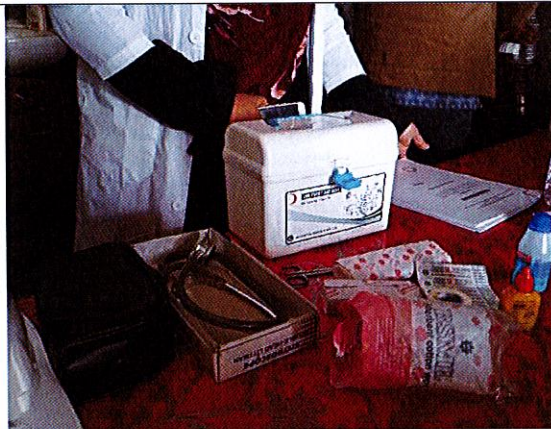
3. First aid box with medical equipment

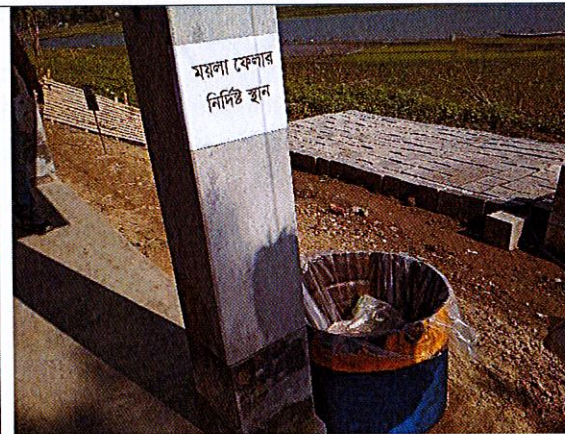
4. Waste bin at site

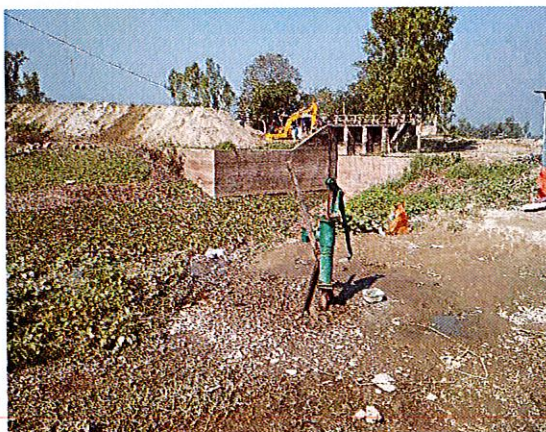
5. Tube well with unprotected base

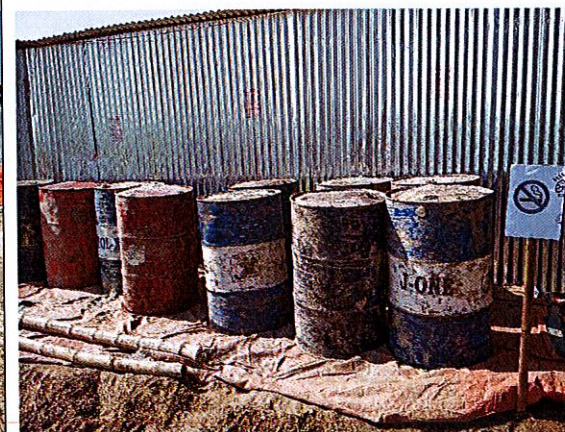
<b>BoQ clause</b>	<b>Item</b>	<b>Score</b>	<b>Comment</b>
			some fuel and lubricant dram were kept in open sky. The lubricants and fuel are carrying in a container to the machine where it is being used.
<b>2.1(v) &amp; 2.4</b>	<b>First aid</b>		
	First-aid box	3	First aid box with necessary equipment is available at site
	Qualified nurse.	2	A nurse is available on call from the nearby bazar.
	<b>Safety equipment to prevent accidents / injuries</b>		
	Helmets & life jackets / buoys.	2	Some equipment available (life jackets) in Contractor's office
	Traffic control signboards.	2	A Signboard containing site information was seen in front of site office and safety enclosure and warning signs was seen at different places at site during visit.
	Guards / walkways / etc.		Guards are deployed at the sites.
<b>2.3</b>	<b>Safety Inspector</b>		
	Employing one Safety inspector.	0	Safety inspector has been employed

1. Fuel and lubricant kept in open sky
