Subject: Submission of EMP Compliance Monitoring Report of 3nos Embankment Packages.

FRERMIP – Monitoring of EMP Implementation

(Contract Package W-03/2016-2017)

(Contact Package W-04/2016-2017)

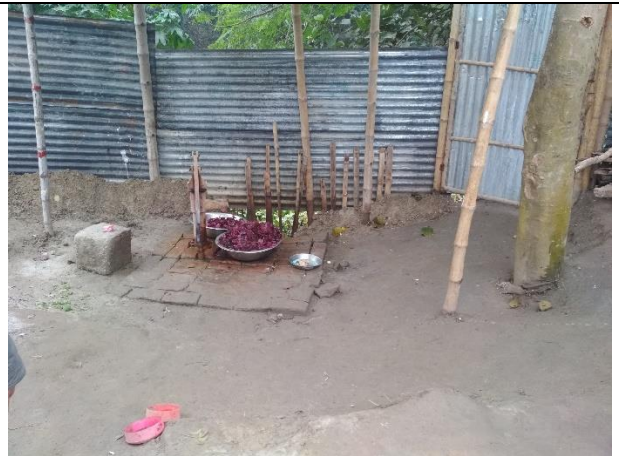
2.1(iii)	Sanitation conditions & waste management		
	Water supply.	2	3 nos. tube well found. Tube wells were seen with protected base
	Sanitation (toilets etc).	2	3 nos. of pucca sanitary toilets with sock pit were found
	Waste management.	2	4 nos. waste bins were found

2. Tube well with protected base

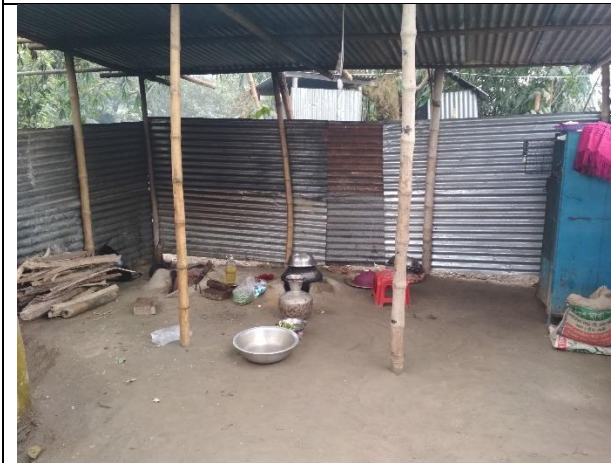
3. Kitchen with C.I sheet roofing and enclosure

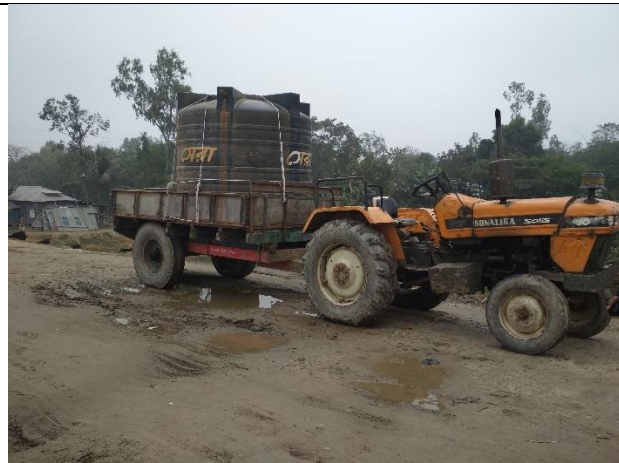
4. Water is being spraying through machine for dust suppression

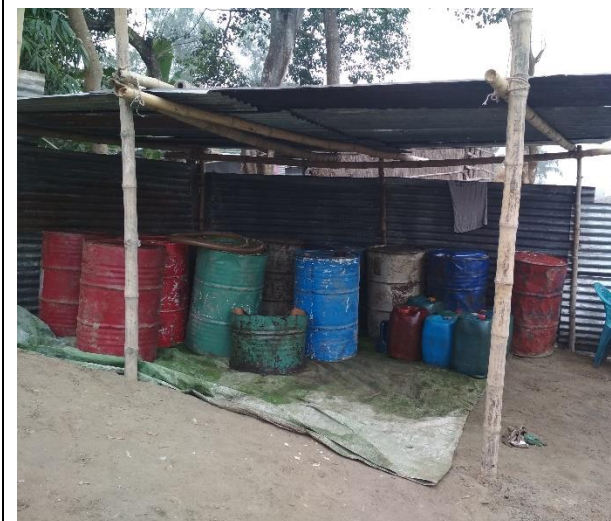
BoQ clause	Item	Score	Comment
2.1(iv)	Pollution		
	Waste disposal at work sites.	2	Contractor reported the waste is collected in an excavated hole at a safe distance and carried away and dumped in a safe place.
	Waste disposal at worker camps.	2	A few waste bins were found in front of the kitchen.
	Preventing spills of lubricants and fuel.	2	Fuel and lubricant drums have been kept on a thick polyethene sheet under a tin shed enclosure

5. Storage of Fuel and lubricant

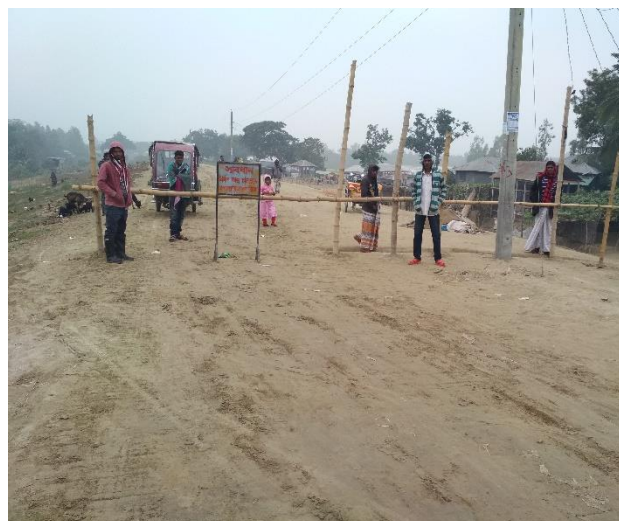
6. Cautionary signboard

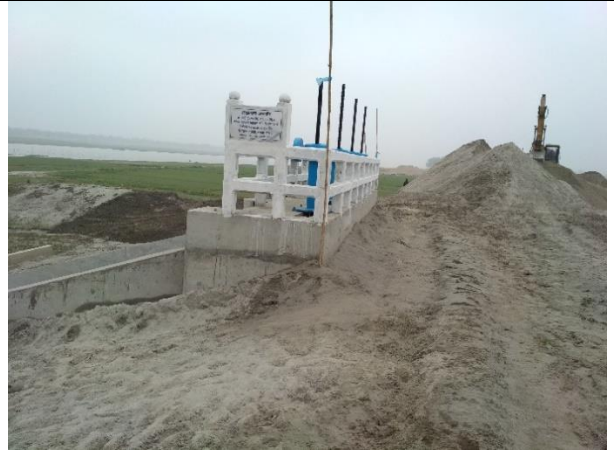
2. Completed 4 vent Regulator

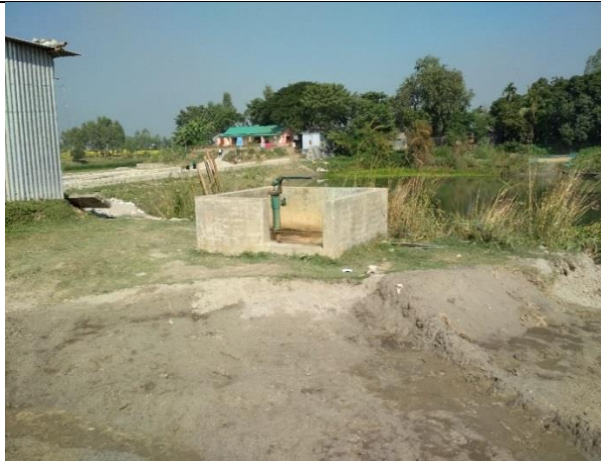
3. Tube well with protection

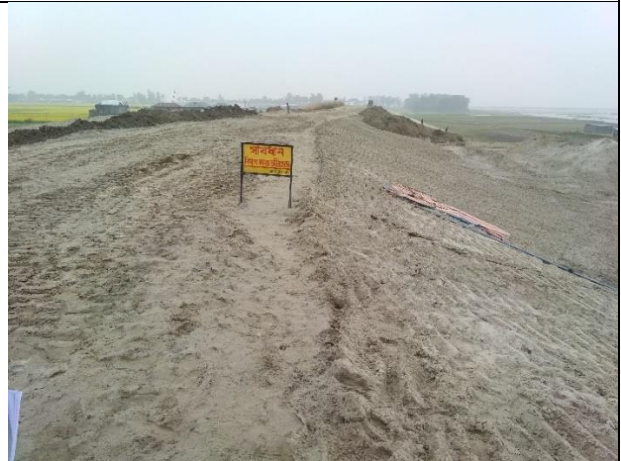
4. Safety warning signboard displayed at site

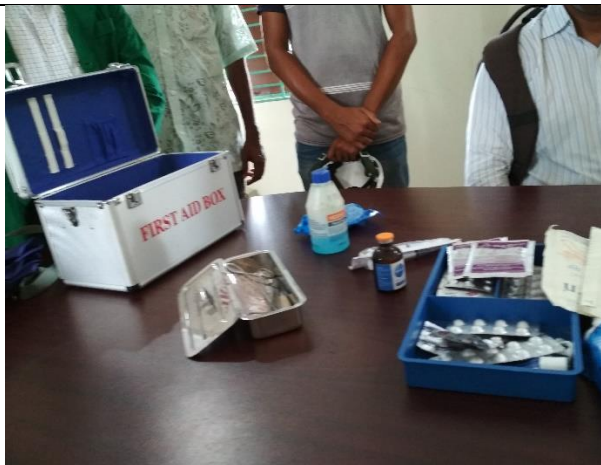
5. First aid box with required items

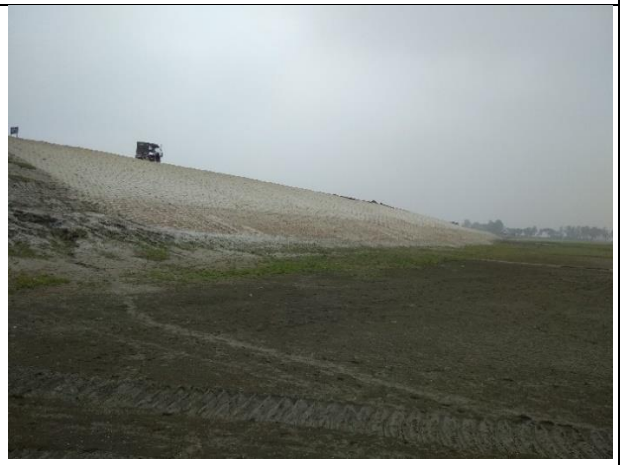
6. Completed Embankment with grout filled jute mattress

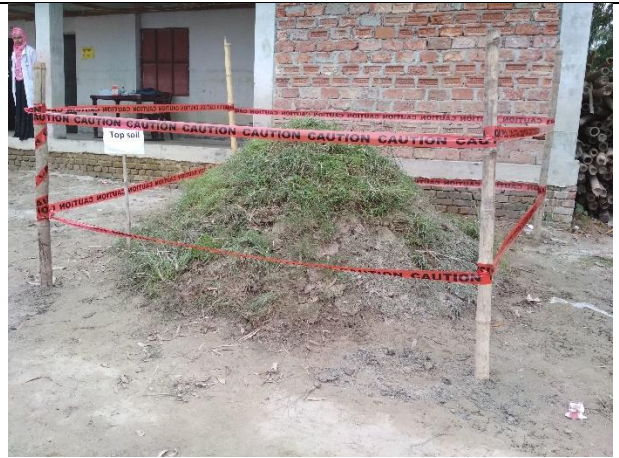
2. Preservation of Top soil

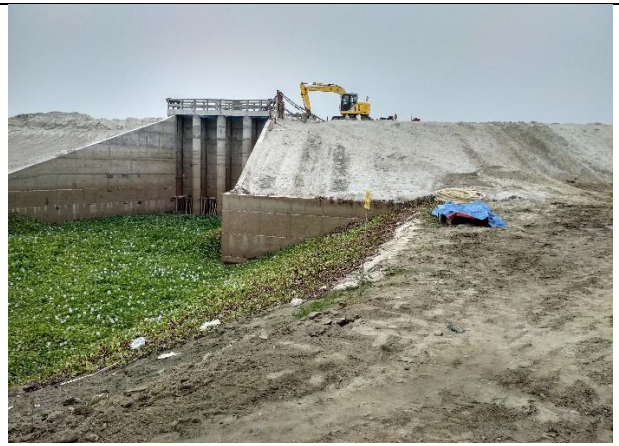
4. Completed 4 vent Regulator at Andermanik

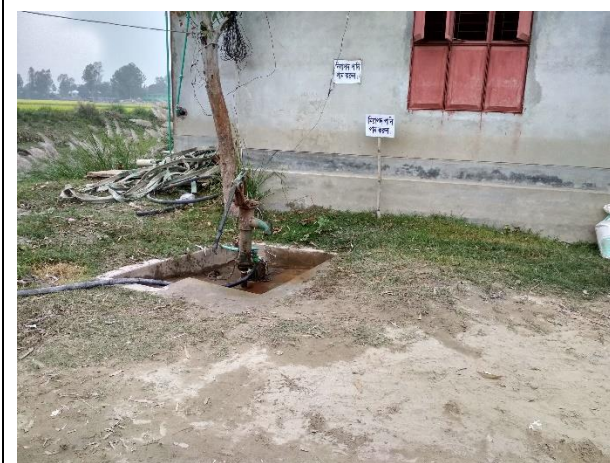
2.1(iii)	Sanitation conditions & waste management		
	Water supply.	4	3 nos. tube well installed. Tube wells were found to be well maintained and protected.
	Sanitation (toilets etc).	3	4 nos. of pucca sanitary toilets with sock pit was installed. 1 no toilet has been reserved for female workers
	Waste management.	2	Waste bins are available. The waste water is disposed in a pit. The overall working site appeared to be clean

5. Tube well with pucca platform

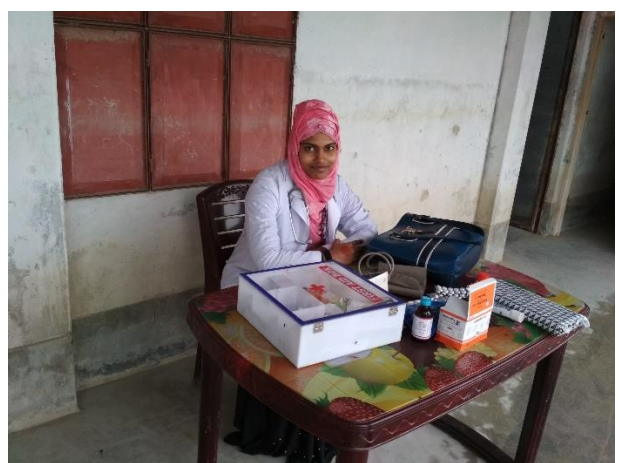
6. First aid box with medical equipment
