Memo

Re: Site monitoring 2018/19

This memo summarizes river changes in the Lower Jamuna and Padma river at Chauhali, Zafarganj, Harirampur, Chauhali upstream, Enayetpur, Kojjuri and PIRDP during the flood season 2018, including a survey update at Chauhali in January 2019.

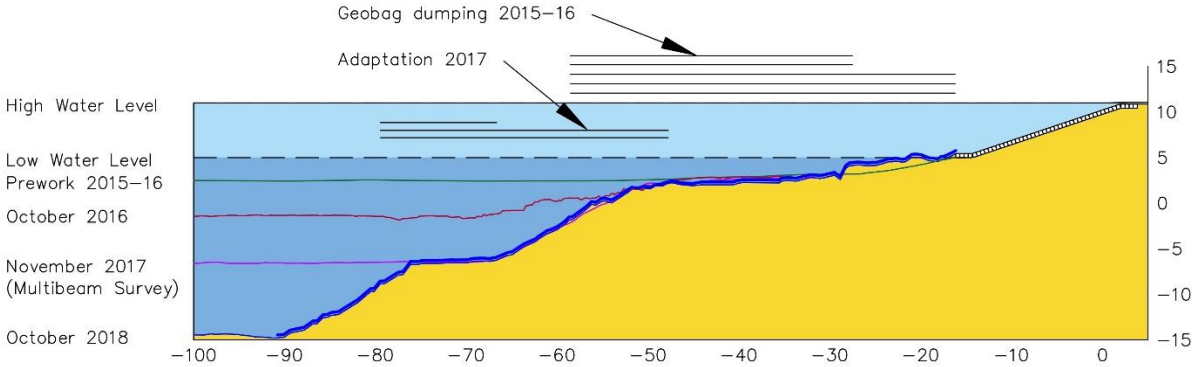
Figure 1-1 Chauhali periodic apron development

The 2017/8 memo included, multibeam survey results from Chauhali and Kojjuri which demonstrate geobags launching, and documenting launching of the apron requiring adaptation works. In total the BWDB implemented 3.8km of adaptation works in early 2018, 2km through variation of work packages W6 and W7 and 1.8km work through a new package W7. During the 2018 flood season, additional launching occurred in some areas. Adaptation work strengthens the existing work and introduces a step in the launched slope that acts as a berm, improving the geotechnical stabilities (Figure 1-1).

After a multitude of damages of the upper slope in 2017 and 18, no damages occurred in areas with adaptation works.

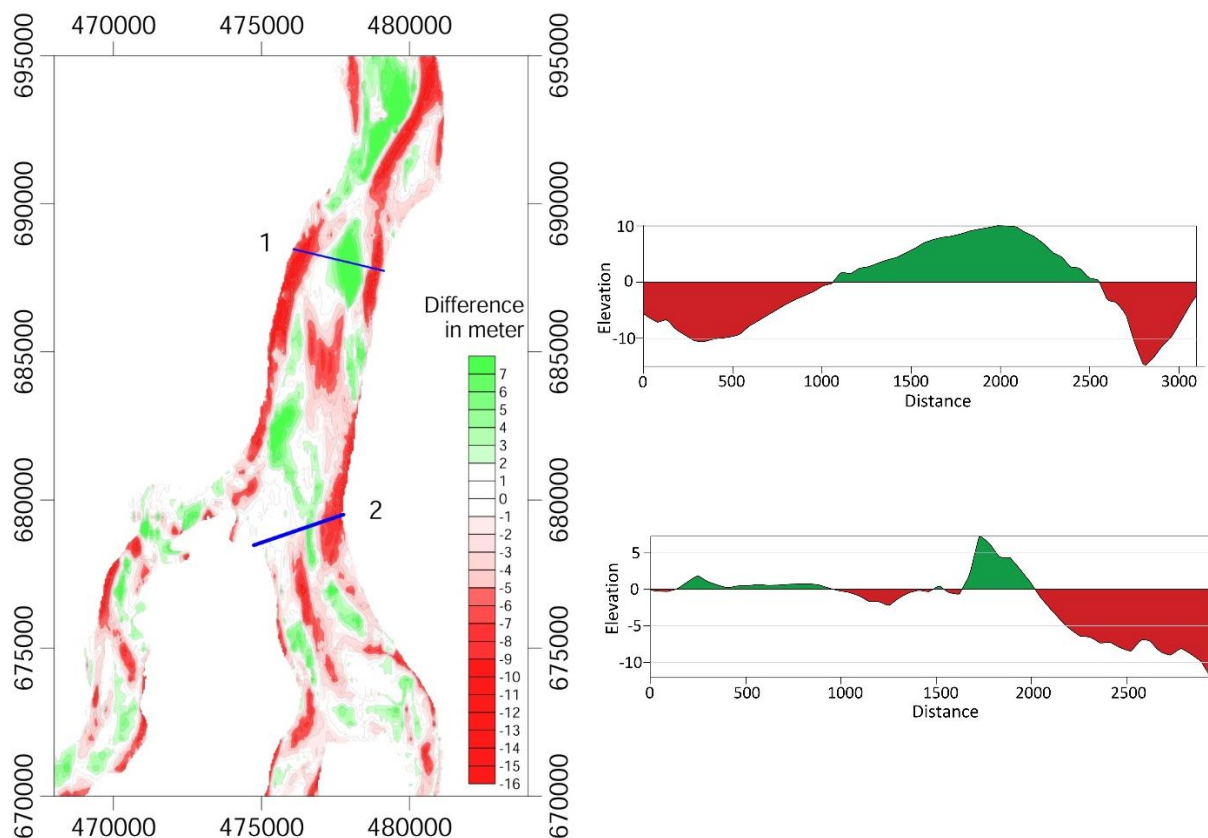
Figure 2-3 Increasing height of sandbar at section 1

- (i) The differential survey map between 2017 and the 2018 shows the overall deepening of the lower Jamuna right and left channel as opposed to a more aggrading situation the year before (Figure 2-8).
- (ii) Upstream of the Lower Jamuna bifurcation, the height of the mid-channel sand bars increased resulting in deeper channels at both banks (Figure 2-3 section 1). Deepening of section 2 indicates erosion of the left bank, which is planned to be addressed through 12 km of riverbank protection during Project 2.

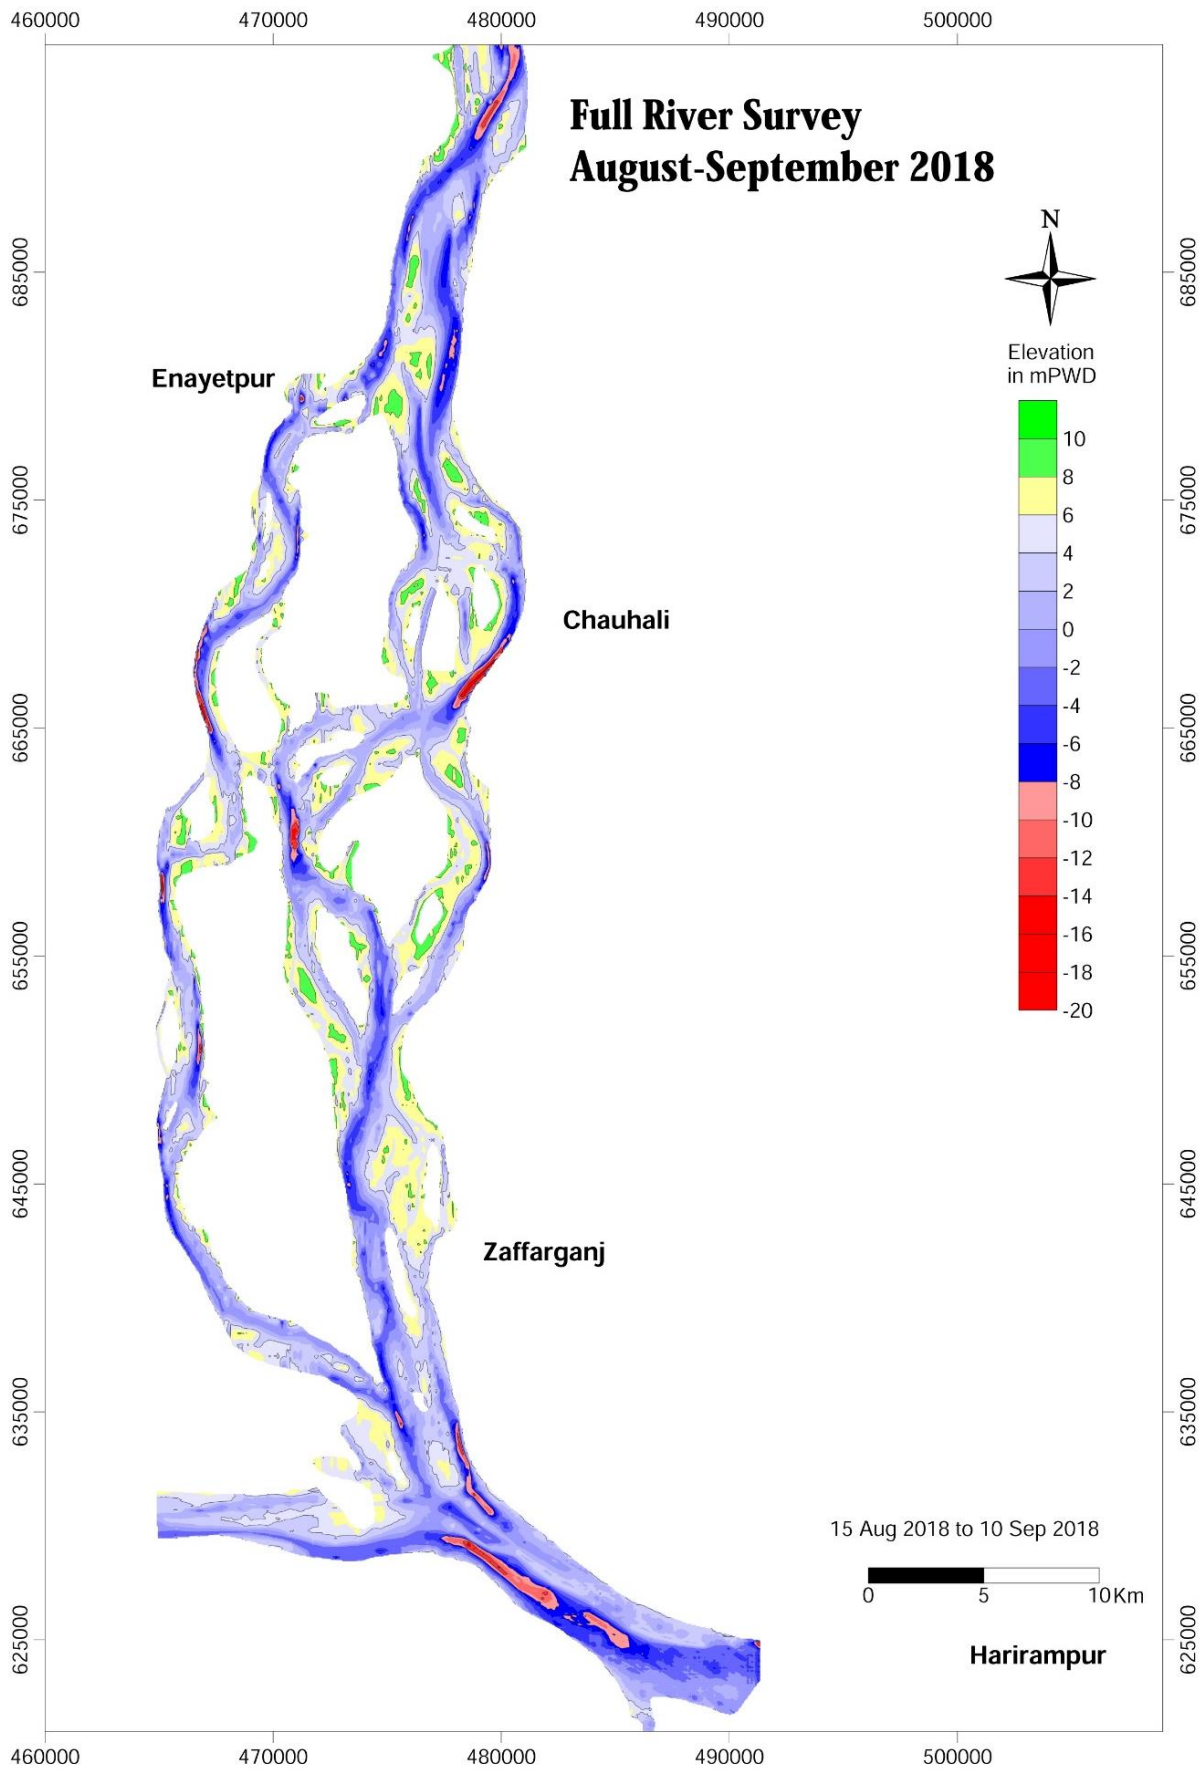
Figure 2-7 Full river bathymetry survey flood Season 2018

The flood season survey (Figure 2-7) shows that despite the average flood substantial changes occurred in the Lower Jamuna:

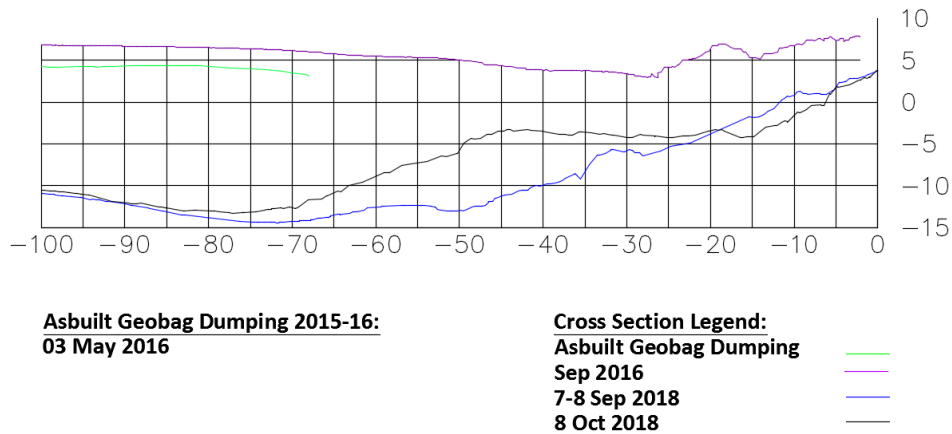
Figure 3-6: Upstream end of underwater apron

- (ii) Differential maps for August 2018 with the November 2017 multibeam survey show sedimentation from stn 4.2 to 0.8. Again, from August to September this soft deposit eroded up to 5m.
- (iii) There was erosion at the upstream end of the Chauhali work which destroyed some 100m slope upstream of station 6.7 (Figure 3-6).

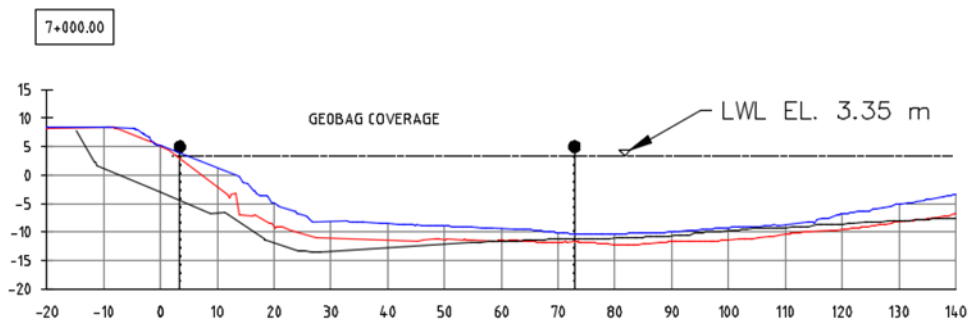
- (i) The August 2018 survey shows that the upstream deposition, observed during the 2017 flood season, has started to erode.
- (ii) Cross sectional analysis shows that the apron was placed during the deepest bed elevation in 2015/16. After that the apron was buried under sediment.
- (iii) The maximum elevation was observed at stn 7 (Figure 3-7).

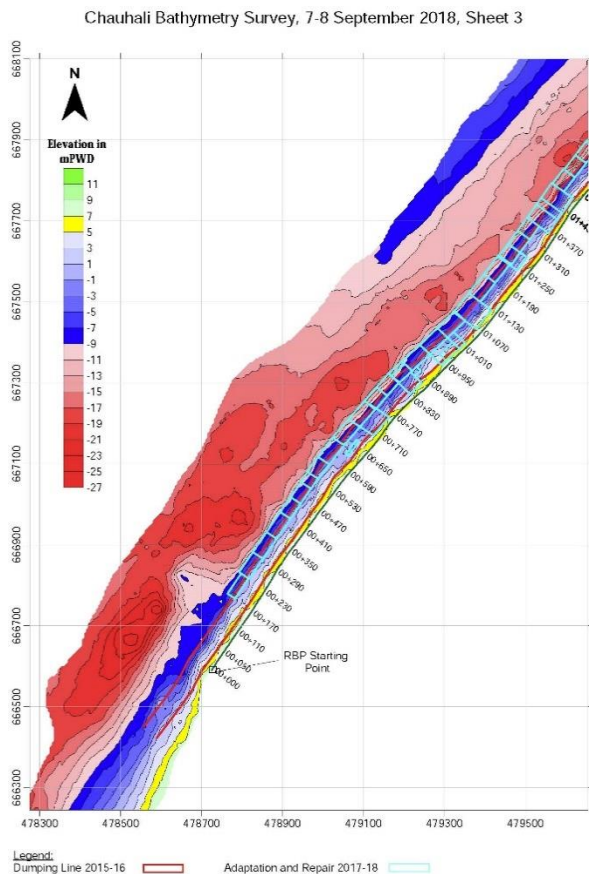
Figure 3-10 Chauhali 7 to 8 September 2018 survey

The survey in early September 2018 shows an explicit, protruding triangular shape with its crest perpendicular to the riverbank at around stn 150. Two events happened that in combination encouraged the geotechnical slope failure:

- (i) A part of the upstream approach flow bifurcating into the right Chauhali channel started shortcutting over the char opposite of the Chauhali riverbank and squeezing the flow along the downstream bank (Figure 3-11). This flow pattern was triggered as shortcut channels had formed over the char, which are still active during the dry season in November 2018.

- (i) Step I: emergency repair: This consists of dumping two layers of geobags from country boats along the riverbank to prevent further erosion into the floodplain. The overall slope in the failure zone is very moderate (in the order of 1V:4H – see Figure 11 stn 0). This emergency coverage is required for around 25 m from the bankline. The total estimated number of bags is around 4,000. The work was completed after dumping 6000 geobags along the riverbank on 3rd October 2018.
- (ii) Step 2: repair of the failed zone (Figure 17): This work consists of repairing the damage over the some 200m length and extending the work to the location of the deep scour hole using the remaining 27,000 geobags. The work ties in with the upstream adaptation work

to avoid discontinuities. The overall channel pattern explained in Figure 9 is likely to prevail during the next flood season, and at least at the beginning of the flood could result in further deep erosion. To this end we recommend to place three layers of geobags over an area of some 9,000m². The total number of bags required is around 27,000.

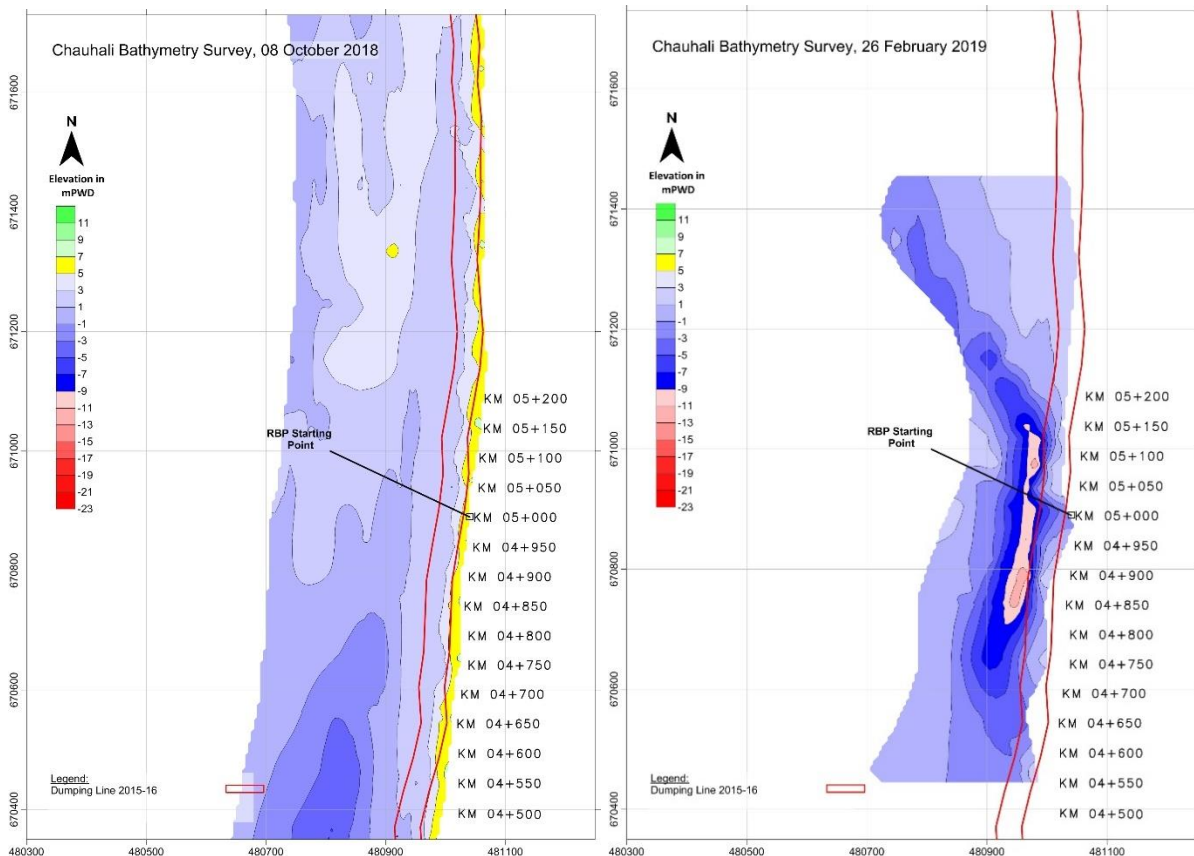
Figure 3-12 Comparison of October 2018 and February 2019 survey (February 2019 survey was carried out as a response to the failures and in the vicinity of the February 2019 failures only)

Two failures occurred between stn 4883 and 4915 km (32m) on 22nd February 2019 and stn 4938 and 5046 (108m) on 25th February 2019. The first failure was at previously placed concrete block wave protection whilst the second failure extended 42m into the temporary geobag wave protection, protecting the upstream end of the upper slope between stn 5,000 and 7,000.

- (i) As in previous cases, the berm consisting of weak soil has eroded and consequently the support for the upper slope has been lost, resulting in slippage of the placed concrete blocks.
- (ii) The underwater apron has eroded, and the erosion has progressed through the whole width of the placed underwater apron (some 40m wide with 5 layers of geobags).

The failure is associated with the failure of the berm (cross sections 4800 to 5100). This is in line with earlier observed failures (see memo 31 July 2018 – ISPMC-FRERMIP-522), particularly as the concrete blocks were dumped on loose soil, bulldozed from the bank into the river to create a loose berm, expected to support the upper slope protection. Some cross sections even show steep upper slope of the loose material under the berm (red circles in cross sections 4850 and 5050) particularly in September 2016 after construction.

Only cross section 5,000 shows erosion into the launched apron. The assumption that this is a result of erosion through nearly 35m of placed apron is not supported by the typically low flow velocities. It is rather an indication of a geotechnical mass failure, which is the only mechanism that is able to displace the five-layer protection. Any failure of this kind indicates the weak subsoil composition, as further confirmed through additional boreholes conducted in the area in 2016 and 2017.

Stn 5,000 was in the location of the second failure that occurred 3 days after the first thereby supporting the theory that the upper berm failure triggered a deep-seated slip failure that caused this location to fail due to weak underlying soils rather than that this area of the bank suffered a failure mechanism that was unique amongst the remaining sections. The failure mechanism is therefore considered to be angular flow attack in a localized area combined with a geotechnical unravelling of the berm due to poor construction, a heavy berm due to the dumping of concrete blocks and weak underlying base soils.

These cross-sections show that the majority of the failures related to the upper slope only with the exception of stn 5,000 where a short length of the top of the lower slope failed alongside the upper slope. Cross-sections at stn 4,750 to 4,850 show that the underwater slope with previous geobag coverage remains both fully intact following erosion and higher than the post apron launching level following the 2016 flood season. Consequently, the failure is associated with the erosion of the berm, as observed in other places and consequently slippage of the concrete block slope protection.

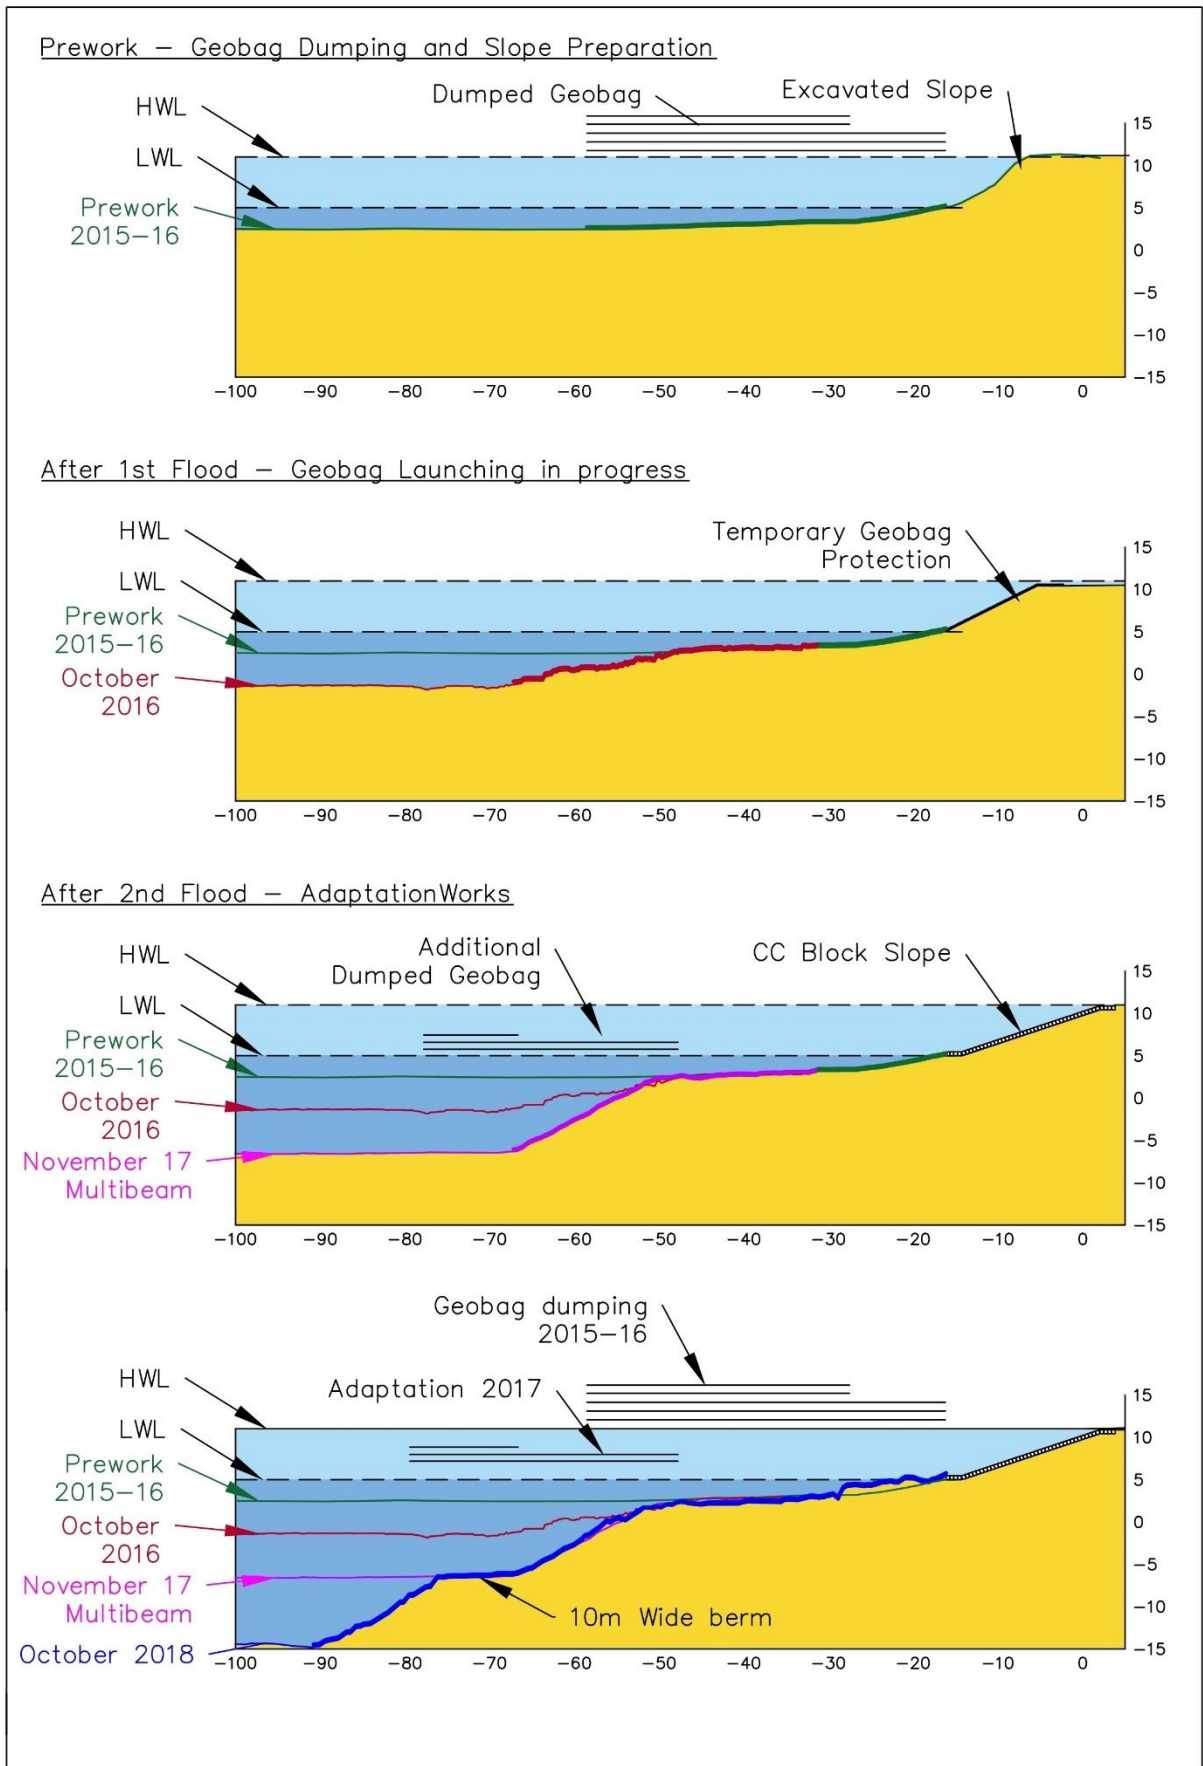
Figure 4-3 Steps of adaptation

Figure 4-3 shows how adaptation actually works. The additional apron which was placed beside the initial launched apron referred in Figure 4-1, started launching newly and formed a stepped slope. This step launching was observed from stn 0.250 to 0.650. Further surveys during the future flood seasons are expected to reveal more details of the launching behavior of the new apron.
