Memo

Re: Flood monitoring report 2019-20

1 Introduction

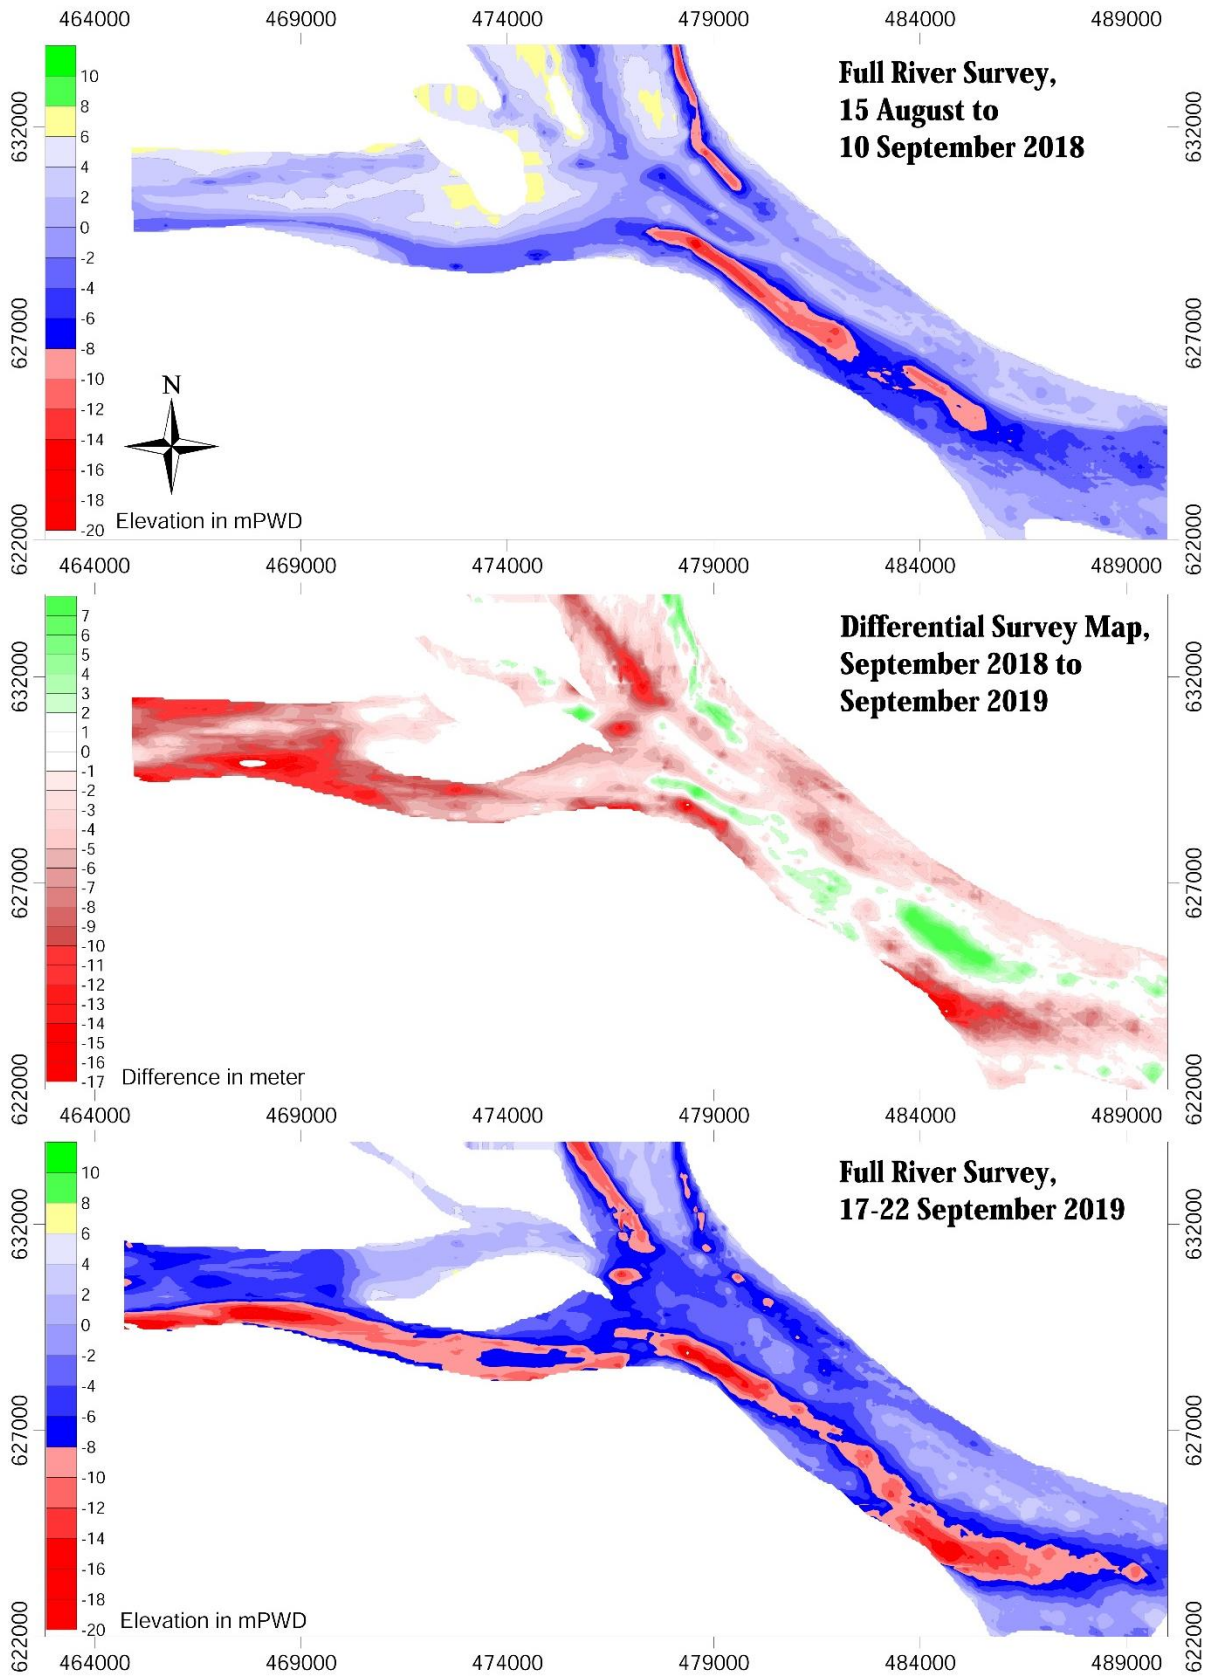
Figure 3-13 Differential from September 2018 to September 2019

The differential map between September 2018 and September 2019 (Figure 3-13) shows:

- i. The river bed of the Ganges has significantly deepened by up to 17m, resulting in a shift of the thalweg to the right side of the channel
- ii. The char at the confluence appears to become more stable
- iii. Bank erosion has been observed in some places at the left bank from Paturia to Harirampur.
- iv. The right channel of the Padma is deepening, in particular just after the confluence and near Faridpur

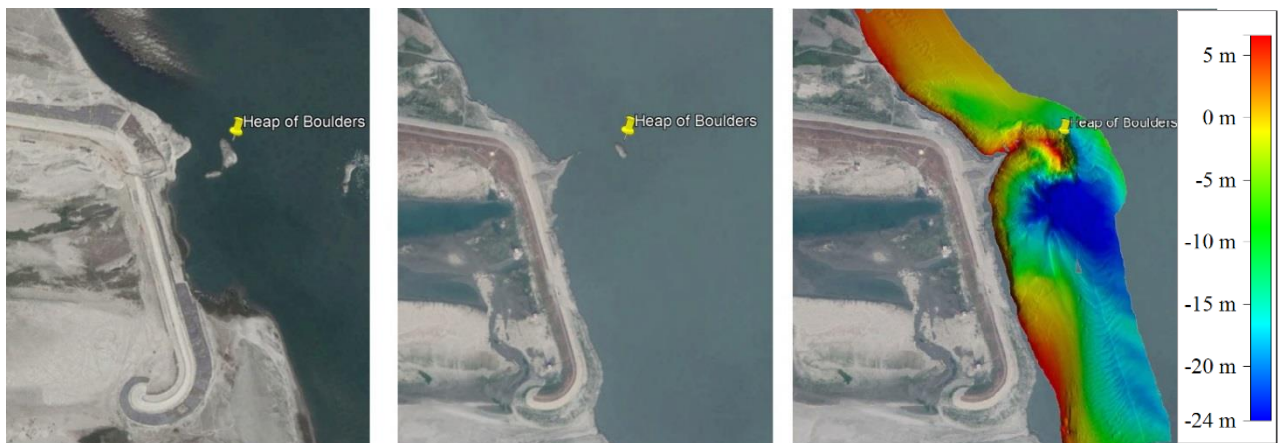
Figure 4-8 Bathymetry near Sirajganj cross bar

- (i) At Stn 0.4, 150m from bankline an underwater spur shape dumping causes a deep scour at Stn 0.5. Satellite image shows heap of boulders dumped at that location. The point marking shows heap of boulders dumped in 2016, visible also in 2019. A detailed image is provided in Appendix 8.6.

- (ii) Boulder's heap at stn 0.4km makes spur like erosion at downstream which results deep scour at stn 0.5km and this deep scour which is 100m far from the bankline affect underwater slope.

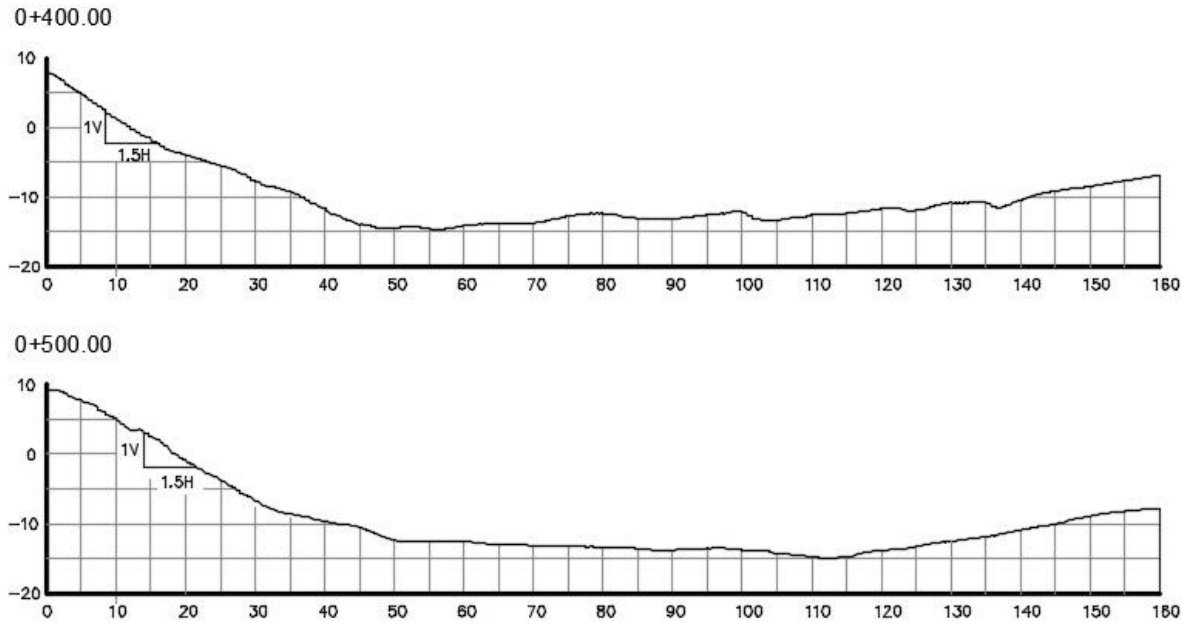
Figure 4-11 Steep slope at the hardpoint area

- (i) Deep scour in particular at the downstream end is -21mPWD at stn 0.5
- (ii) At hardpoint site steep slope observes. Slope varies from 1V:1H to 1V:2H with most slopes being around 1V:1.5H. the steepest slopes occur at the head of the hardpoint

(iii) Distinct protrusion scour showing impact of eddy on downstream side.

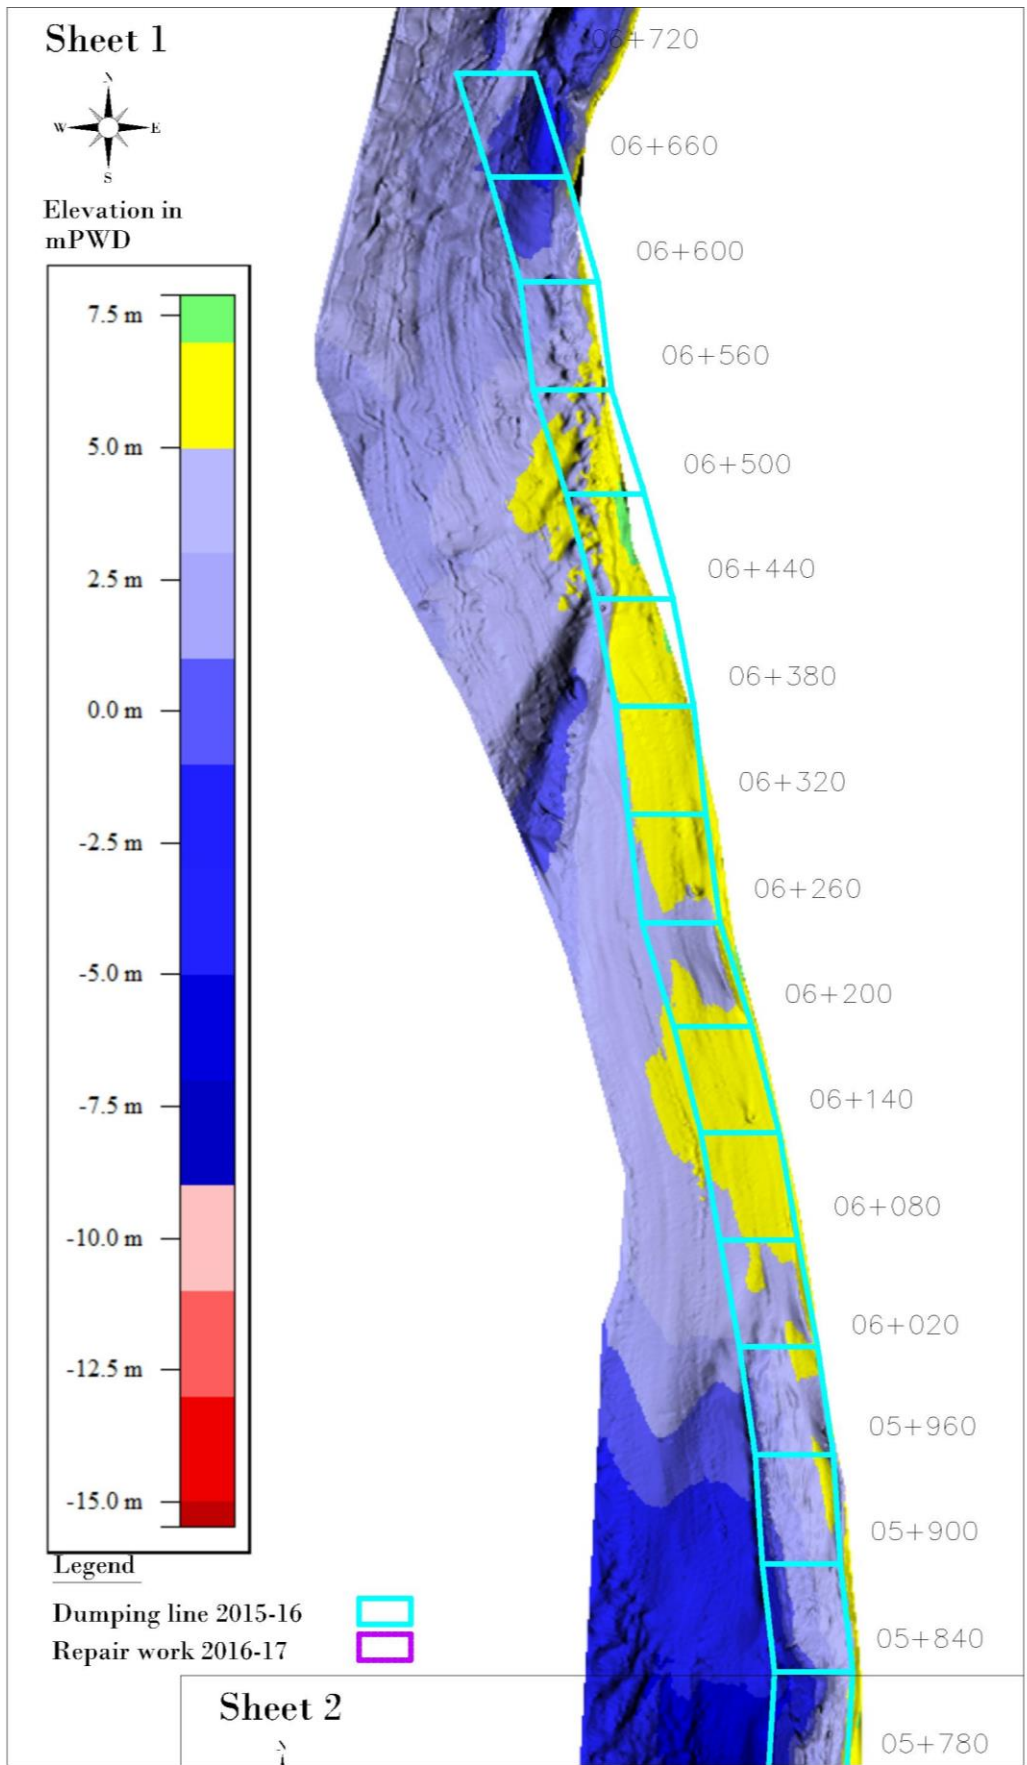
There is a bankfailure and underwater erosion near the outflank at km 6+700. In this location apron is buried under sediment and except the outflank no other erosion observed.

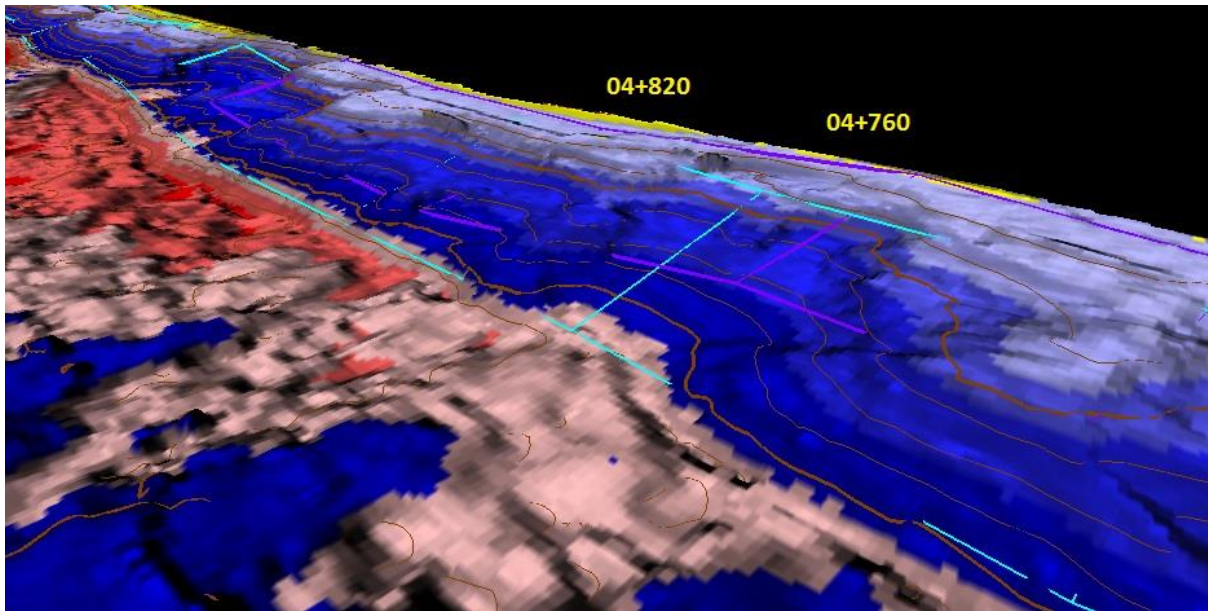
Figure 8-4 Under water erosion at km 04+760

At this location erosion was observed during the 2016-17 flood season. After 2017 flood this location starts filling and recent survey shows new scour but still the launched slope is not completely exposed. From the plan view eroded location, dumping plan, repair strips and location of the adaptation work can be seen.

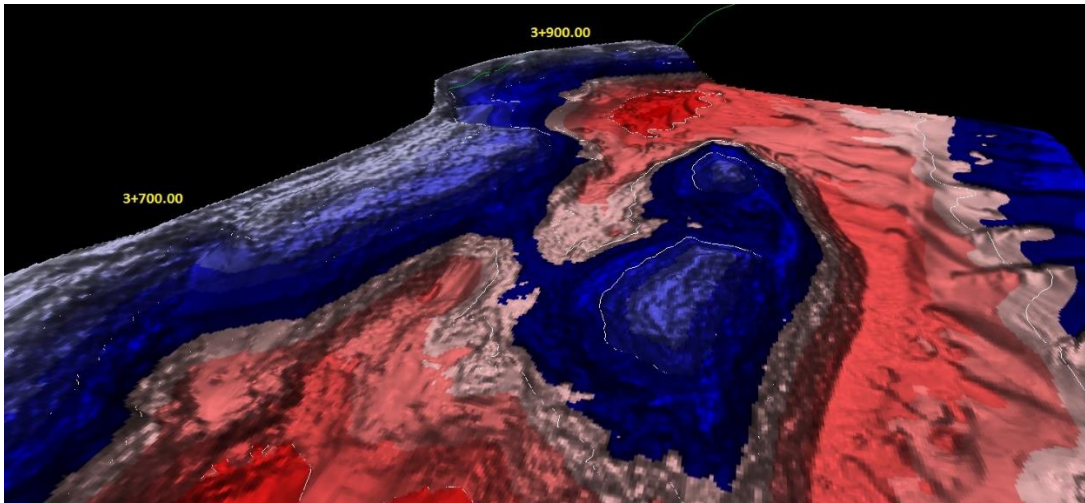
Figure 8-20 Under water erosion at km3+900.00 and launched slope

At this location near km 3+800, 100m from the bankline one big hump observed. This natural earth formation could be clay which did not eroded. This hump could disturb the flow which might aggravate the underwater erosion located from 3+700 to 3+300.

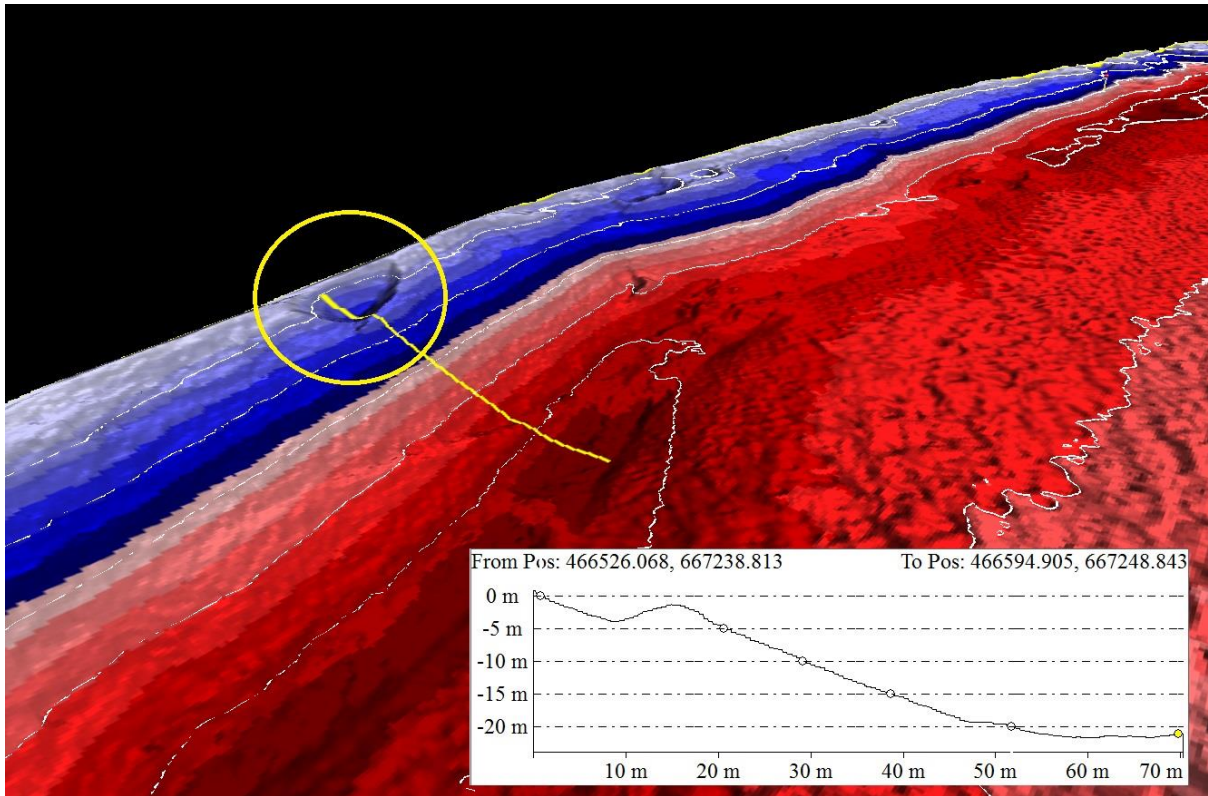
Figure 8-23 Pockets or holes at upperslope

At this location two pockets in dumping observed at km 2+900 and 2+800. Other location shows nicely launched slope.

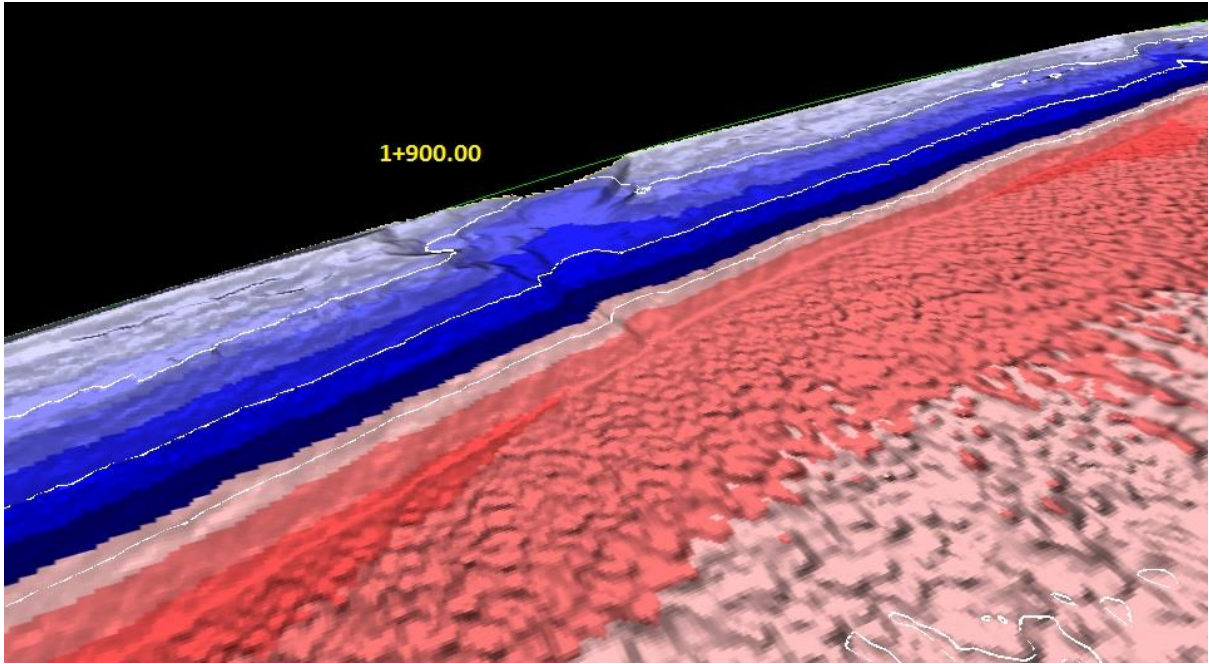
Figure 8-25 Under water slope failure at km 1+900

At this location, pockets in dumping observed at three places, those are at km 1+700, km 1+600 and km 1+400. One slip circle observed at km 1+900 .

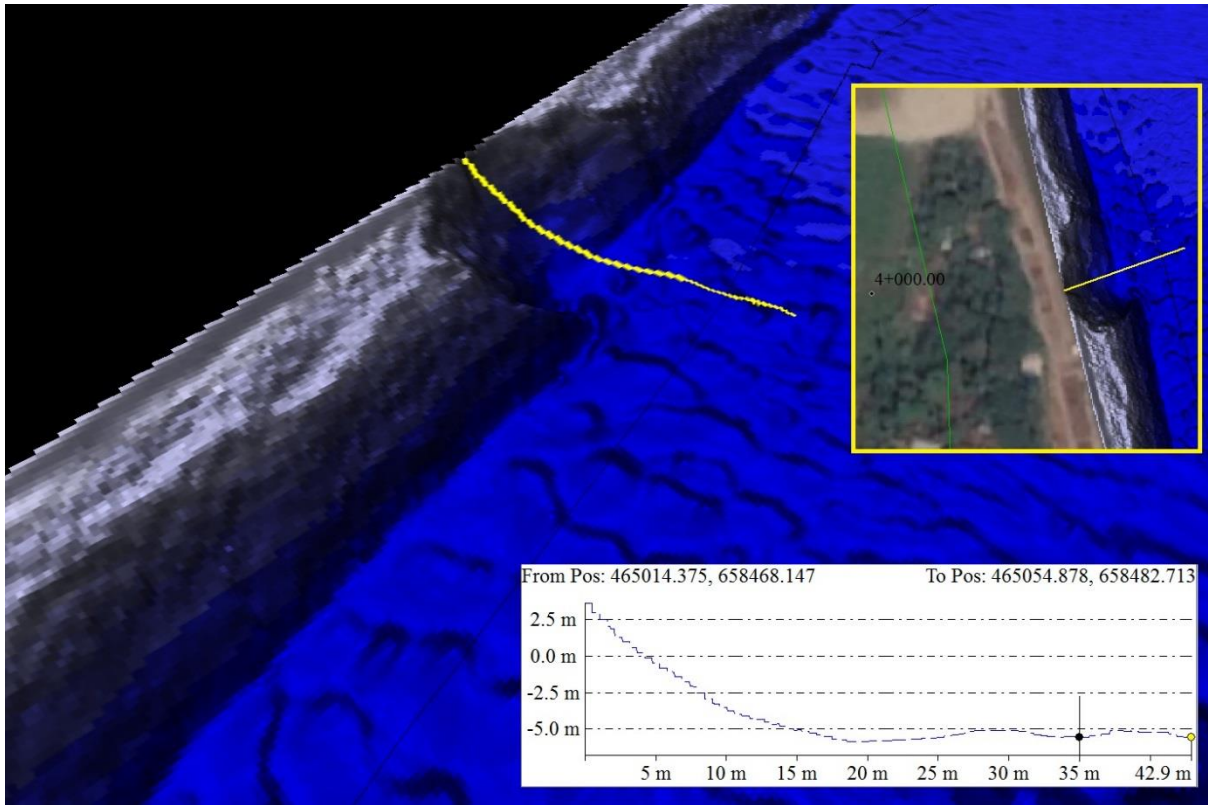
Figure 8-38 : Localized failure of the slope, potentially resulting from flow sildes triggered by rapid scouring

experience from Chauhali where similar shapes have been observed in 12 locations under much more severe attack, it can be assumed that this is related to flow slides. Flow slides are a result of rapid scouring and unloading of the toe of the protected works. They can only be controlled through wide aprons. As the approach channel turns sharply, resulting in pronounced bend scour, flow slides are likely. The lesson learned is that adaptation works has to be implemented immediately after the detection, in order to avoid progression of the flow slide and damage to the upper slope. The primary means to avoid the translation into the upper slope remains building wider aprons.

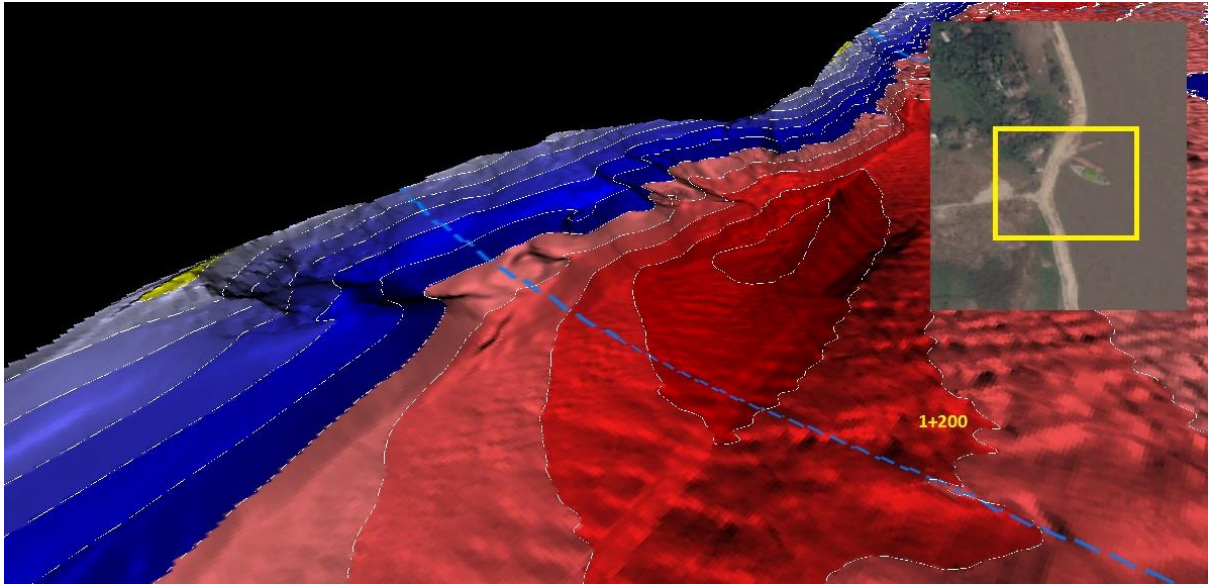
Figure 8-57 3D view of underwater launched geobag slope at bend area

At km 1+200, an inner bend formed. One slip circle observed there. Rest of the location has a 1V:2H launched slope.

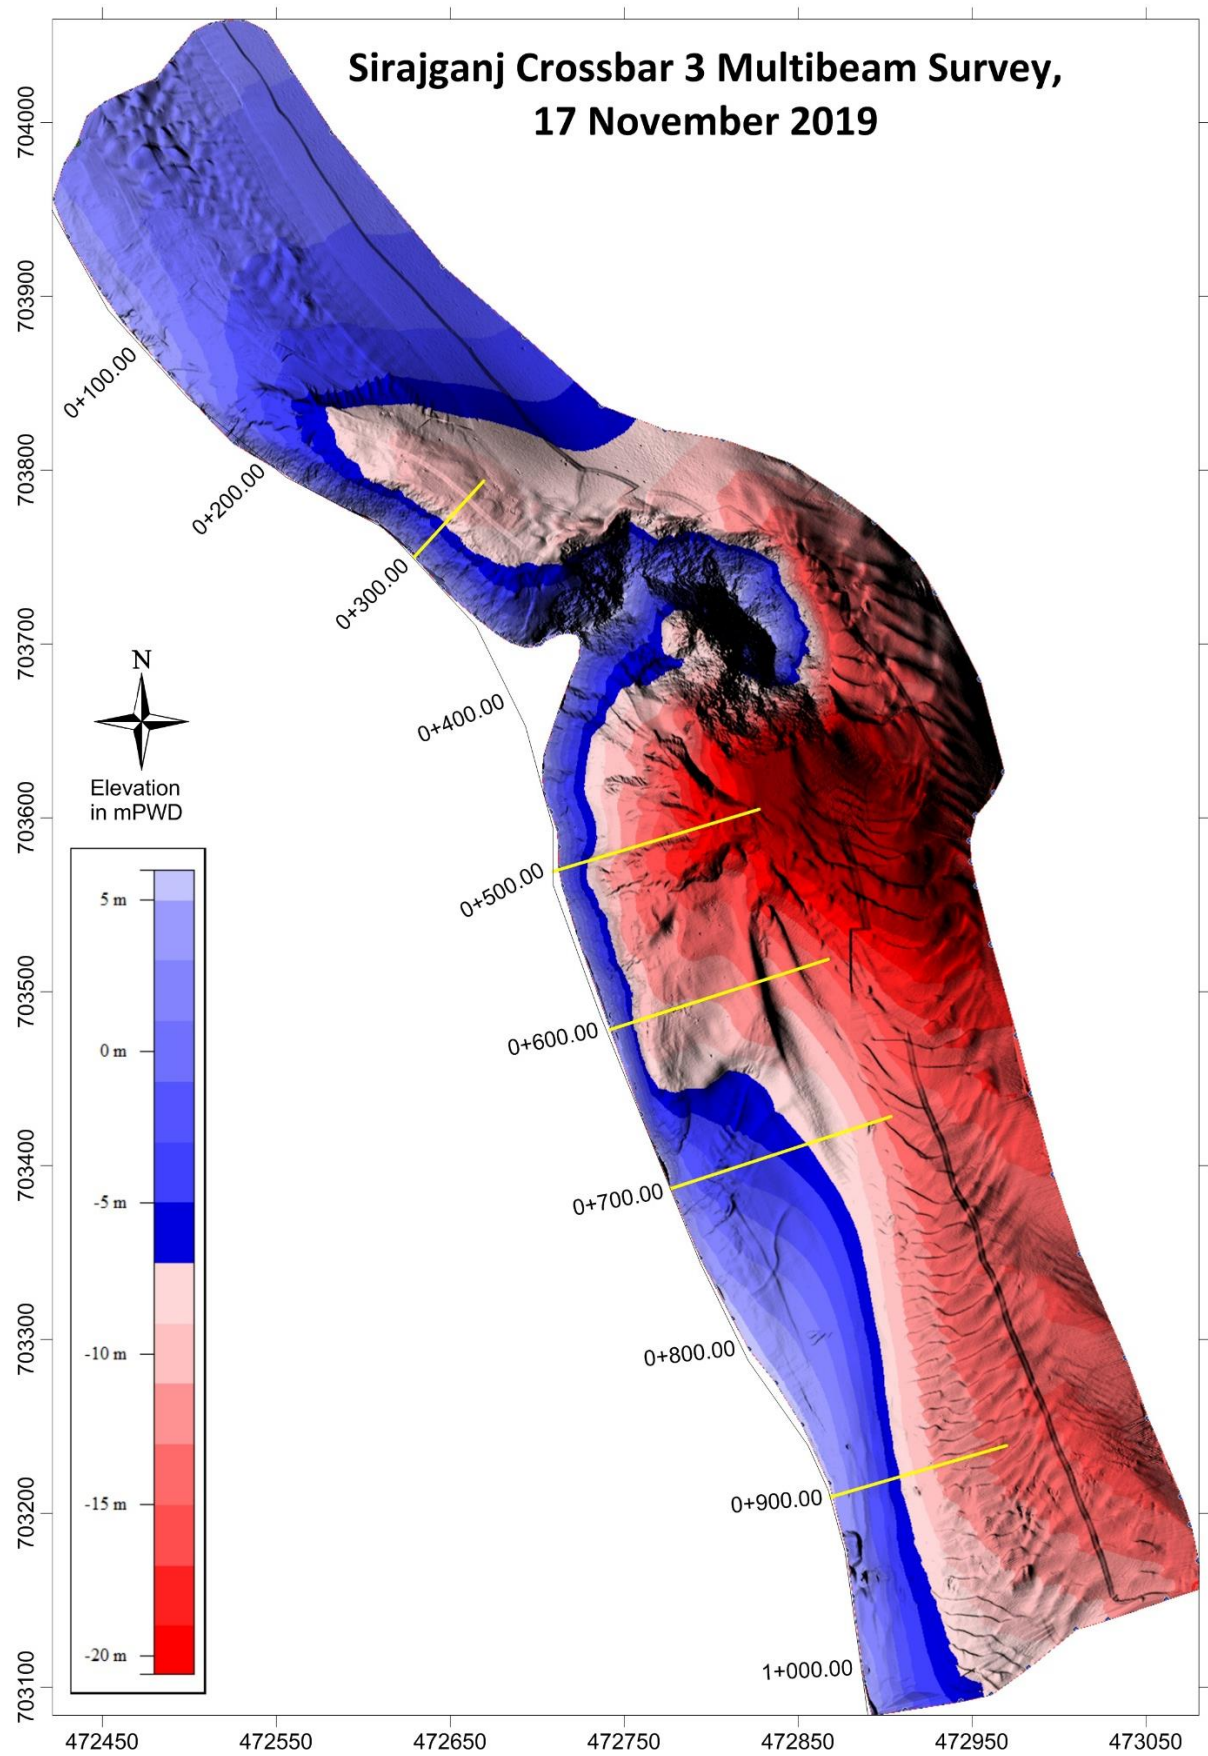
At Sirajganj cross bar 3 site upstream part is silted. At stn 0.4km there a heap of boulders that act like a spur and due to that downstream stn 0.5km was affected. Stn 0.6km shows launched stone covered slope. From stn 0.7km to downstream there sedimentation observed. Below some cross section was provided. The yellow line in the plan view represents the cross section line.
