FRERMIP – Monitoring of EMP Implementation – Round 2

21/22 March 2016: Harirampur, Zafarganj, Chauhali

FRERMIP – Monitoring of EMP Implementation

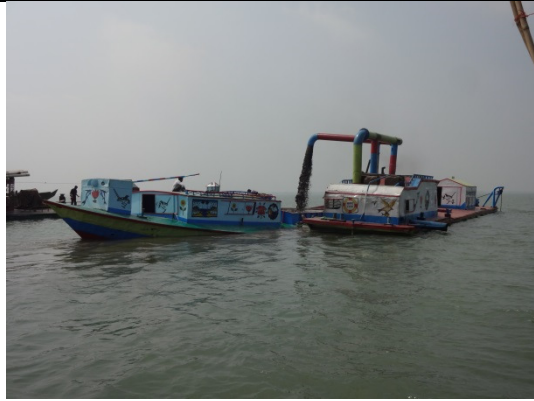
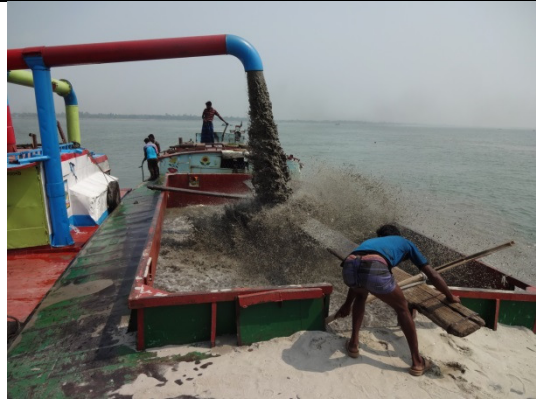
1. Sand mining from a dredger in the middle of Padma River

2. As Picture 1

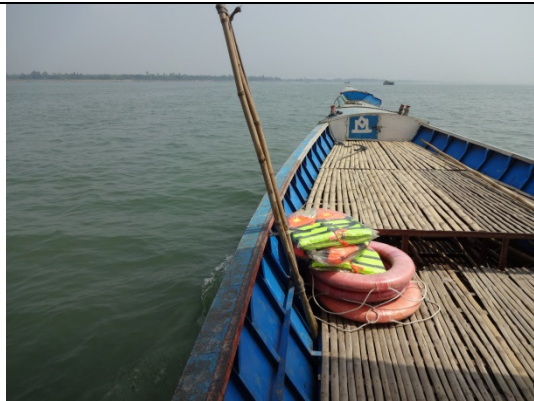
2.3.1	Safety equipment to prevent accidents / injuries		
	Helmets & life jackets / buoys	2	Some equipment (helmets/vests) has been acquired and is available in inspection barge (not used though). Workers on dredgers and sand filling barges do not wear or use safety equipment.
	Traffic control signboards	0	None recorded.
	Guards / walkways / etc	0	Walkways on sand filling barges are available but there are no guards

3. Life-jackets aboard inspection barge (un-used)

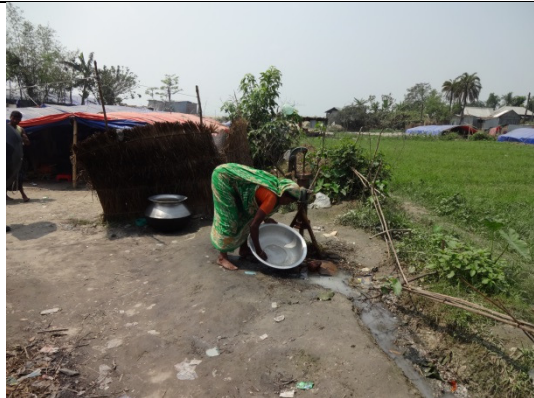
2.4.2	Lay-out drawings		
	Submission on demand		Not assessed.
2.4.3	Sanitation conditions & waste management		
	Water supply	1	Few standpipes are available but there is no concrete platform around and drainage pipe away from these to divert wastewater that could pollute source. Open pit wastewater dump amidst tents or near toilets. Unhealthy conditions.
	Sanitation (toilets etc)	1	Some 30 latrines provided (= 1400 / 30 = 50 persons/latrine), that all lack proper doors; drainage into open pits (that appear full) that cause nuisance to villagers in surroundings. Villagers complain openly.
	Waste management	1	No waste bins available for paper / plastic.

5. Washing at tubewell in worker's camp

13. Install proper fencing as may be needed.	13. Asap
14. Improve waste water management around water points.	14. With immediate effect.
15. Improve sanitation facilities in line with villager's complaints.	15. With immediate effect.
16. Identify, introduce and operate an environmentally sound disposal system for discarded fuel and lubricants and other waste from machinery, as needed.	16. Asap.
17. Develop, introduce and operate a formal Grievance Redress Mechanism.	17. Asap.

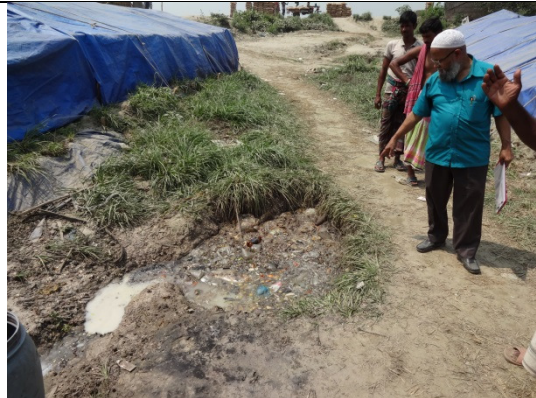
EMP Clause	Item	Score	Comment
	Waste disposal at worker camps	1	Solid waste in camp sites (paper / plastic / kitchen spoils) is not collected; there are no waste bins on site. Liquid waste flows in open pit depressions amidst dormitory/tent sites, attracting flies and other nuisance. Toilet facilities are considered poor. Villagers openly complain about bad smells.

6. Wastewater dump near worker's dormitory (tent)

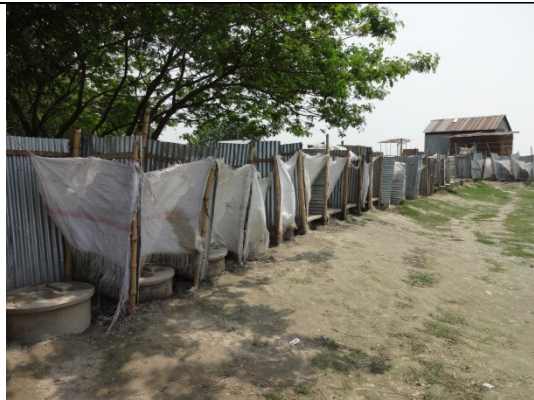
7. Toilet facilities for 1400 labourers

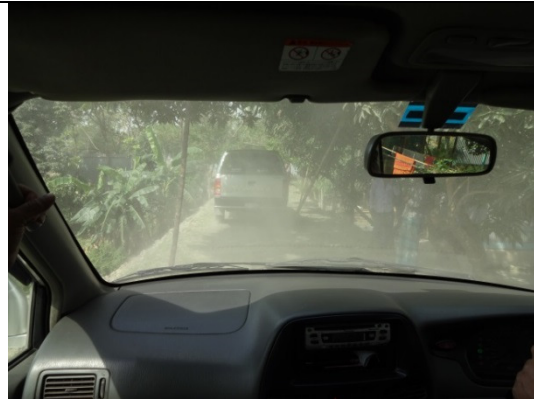
2.2.2	Roads		
	Road inspections.		Not recorded.
	Road use & maintenance.	1	Roads are not sprinkled; however, vehicle movement is limited anyway.
2.2.3	Excavation of earth in slope protection		
	Excavation is accordance with approvals.		Not discussed or noted.

1. Dust from moving vehicles

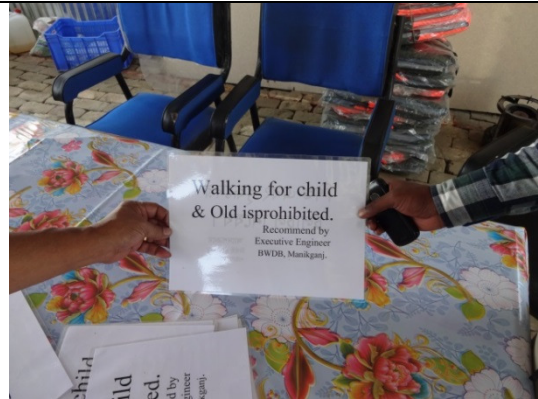
2.3.1	Safety equipment to prevent accidents / injuries		
	Helmets & life jackets / buoys.		Some equipment available (life jackets) in Contractor's office but not (yet) used
	Traffic control signboards.		Signboards are being prepared.
	Guards / walkways / etc.		Not noted or discussed.

2. Signboards meant for display (backside in Bangla)

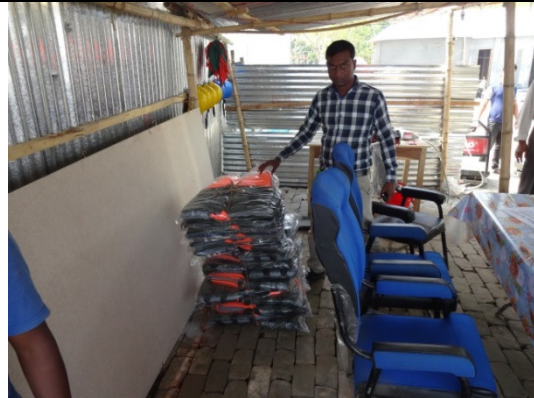
3. Life-jackets (un-used)

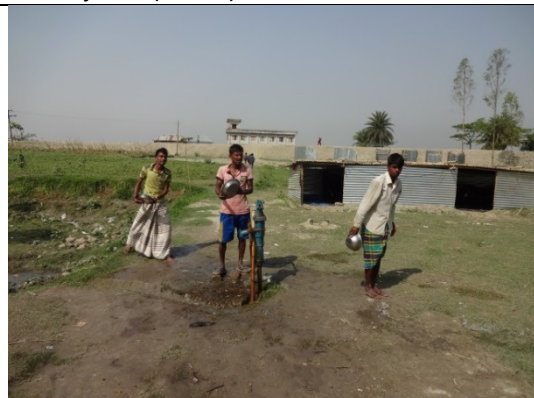
5. Washing at unprotected tubewell in worker's camp

13. Install proper fencing as may be needed.	13. Asap
14. Improve waste water management around water points.	14. With immediate effect.
15. Improve sanitation facilities in line with villager's complaints. 6 latrines for 400 workers (1:66) seem insufficient; aim at 1:25.	15. With immediate effect.
16. Identify, introduce and operate an environmentally sound disposal system for discarded fuel and lubricants and other waste from machinery, as needed.	16. Asap.
17. Develop, introduce and operate a formal Grievance Redress Mechanism.	17. Asap.

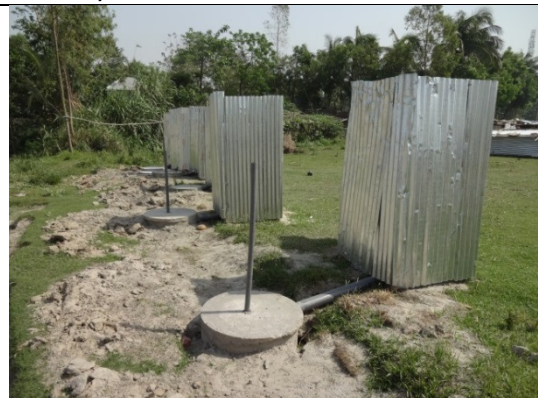
6. Toilets (6) for about 400 workers

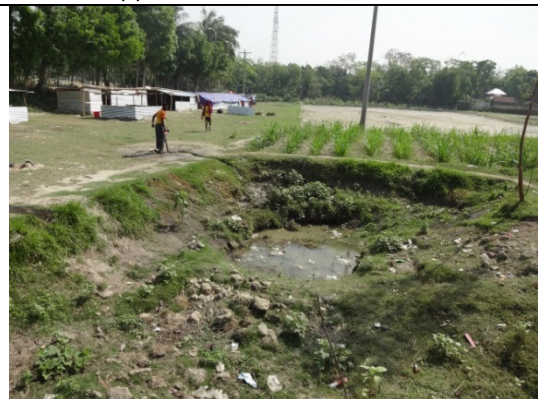
EMP Clause	Item	Score	Comment
	Waste disposal at worker camps.	1	No wastebins available; wastewater in worker's camp is drained in open pit.
2.1.5	Disruption of agricultural activities		
	Minimizing disturbance.		Not noted / recorded.
	Compensation arrangements.		A land lease has been entered.

EMP Clause	Item	Score	Comment
	Clearing obstructions, grading, working / storage sites.		Not noted.
	Protection of existing structures.	3	
	Maintenance of temporary roads.	2	Dust generation on temporary road to worker's camp.
	Building maintenance.	3	Building under construction
	Site fencing.	3	Most sites have been fenced.
	Equipment management.		Not assessed.
2.4.2	Lay-out drawings		
	Submission on demand.		Not assessed.
2.4.3	Sanitation conditions & waste management		
	Water supply.	1	1 unprotected borehole is available.
	Sanitation (toilets etc).	2	6 toilets are available
	Waste management.	1	No wastebins are available; wastewater is drained in an open pit.

8. Wastewater drainage pit

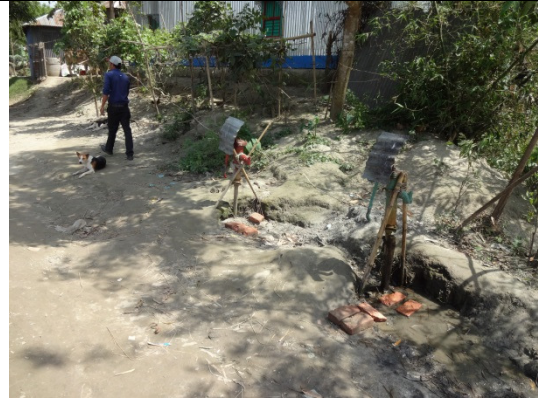
2. Two tubewells in worker's camp, one is operational.

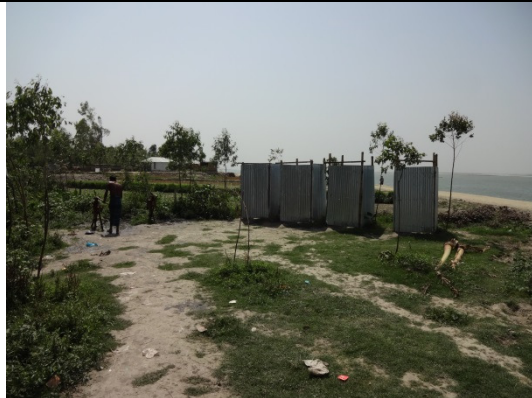
3. Toilets (4) in worker's camp (for about 350 workers).

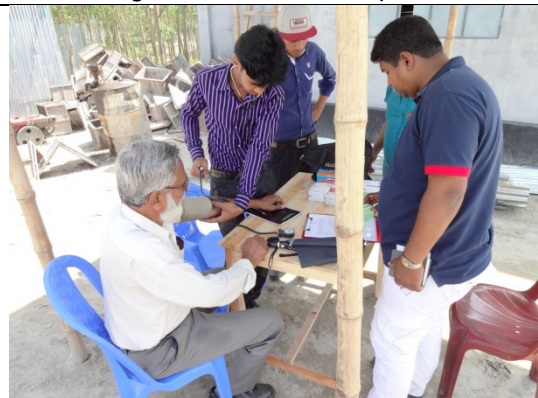
2.3.2	First aid		
	First-aid nurse.	3	Nurse available and met; demonstration of equipment given.
	Qualified medical doctor.	0	Not noted.
	Health inspection & vaccination to workers.		Not discussed.

6. Nurse on-site demonstrating blood pressure equipment.

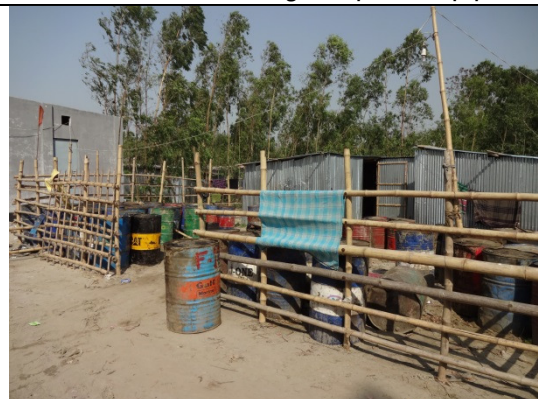
EMP Clause	Item	Score	Comment
	Protection of existing structures.	2	Fencing constructed, however accessible
	Maintenance of temporary roads.		Not discussed or assessed.
	Building maintenance.		Not noted.
	Site fencing.		Fencing constructed, however accessible to public
	Equipment management.		Not assessed.
2.4.2	Lay-out drawings		
	Submission on demand.		Not discussed.
2.4.3	Sanitation conditions & waste management		
	Water supply.	1	Two tubewells noted, both lacking protection and proper discharge.
	Sanitation (toilets etc).	1	Existing toilets (about 1 per 90 workers) is insufficient.
	Waste management.	0	No wastebins or proper management system in place.

8. Fencing of fuel & lubricant storage
