Subject: Draft EMP compliance report for PMO completion

**FRERMIP – Monitoring of EMP Implementation
Chauhali bank protection site**

FRERMIP – Monitoring of EMP Implementation Zafarganj Bank protection site

FRERMIP – Monitoring of EMP Implementation – Round 1
5 and 10 January 17: Chauhali and Zafarganj

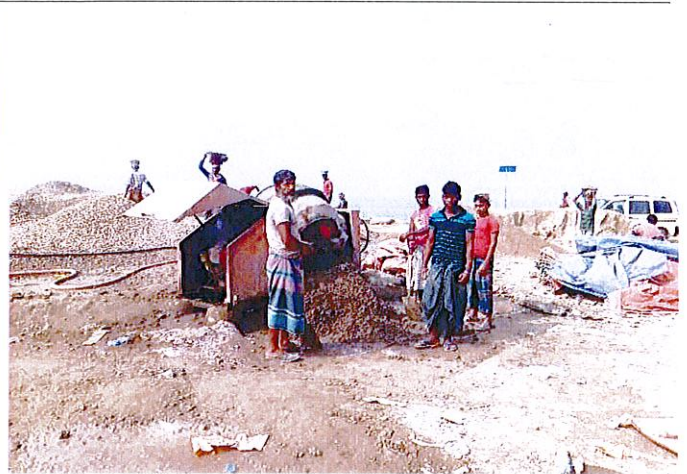
2. Concrete mixture machine is operating without safety instrument.

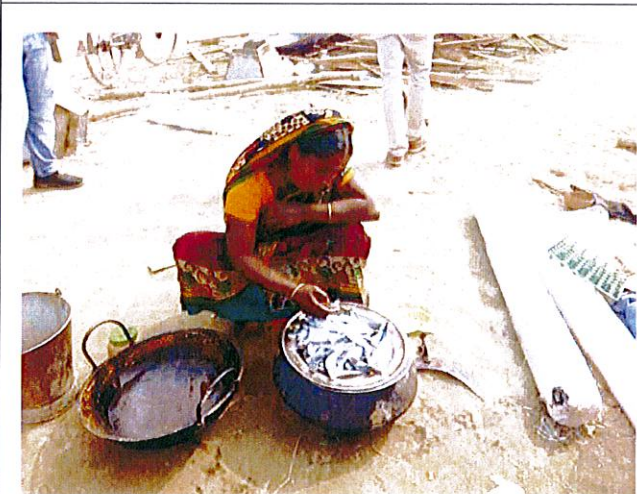
3. Cooing is done in open sky

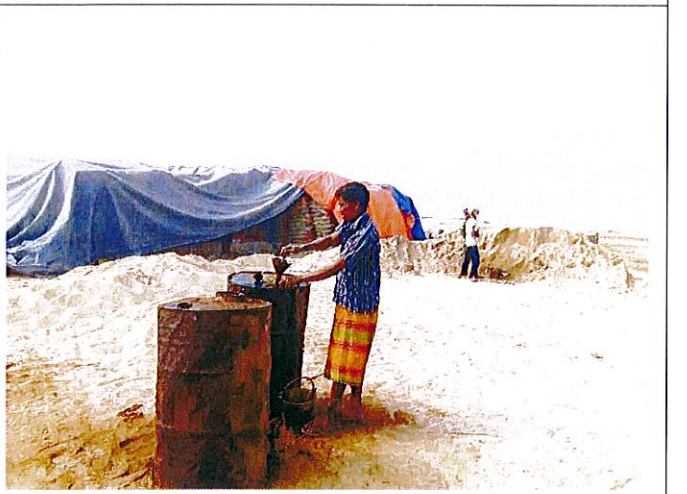
2.1.4	Pollution		
	Preventing spills of lubricants and fuel.	2	According to the Contractor there are fuel or lubricant spills occasionally but these are then removed and dumped somewhere inland. Used lubricants are collected in a container and periodically sold in the market, reportedly.
	Waste disposal at work sites.	2	Contractor reported the waste is collected at a place and carried away and dumped in a safe place.
	Waste disposal at worker camps.	1	A few waste bin was found during the visit. But organic solid waste is not putting in the bins properly. Waste were seen lying around the worker’s camp.

4. Lubricants and fuel is used contaminating ground arround

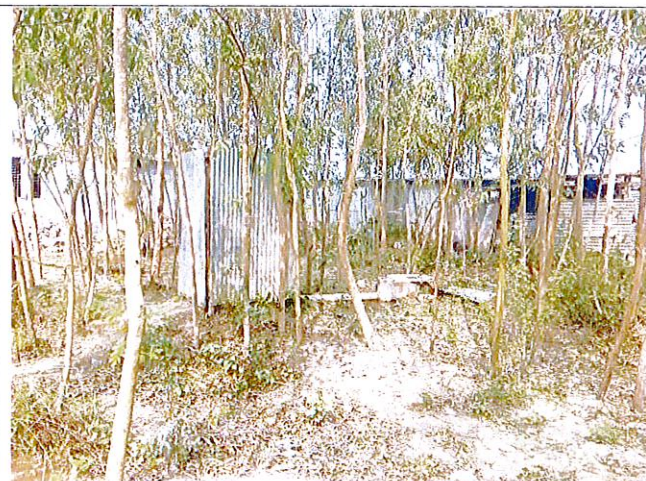
5. Toilets with sock pit and cover

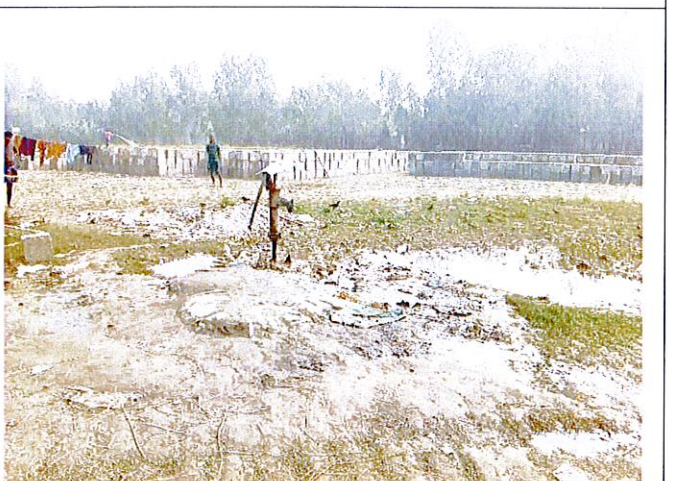
2.4.2	Lay-out drawings		
	Submission on demand.		Not discussed.
2.4.3	Sanitation conditions & waste management		
	Water supply.	1	No improvement was noted in the existing tube wells; there is no protection and so are still defunct.
	Sanitation (toilets etc).	2	Number of sanitary toilet increased found; About 1 person per 25 workers was estimated.
	Waste management.	1	A few waste bins are found near kitchen. Still no proper management system in place.

6. Tube well with no protection directly discharging in nature

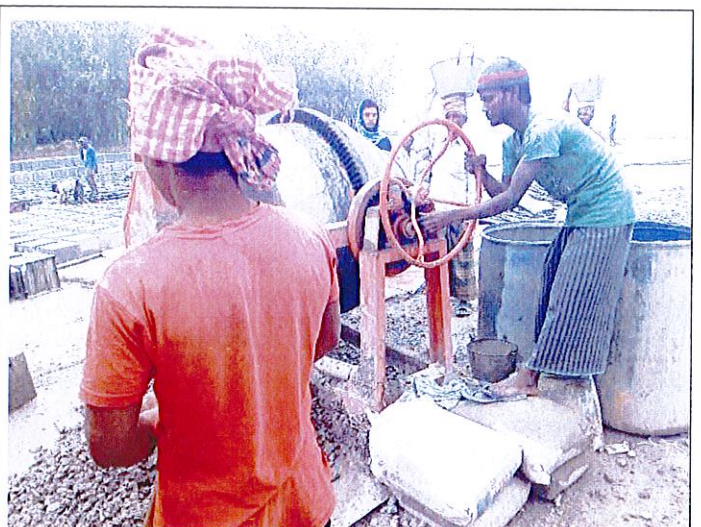
2. Concrete mixture machine is driven without safety equipment

14. Prepare and submit monthly environmental reports and establish a proper filing system for these.	14. As from Jan 2017.
15. Install proper noise silencer on boat and concrete mixture machine.	15. As needed.

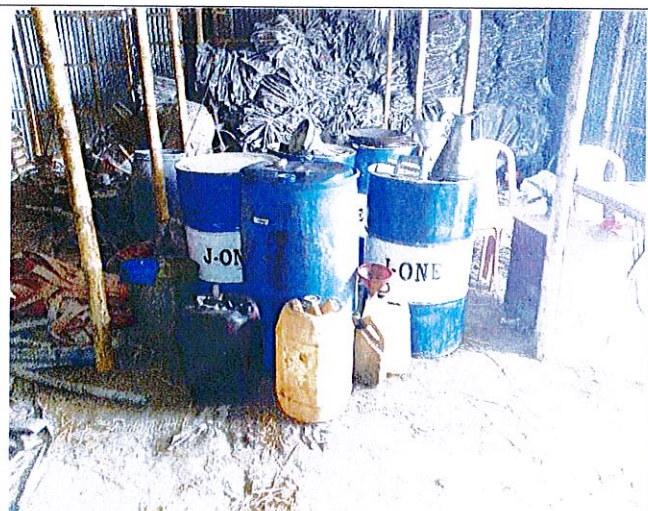
2.1.4	Pollution		
	Preventing spills of lubricants and fuel.	3	The lubricants and fuel drum is stored in a store in two sites where the manufacturing of blocks is being done. The lubricants and fuel are carrying in a container to the machine where it is being used. It is reported used oil and lubricants are collected in a container which is then collected by someone and disposed of. No significant spills of lubricants and fuel was not found during the visit.
	Waste disposal at work sites.	1	Contractor reported the waste is collected at a place and carried away and dumped in a safe place.
	Waste disposal at worker camps.	1	No wastebins available; wastewater in worker's camp is drained in open pit.

3. Lubricants and fuel stored in go down

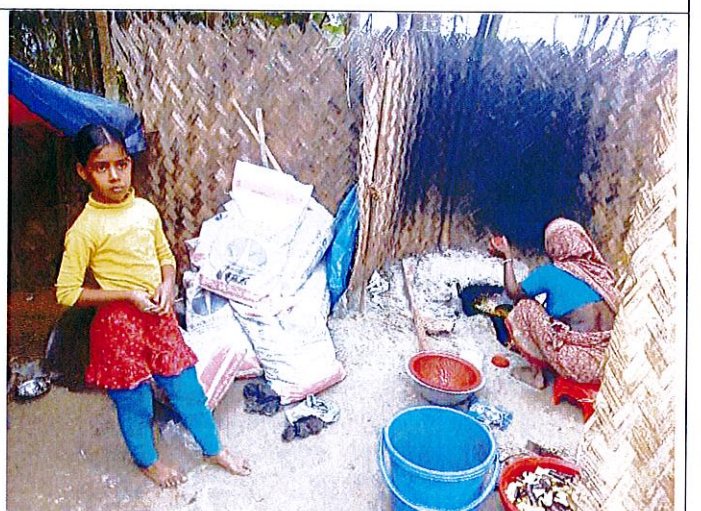
4. Kitchen without rooftop

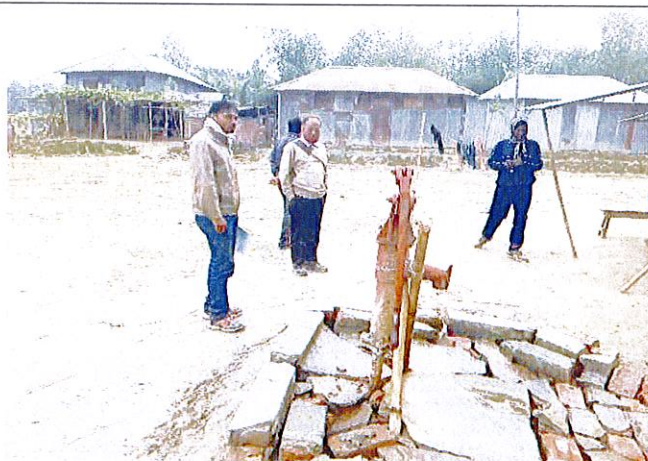
2.4.2	Lay-out drawings		
	Submission on demand.		Not assessed.
2.4.3	Sanitation conditions & waste management		
	Water supply.	2	Tube wells are not protected. Contractor reported the work just started, could not complete protection work-promised to complete the protection very soon
	Sanitation (toilets etc).	2	14 toilets are available
	Waste management.	1	No wastebins are available; wastewater is drained in an open pit.

5. Broken protection of tube well

17. Improve waste water management around water points.	17. Asap
18. Improve sanitation facilities and increase number of toilets.	18. With immediate effect.
