Memo

Re: Site monitoring from 2015 to 2017

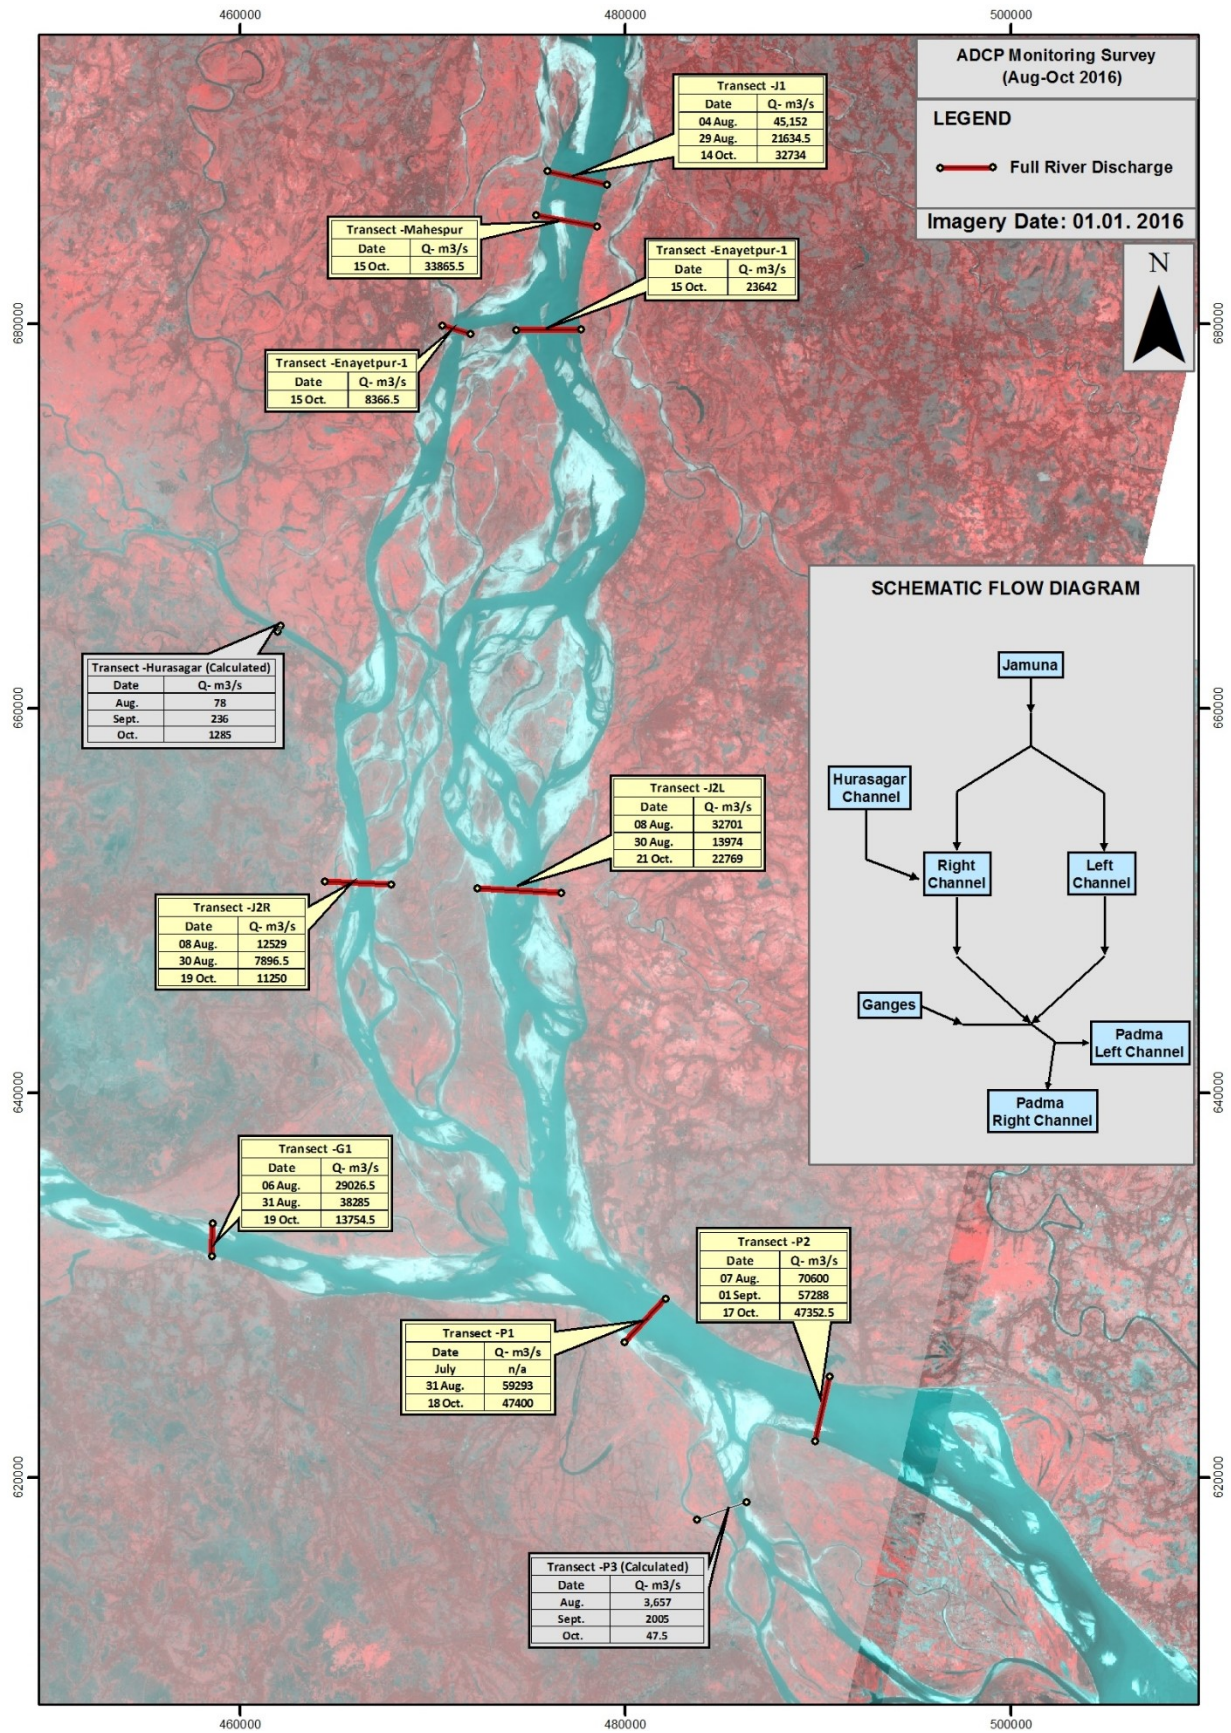
Figure 2-1 Discharge measurements and float tracks during different times of the 2016 flood

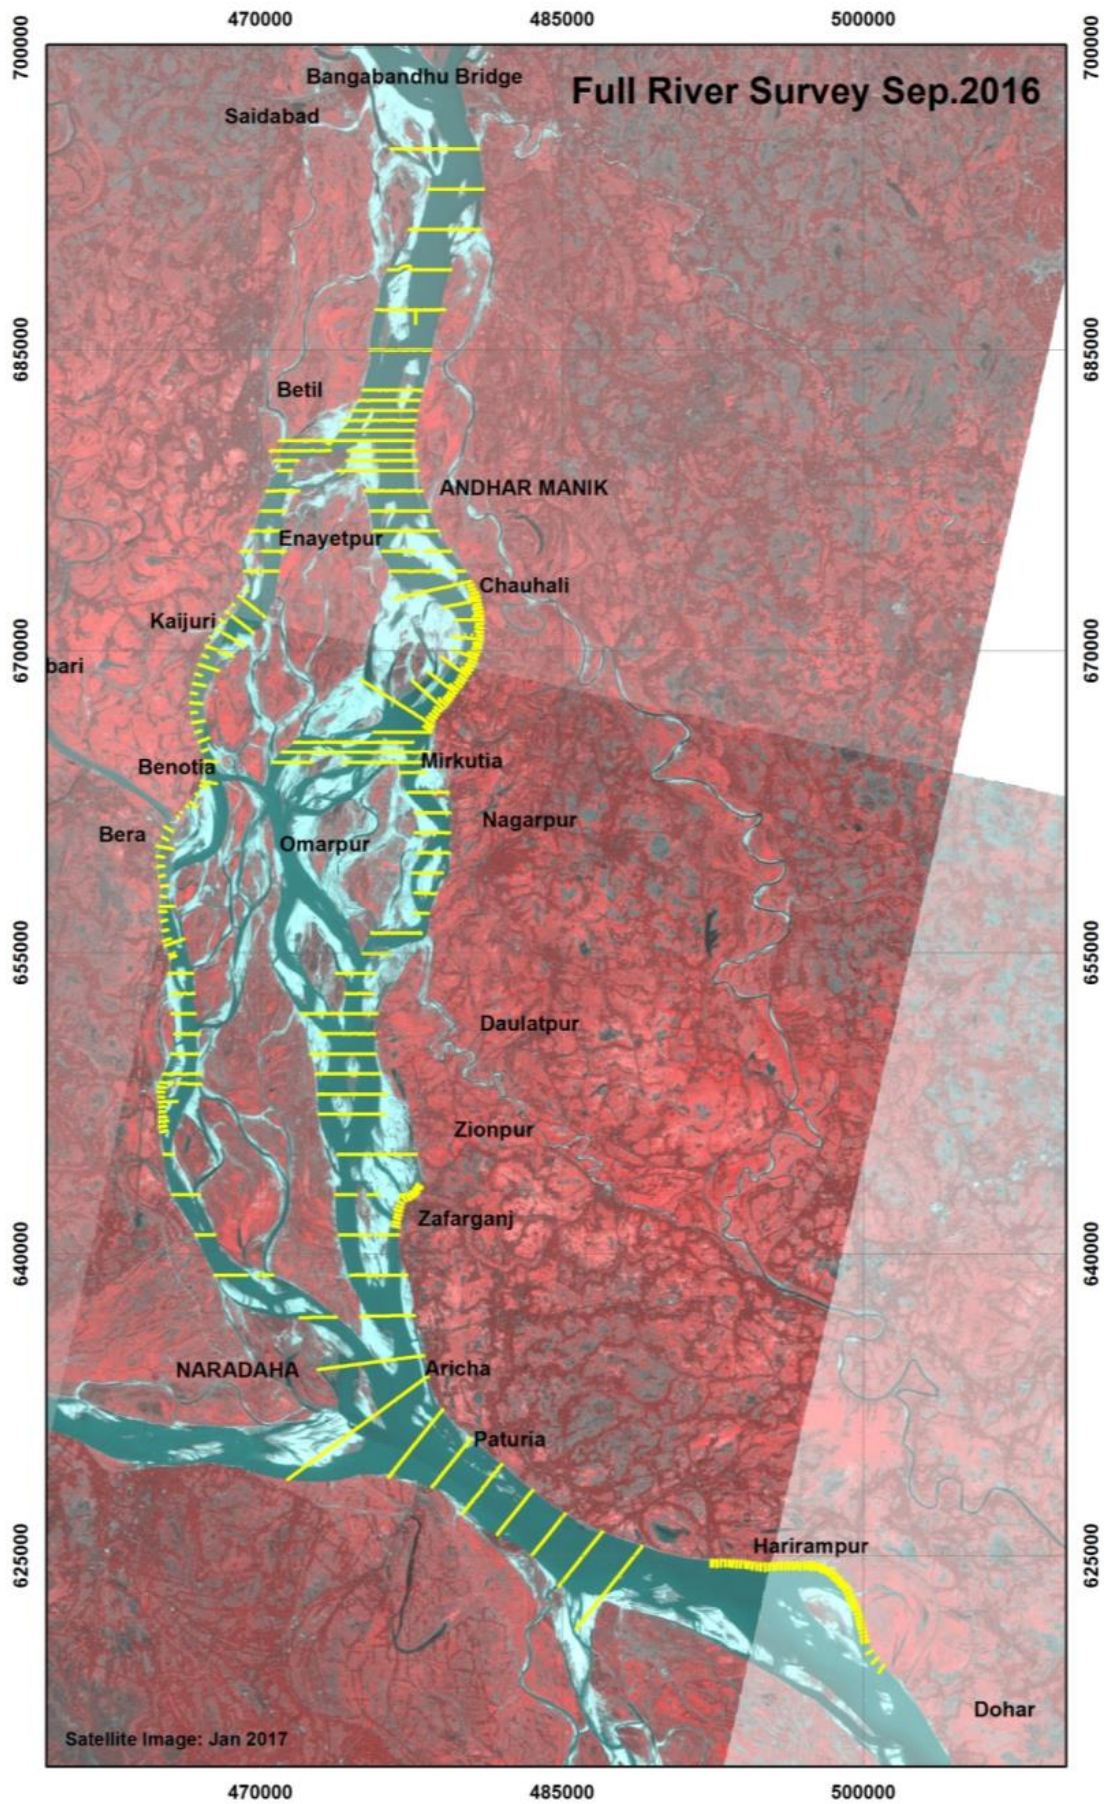
Figure 2-2 General River monitoring coverage area

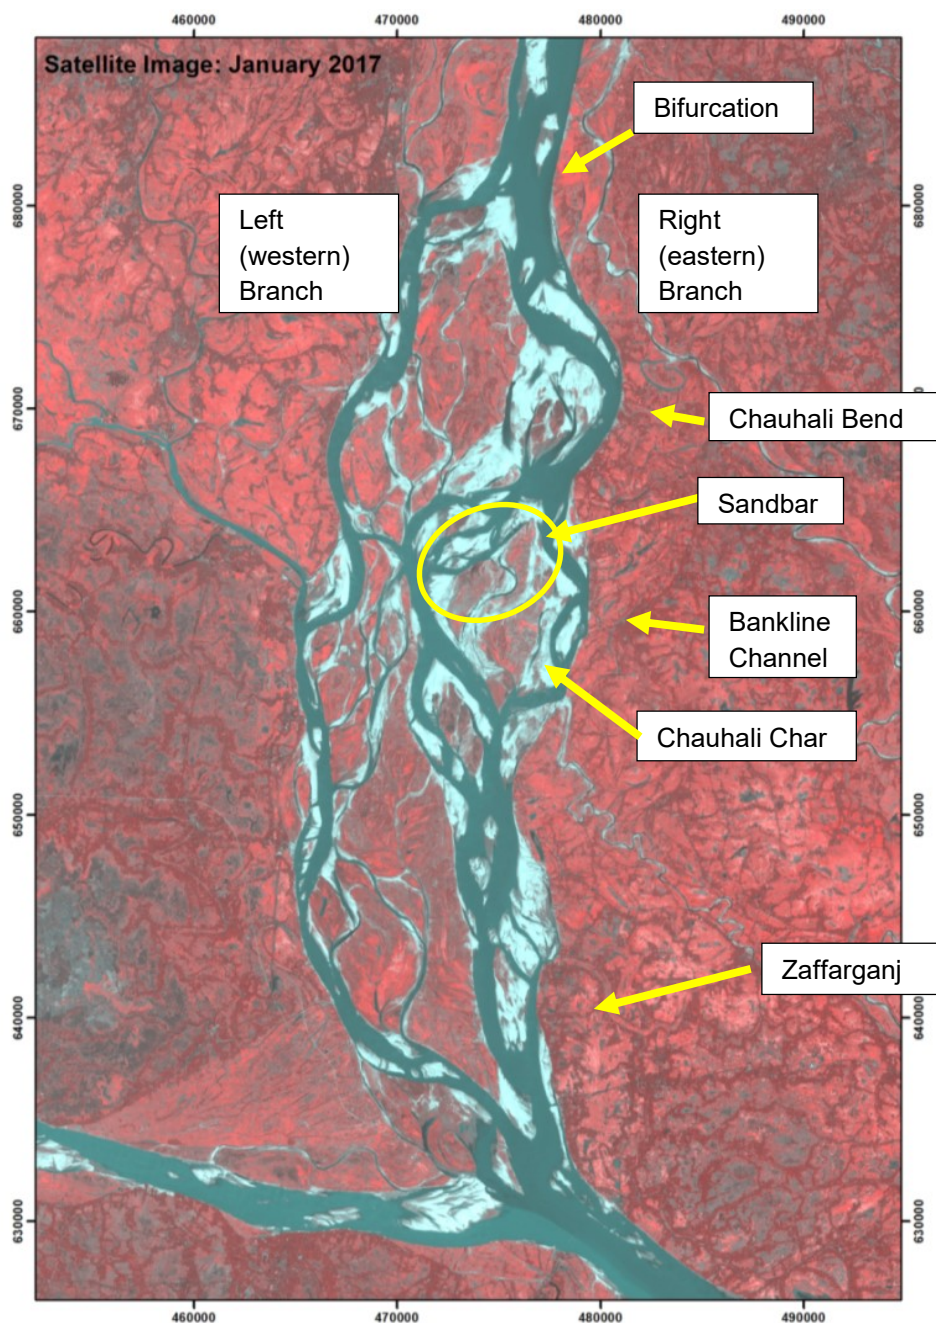
- (vi) There is no indication that Zafarganj remains under heavy flow attack. In September the flow appears to be not moving towards Zafarganj, but stay away from the upstream bankline and flows fairly straight to the south, parallel to the riverbank downstream of Zafarganj. The dry season image shows that Zafarganj is sheltered by large sand bars (Figure 2-5).

The dry season situation is depicted in Figure 2-5.

Figure 2-5 Dry season channel pattern of the Lower Jamuna River, January 2017

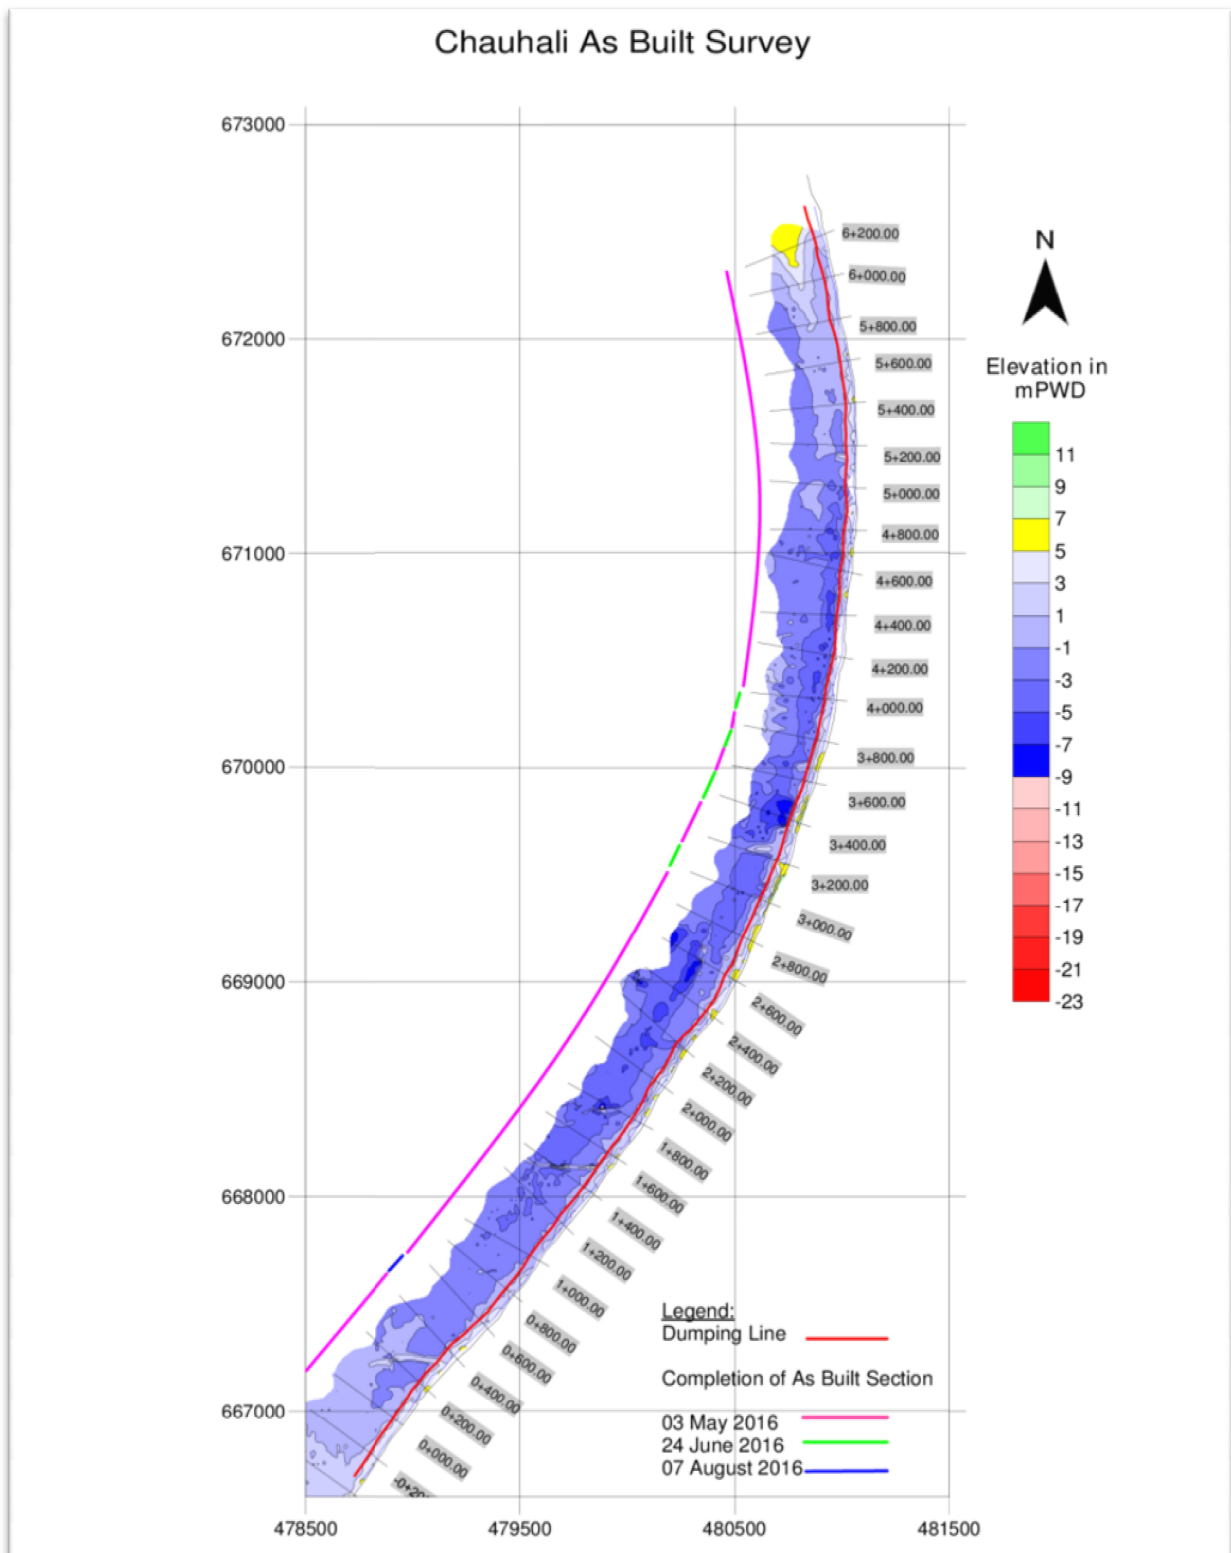
Figure 3-1 2016 as-built survey Chauhali

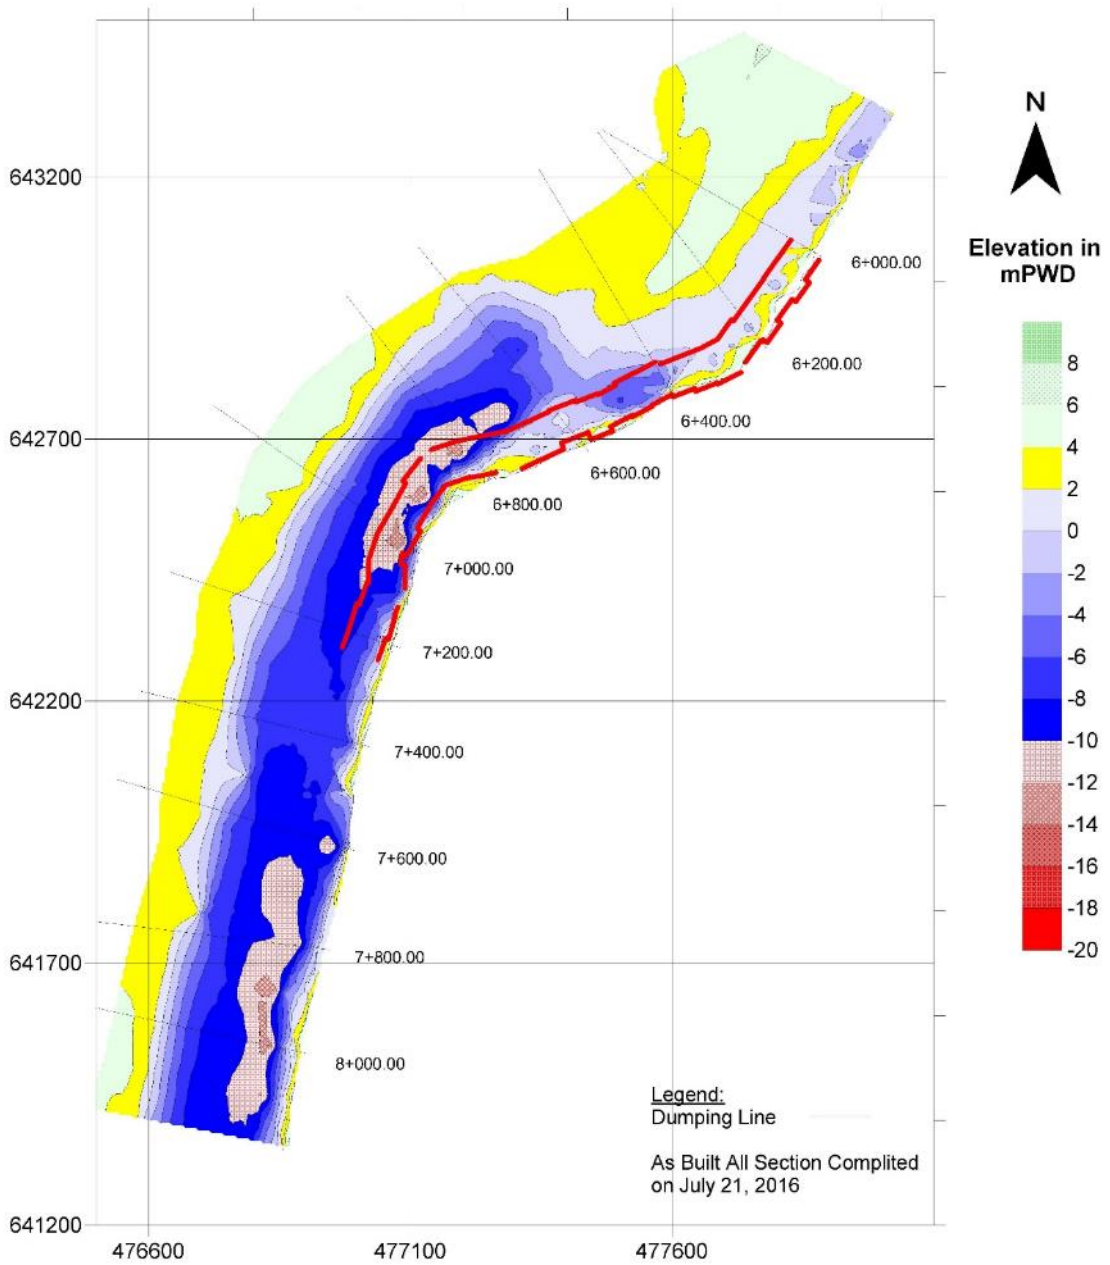
Zaffarganj As Built Survey

Figure 3-2 2016 as-built survey at Zafarganj

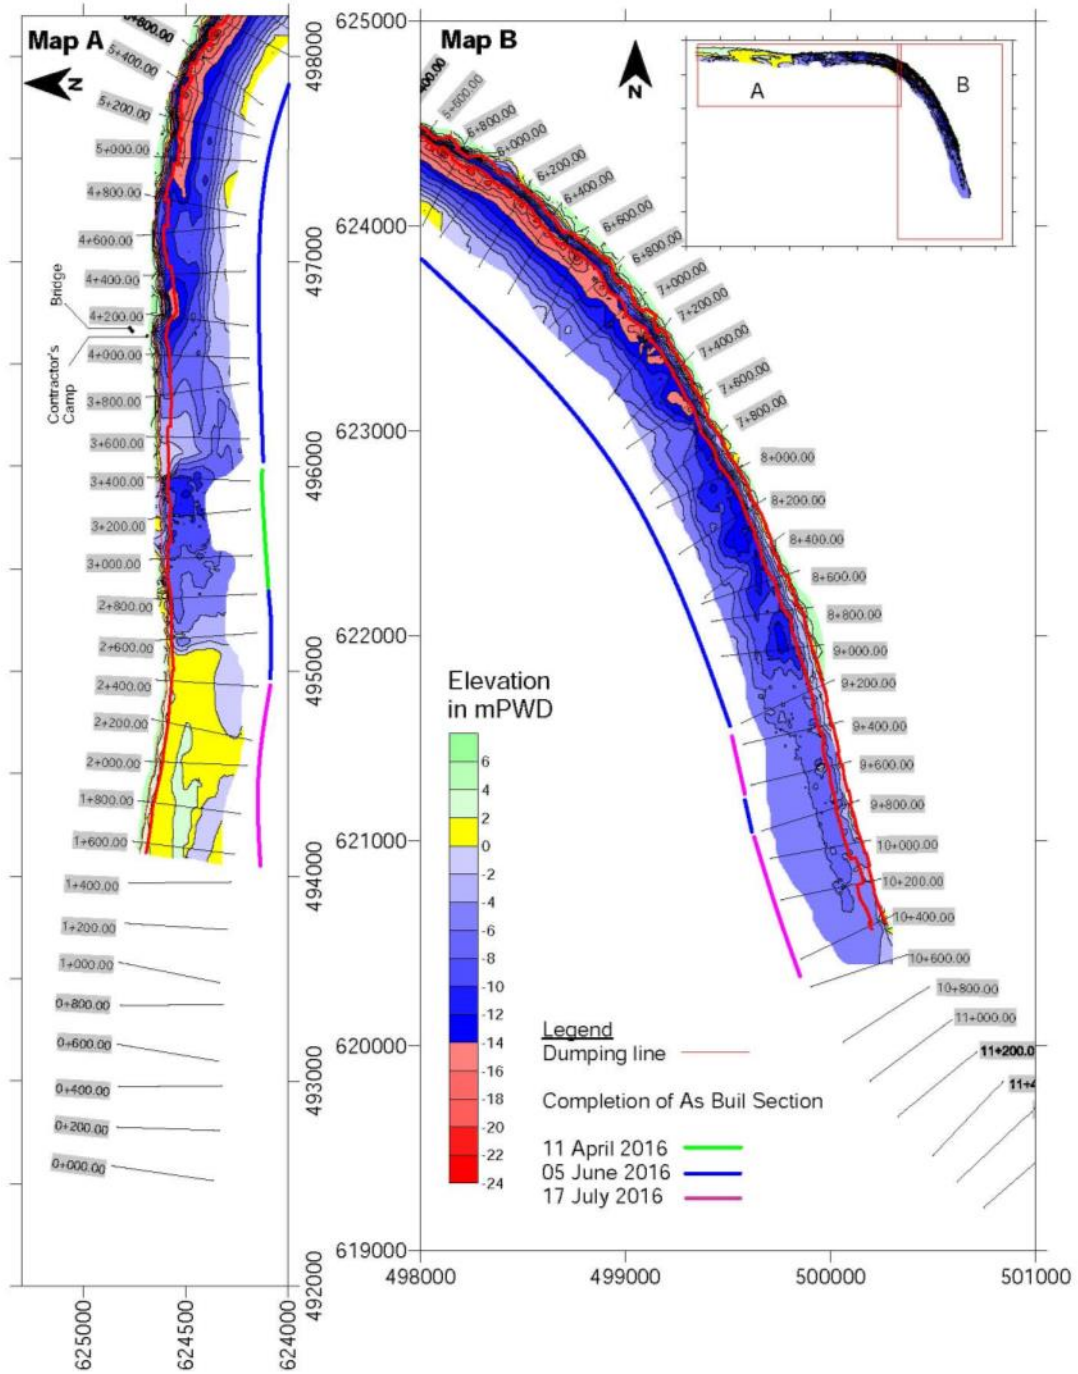
Harirampur As Built Survey

Figure 3-3 2016 as-built survey at Harirampur

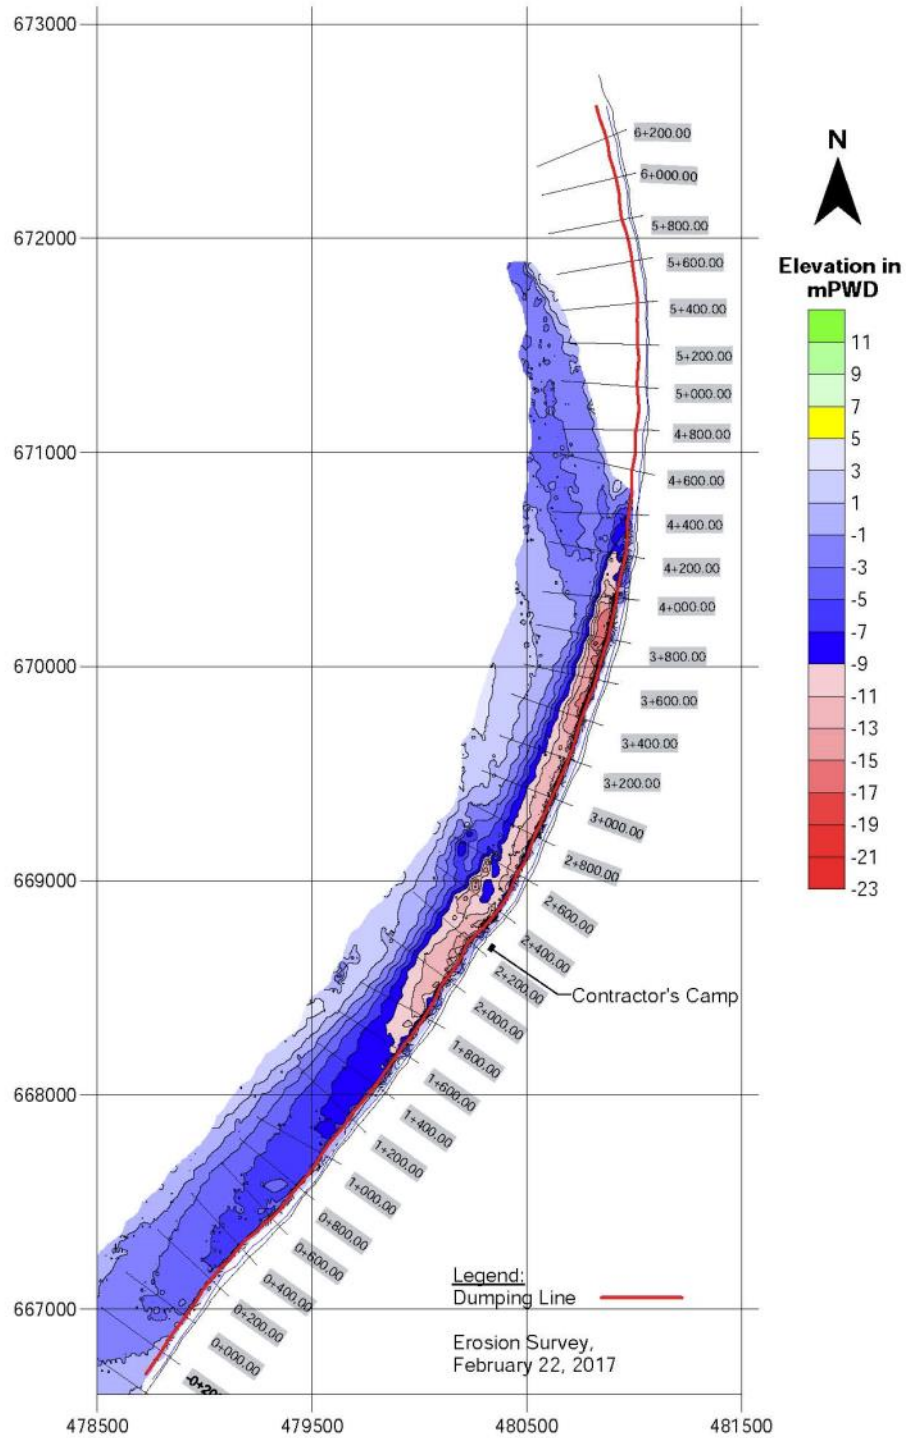
Chauhali Survey, February 2017

Figure 3-4 Chauhali February 2017 pre-work survey for adaptation works

in Zaffarganj (Figure 3-5) and before adaptation works in Chauhali and Harirampur (Figure 3-4 and Figure 3-6).

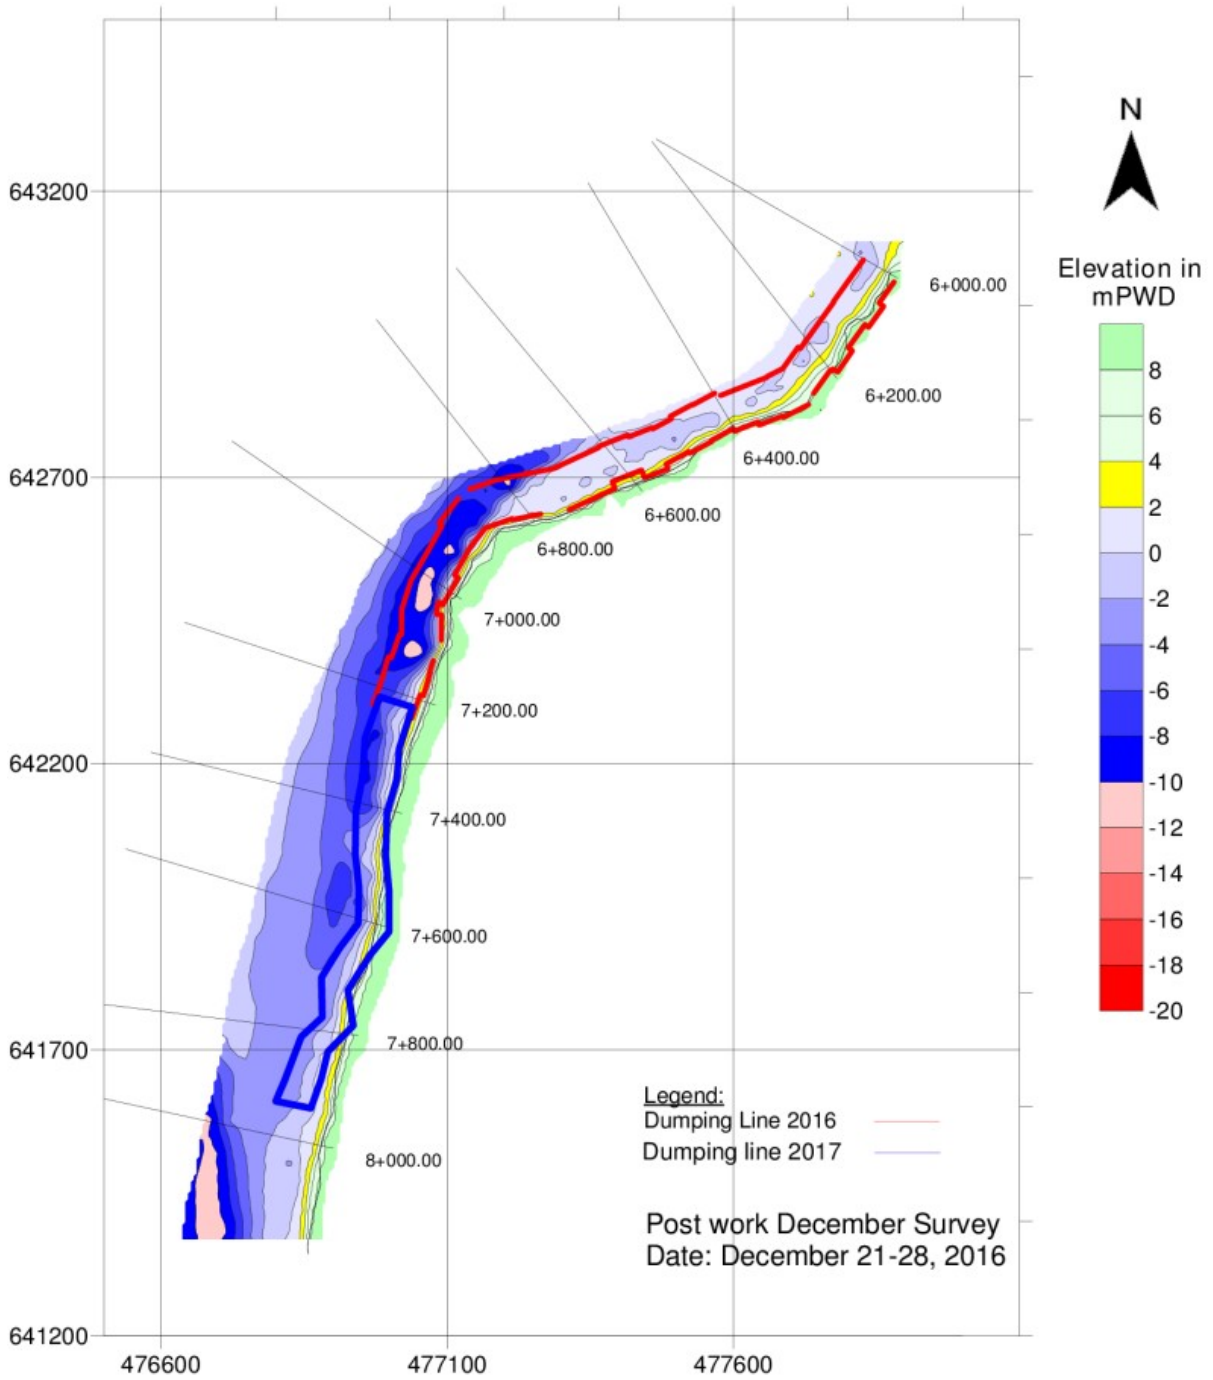
Zaffarganj Bathymetric Survey, December 2016

Figure 3-5 Zafarganj December 2016 pre-work survey, for 2016/17 works (shown in blue)

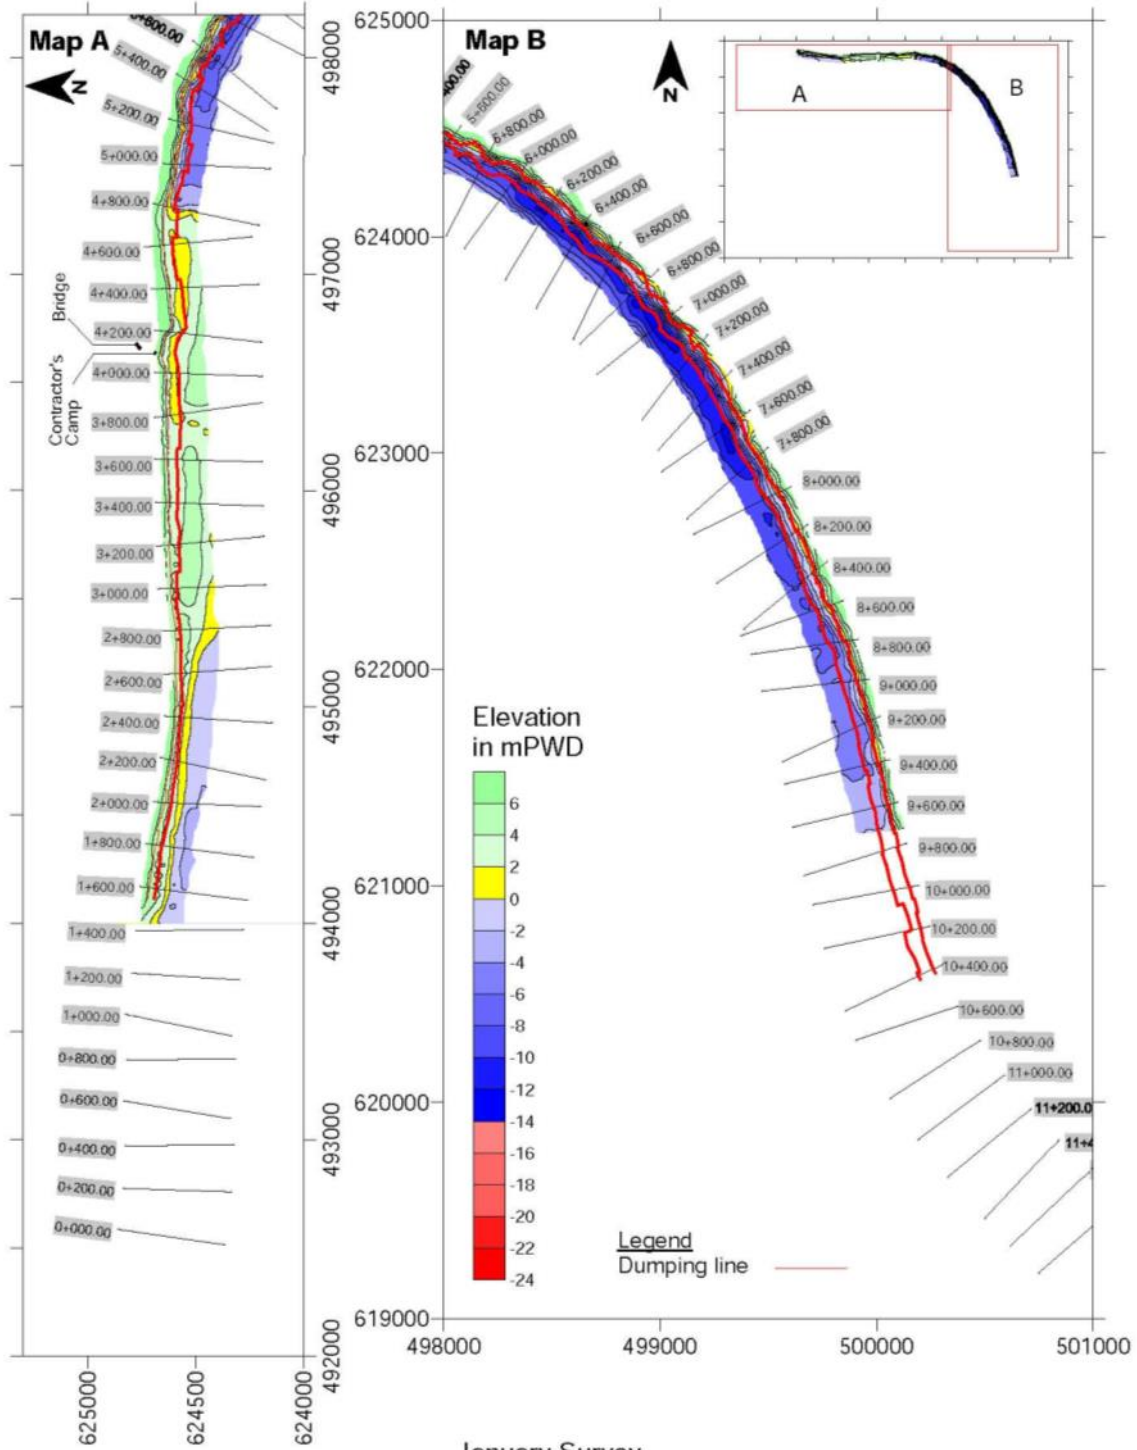
January Survey
Date: Januar 24-31, 2017

Figure 3-6 Harirampur January 2017 survey, used as baseline survey for 2016/17 adaptation works

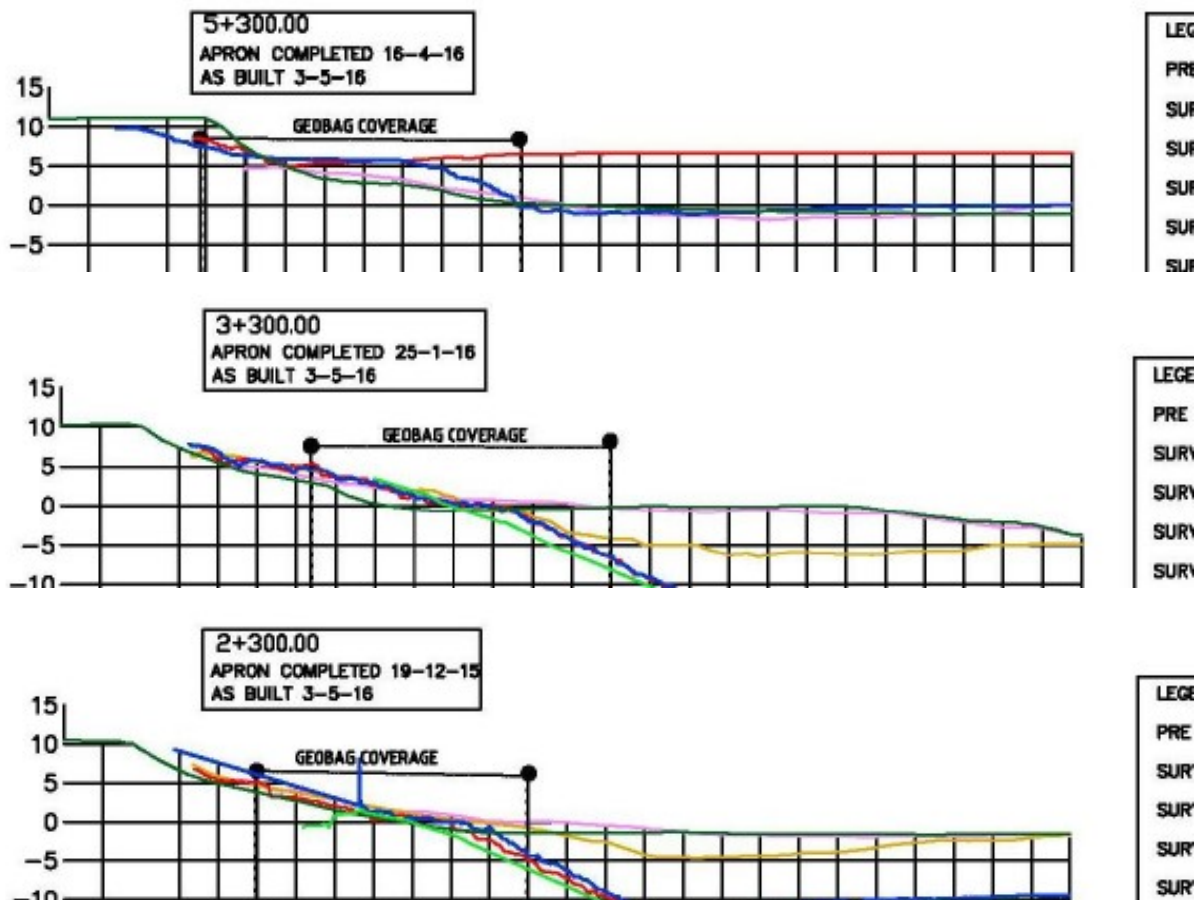
- (i) During the 2015/16 dry season, no scour is observed at Chauhali, but at the upstream end a sandbar has formed.
- (ii) In June, a small scour develops between station 4.0 and 4.8 with a depth of up to 19m below LWL. By August, this scour reached an extend of 3.0km between station 1.8 and 4.8km with the deepest sections being 21m below LWL. Until October the scour migrated marginally downstream to station 1.7km and shortened to 2.8km. The depth remained the same. Diving in February 2017 at the contractor’s camp (chainage 2500) indicated a bed level at about -13m+PWD, roughly corresponding with the bed level during the flood season and indicating that no sedimentation has happened. This was confirmed through a February 2017 survey. Figure 3-8 provides some examples of the site development during the flood season.

Figure 3-8 Bathymetry development during each survey period, compared to the as-built condition (August), Chauhali

- (iii) The upstream sediment deposit has migrated downstream and reached station 5.0km by October. It is part of a 3km long char situated parallel to the left bank that has top elevations of 5-7m+PWD and is above LWL. This char is well visible in Figure 2-5.
- (iv) At Chauhali some places near bank were eroded at 11 places during and at the end of this flood season. Those places were located from station 0.5 to 5. More than 5m apron launched from section 0.9 to 5.1.

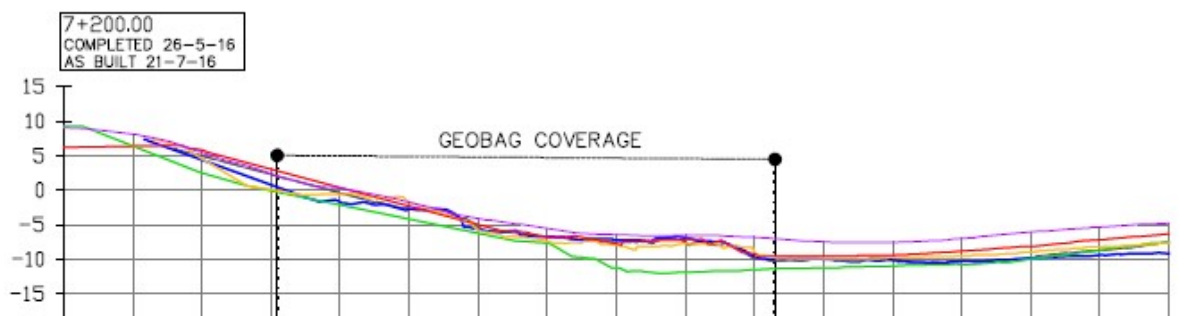
- (i) The upstream deposition remained stable at Station 6.5 with a small near-bank channel active during the flood season. This channel caused some localized erosion upstream.
- (ii) The deeper scour is situated at the protrusion between bazar and school at station 6.5 and has changed little in position. However, it reduced in size during the flood season but maintained the deepest point of around -17m+PWD locally.
- (iii) The erosion alongside the downstream clayey riverbank, in extension of the protrusion scour at Zafarganj, has moved downstream. It is located outside the planned work area. Given the low erosion potential of the downstream riverbank, the main risk is wave erosion upstream in future.
- (iv) No apron launching was recorded during this flood season (Figure 3-9)

Figure 3-9 Bathymetry development during each survey period, compared to the as-built condition (July), Zafarganj

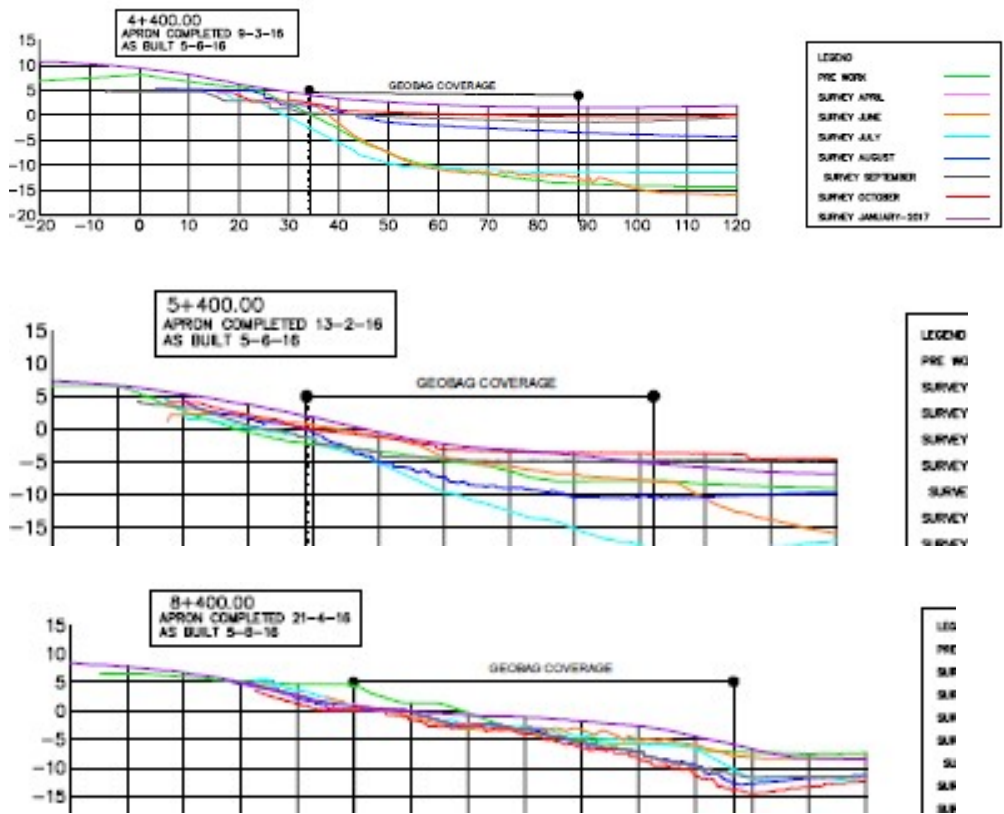
- (iv) At Harirampur near bank erosion resulted in apron launching during the 2016 flood season. Initially launching occurred from station 5.2 to station 7 by July. Then this area silted up, while erosion occurred downstream between station 7 and 9. More than 5m apron launched between chainage 5.8 to 9. However, most of this was covered with a more than 10m thick layer of sand at the end of the flood- and early dry season. A number of cross sections depict slopes flatter than 1V:3H, which indicates that static flow slides could have occurred. This will be confirmed through diving investigations prior to starting the adaptation works.

Long profiles along the deepest scour at the end of the apron, provided in Appendix 9, document the scour and sedimentation development between each survey period, compared to the as built, and 2017 dry season condition. For Chauhali, also numerical modelling prediction for potential scour movement during the 2017 flood has been shown. Long sections have been prepared for Chauhali and Harirampur, where launching occurred. These sections are based on simplified 200m interval cross sections not following the exact length of the dumping barges, as the cross sectional data were taken every 200m.

Figure 3-10 Development of the cross sections over time in Harirampur

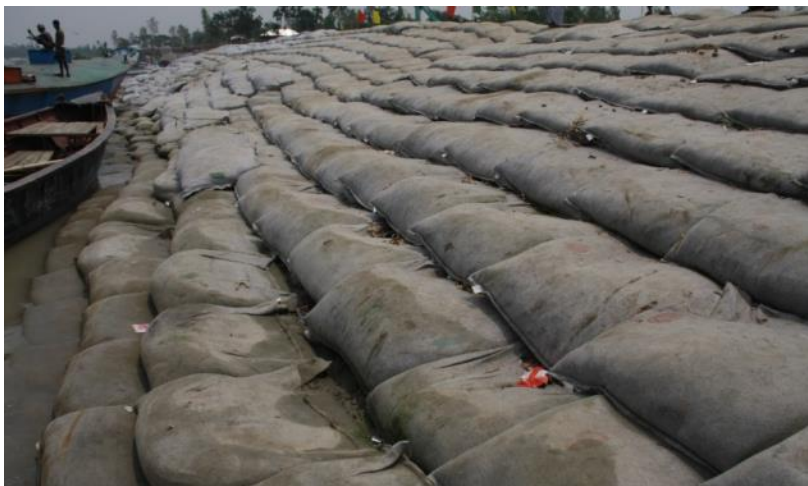
In Chauhali and Harirampur, the bank was protected during the last flood season by a temporary protection that generally followed the design as shown in Figure 3-11. However, during the first construction season only one layer of above water protection was placed, which proved insufficient in some places.

Figure 3-11 Temporary slope protection consisting of one layer of geobags

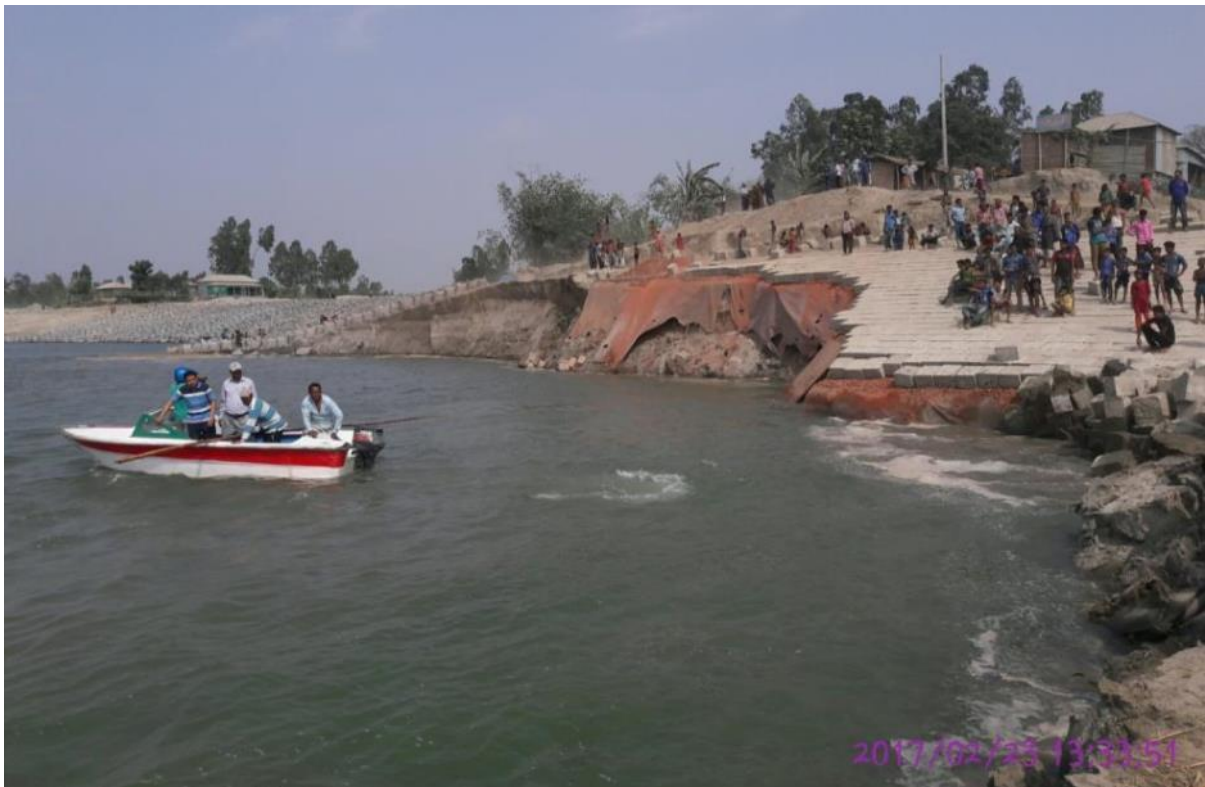
During the flood season, some local failures occurred at the Chauhali site, resulting in a loss of some 0.9ha of land alongside the riverbank. The locations of the erosion are shown in Table 3-6. There are two reasons for this failure:

While at least two failures were obviously due to geotechnical instability (confirmed by diving), the others were induced by winnowing failure of the single layer temporary wave protection. After the failure, the flow eroded the upper part of the bankline, resulting in the formation of a wide berm about 3 to 5m below low water level. The design of the temporary wave protection has underestimated the impact of waves and high flow velocities.

Figure 3-12 Bank failure in Chauhali

- (iv) The erosion of temporary wave protection in 11 locations causing a loss of around 0.9ha of the above water slope and floodplain requires protection of minimum three layers of geobags systematically dumped from barges onto the formed berm. The above water slope and berm are to be adjusted as per design. The situation is critical at the upstream end, where a major slope failure occurred at the end of February, which affected completed works (Figure 3-12).

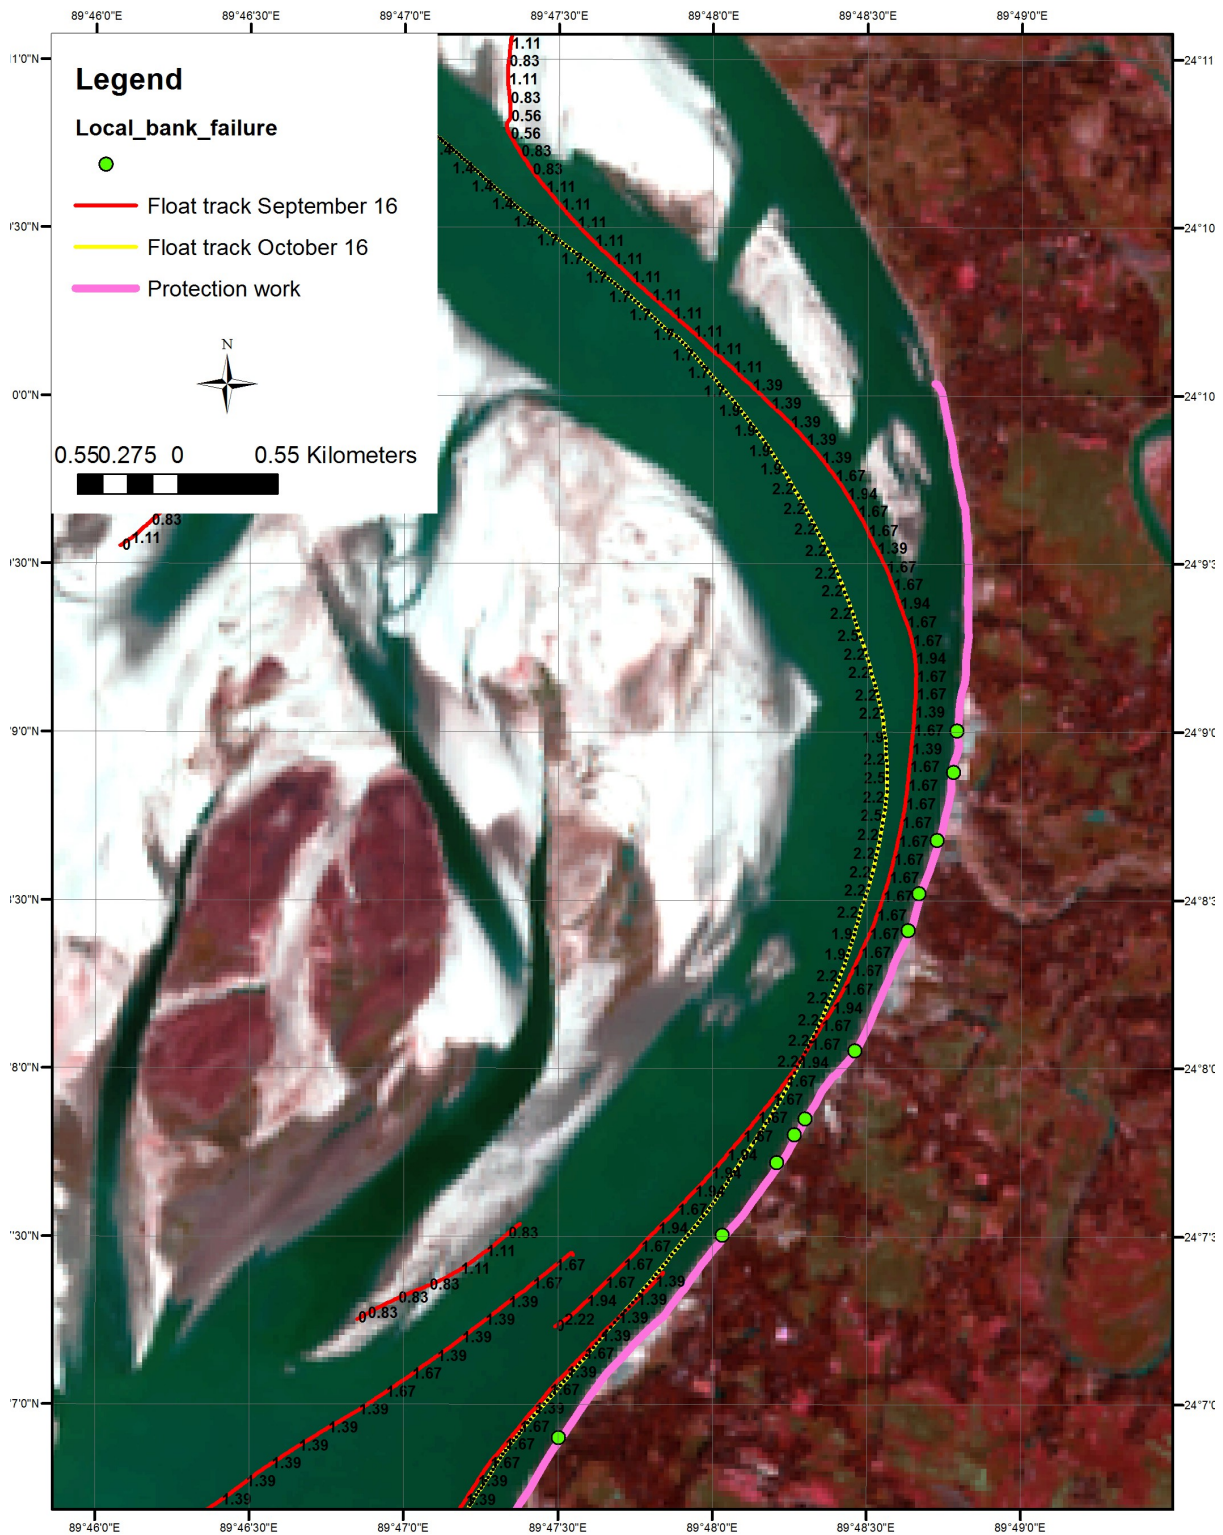
As can be clearly seen in Figure 3-13, all bank failures occurred where the flow lines are close to the bankline and exhibit relatively high velocities. This indicates that the design underestimated not only the risk of winnowing for the temporary wave protection but also of geotechnical failure by and large.

Figure 3-13 Location of slope failure with float tracks from September / October 2016 on 2017 satellite image
