Memo

Re: Site monitoring from 2015 to 2017

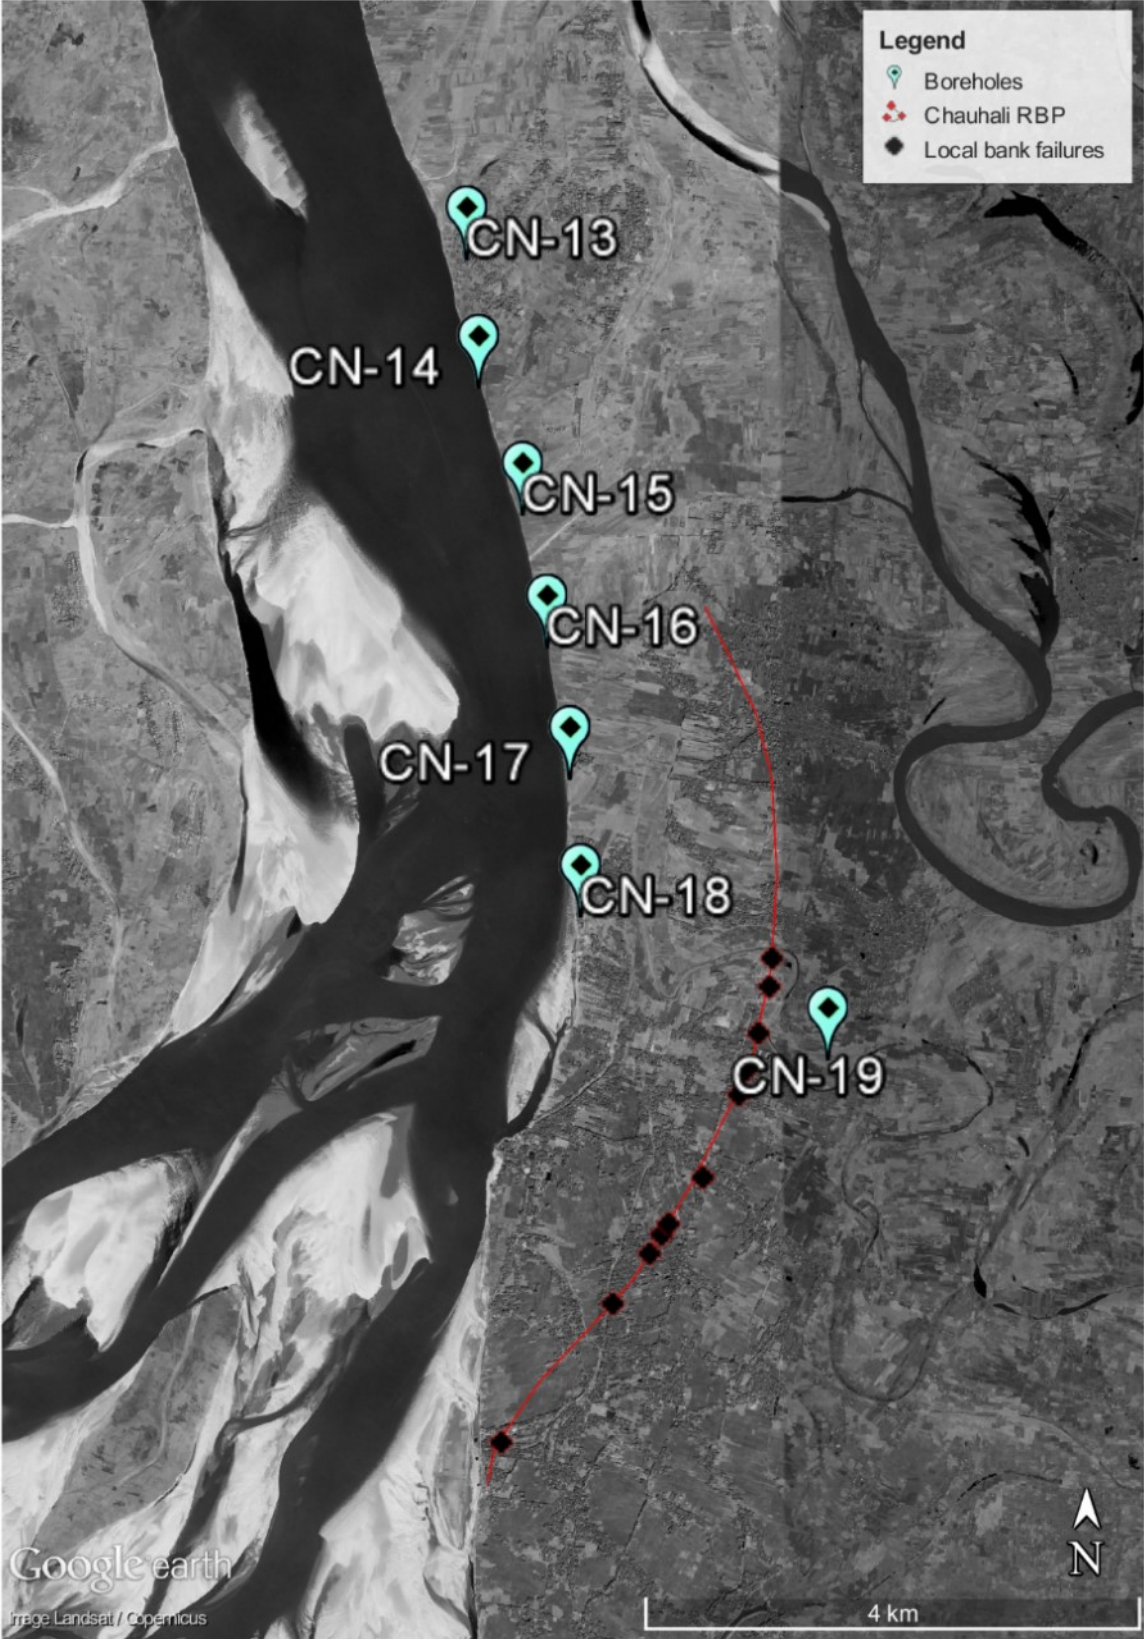
parts of the 2016 work site (for the location of the boreholes see Figure 3-14). The responsible design office could use this information to confirm the subsoil conditions along the present bankline.

Figure 3-14 Borehole location of 2012 and local bank failure locations from 2017 on 2013 satellite picture

Although all borehole locations from 2013 were eroded by 2016, there could be relevant information from one borehole. Borehole CN-19 is the closest one to the 2016 bankline and also the only borehole location not eroded. By comparing the location of the bank failures with the location of the boreholes, it is noticeable that the majority of the failures are near or downstream of borehole CN-19 (Figure 3-14).

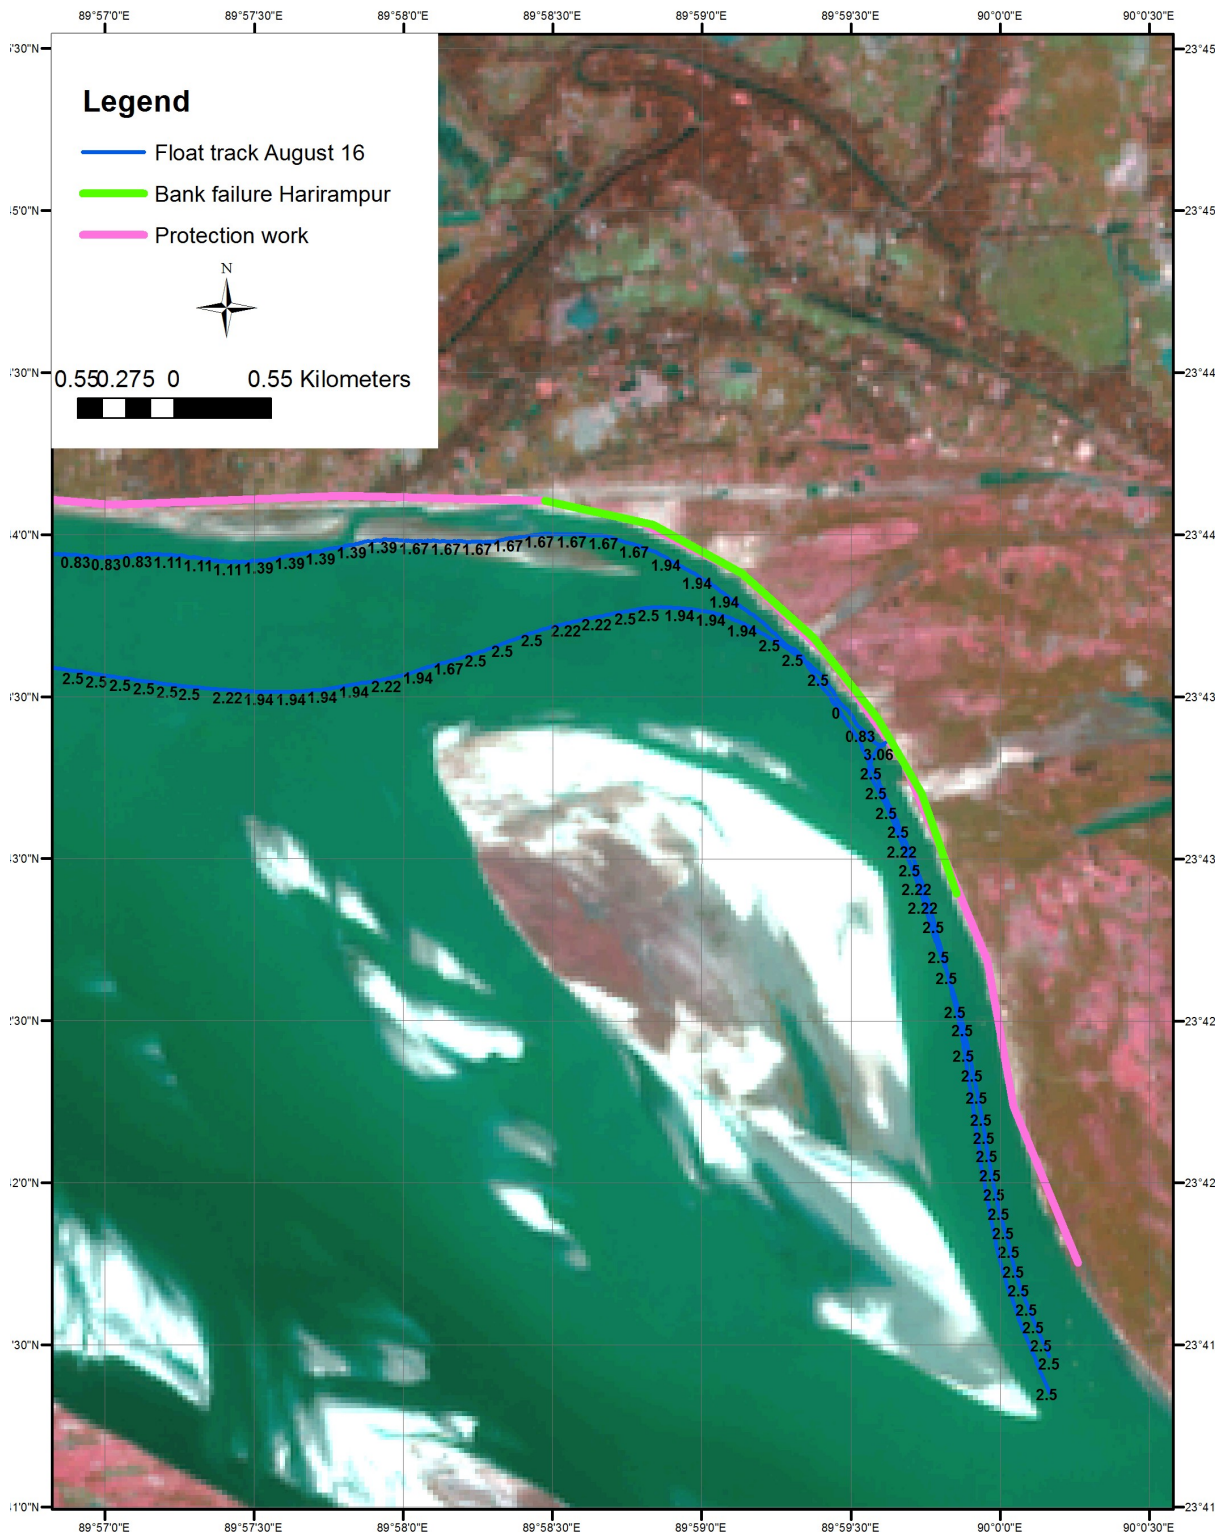
In Harirampur, winnowing failure also occurred, caused by the insufficient thickness of the temporary wave protection, leading to erosion of the riverbank in places, especially in the curved section. In total, about 700m of protection was completely destroyed and several kilometers have been partially damaged. The failures zones will be investigated more in detail to determine if static flow slides contributed to the failure of the wave protection as well.

Figure 3-16 confirms that the failure mostly occurred in the area, where the flow hits the bankline. This indicates that also here the impact of the high flow velocities and the waves were underestimated by the designers of the temporary wave protection.

Figure 3-16 Location of slope failure with float tracks from August 2016

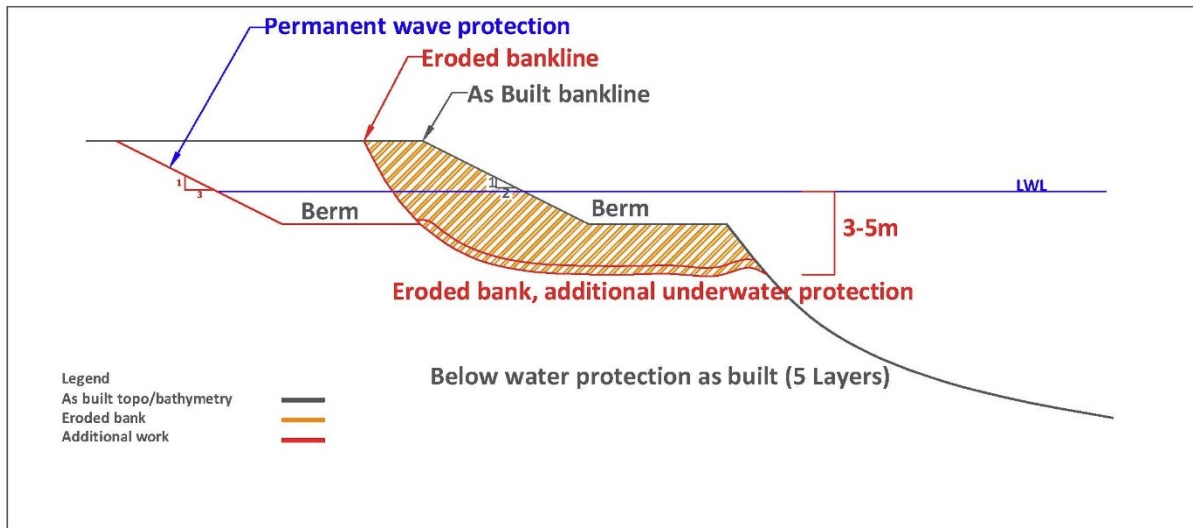
The winnowing failure mechanism is characterized by a gradual destruction of the wave protection and subsequently erosion of the riverbank in the area above the multi-layer underwater protection. Figure 3-17 and Figure 3-18 explain the process in detail. This failure mechanism is very similar to the gradual erosion of launched aprons, resulting in steepening slopes and eventual geotechnical failure, if not upgraded through adaptation works.

Figure 3-17 Schematic of slope erosion due to under-designed temporary wave protection

- (i) The single layer coverage of the launched apron has to be upgraded to reliable thickness (minimum three layers) as the slope would otherwise gradually steepen from winnowing and eventually fail due to slope instability (Figure 4-1). The construction in flowing water results in the dumping of three additional layers over the launched slope to arrive at consistent coverage. In stagnant or near stagnant water two layers can be dumped as the dumped material is not displaced. Upgrading of the launched apron can also be achieved through an additional apron launching from a higher deposit (Figure 4-1). In this way, at least two layer coverage will be achieved after renewed scouring.

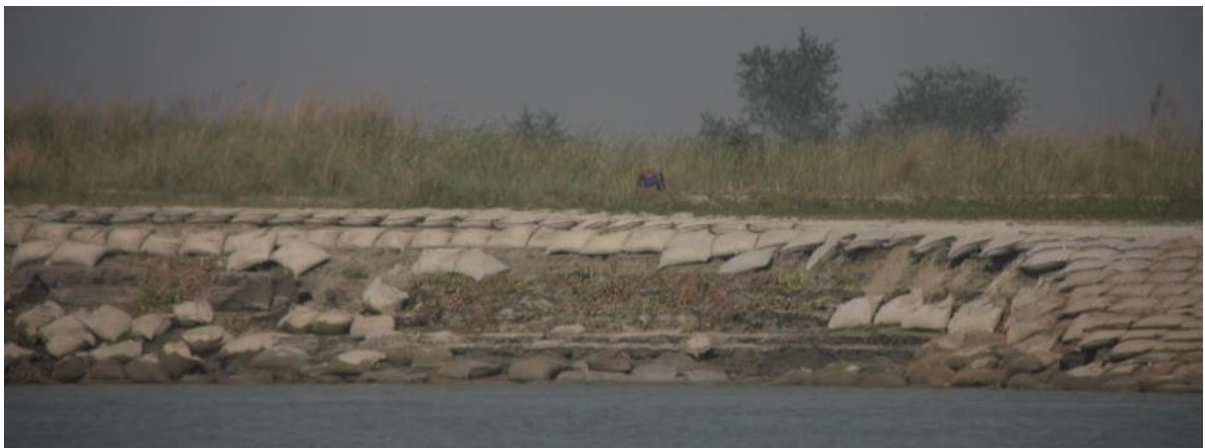
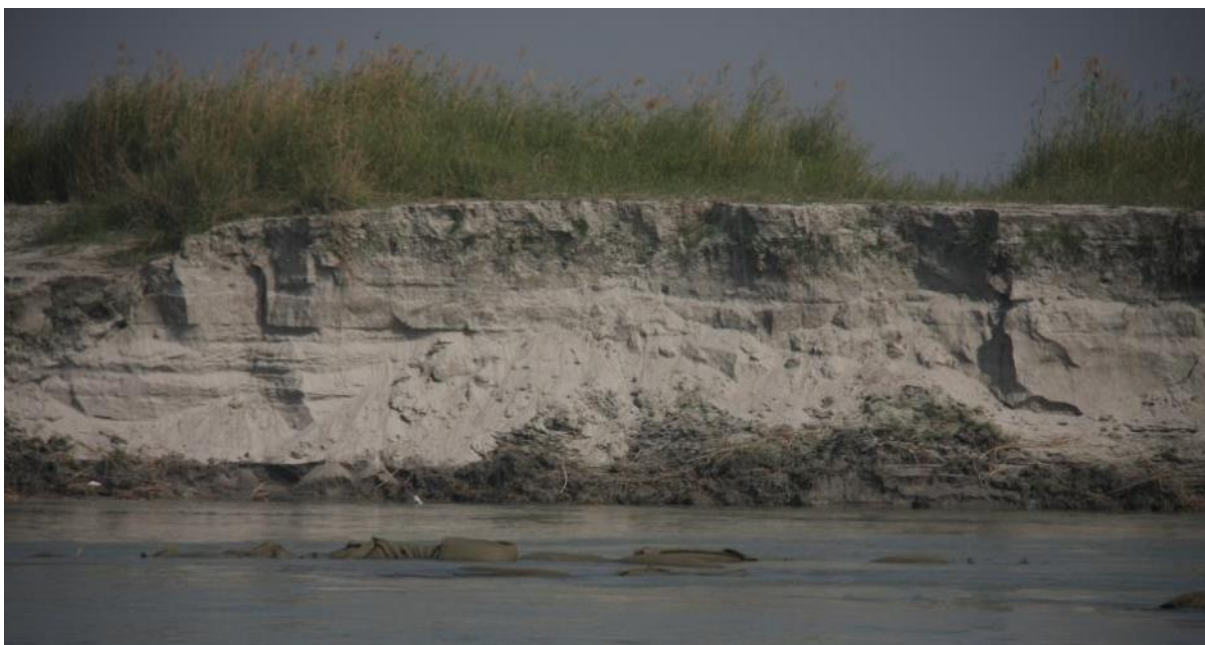
Figure 3-18 Progression of destruction of temporary slope protection: (1) surface protection disintegrates into elements (through high velocities or wave impact) (2) hole eroded in bankline with regressive erosion and deepens, but underwater protection is still in place (foreground at low water level)

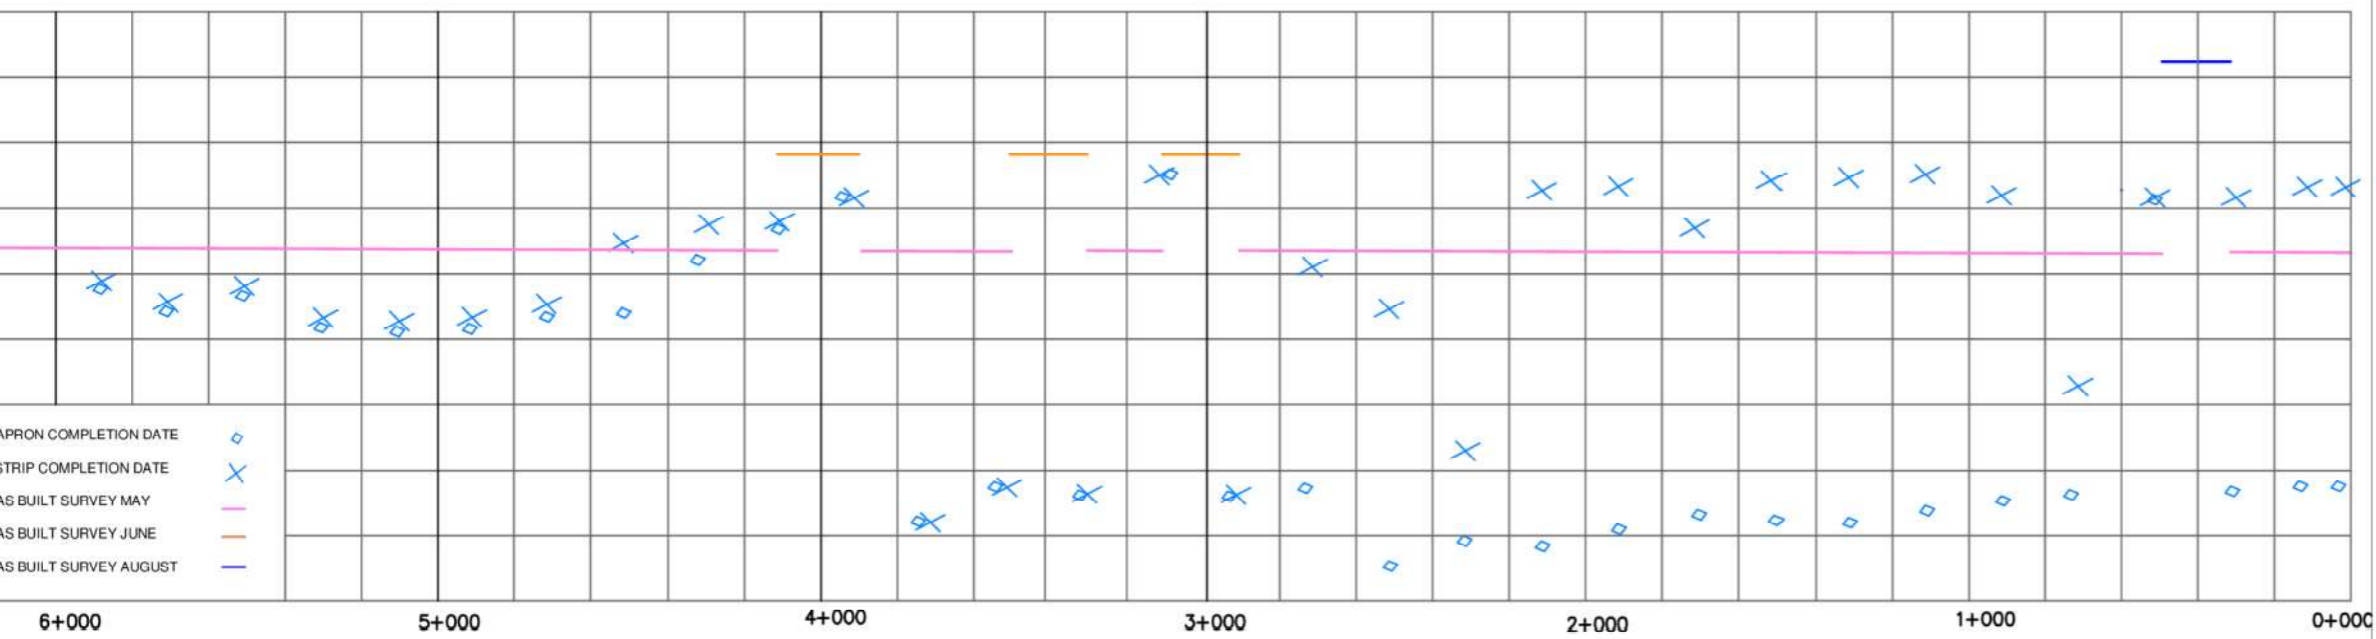
Progress and As-Built Survey

9.1.2 Longitudinal Section – Launching of Apron

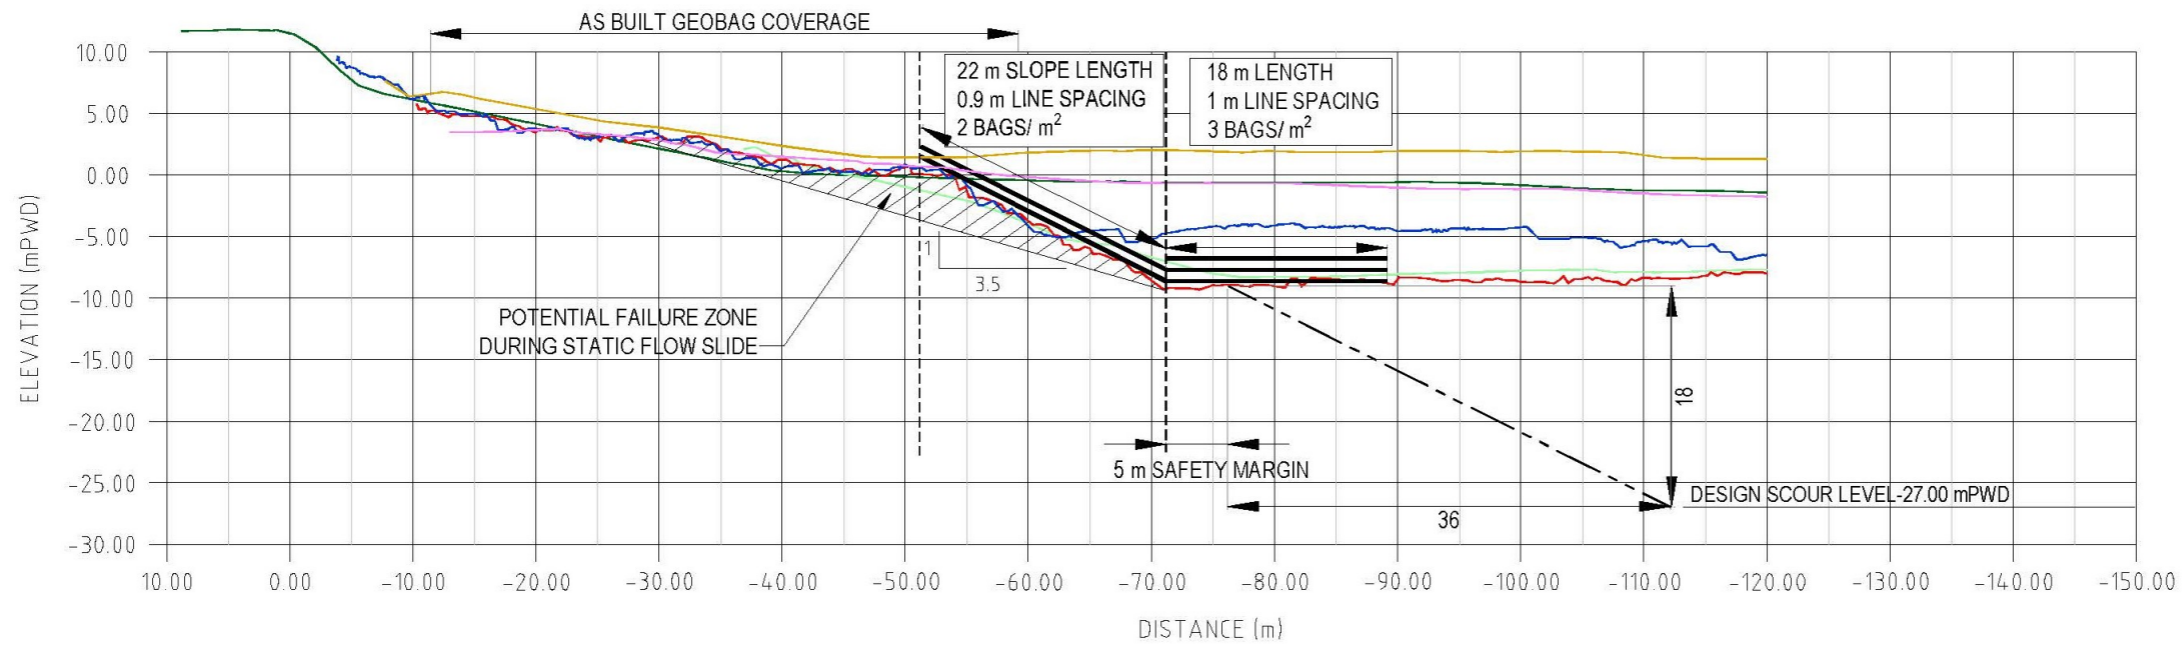
CHAINAGE 1+300 AT CHAUHALI

9.1.3 Cross Section – Example Provisional Adaptation Works

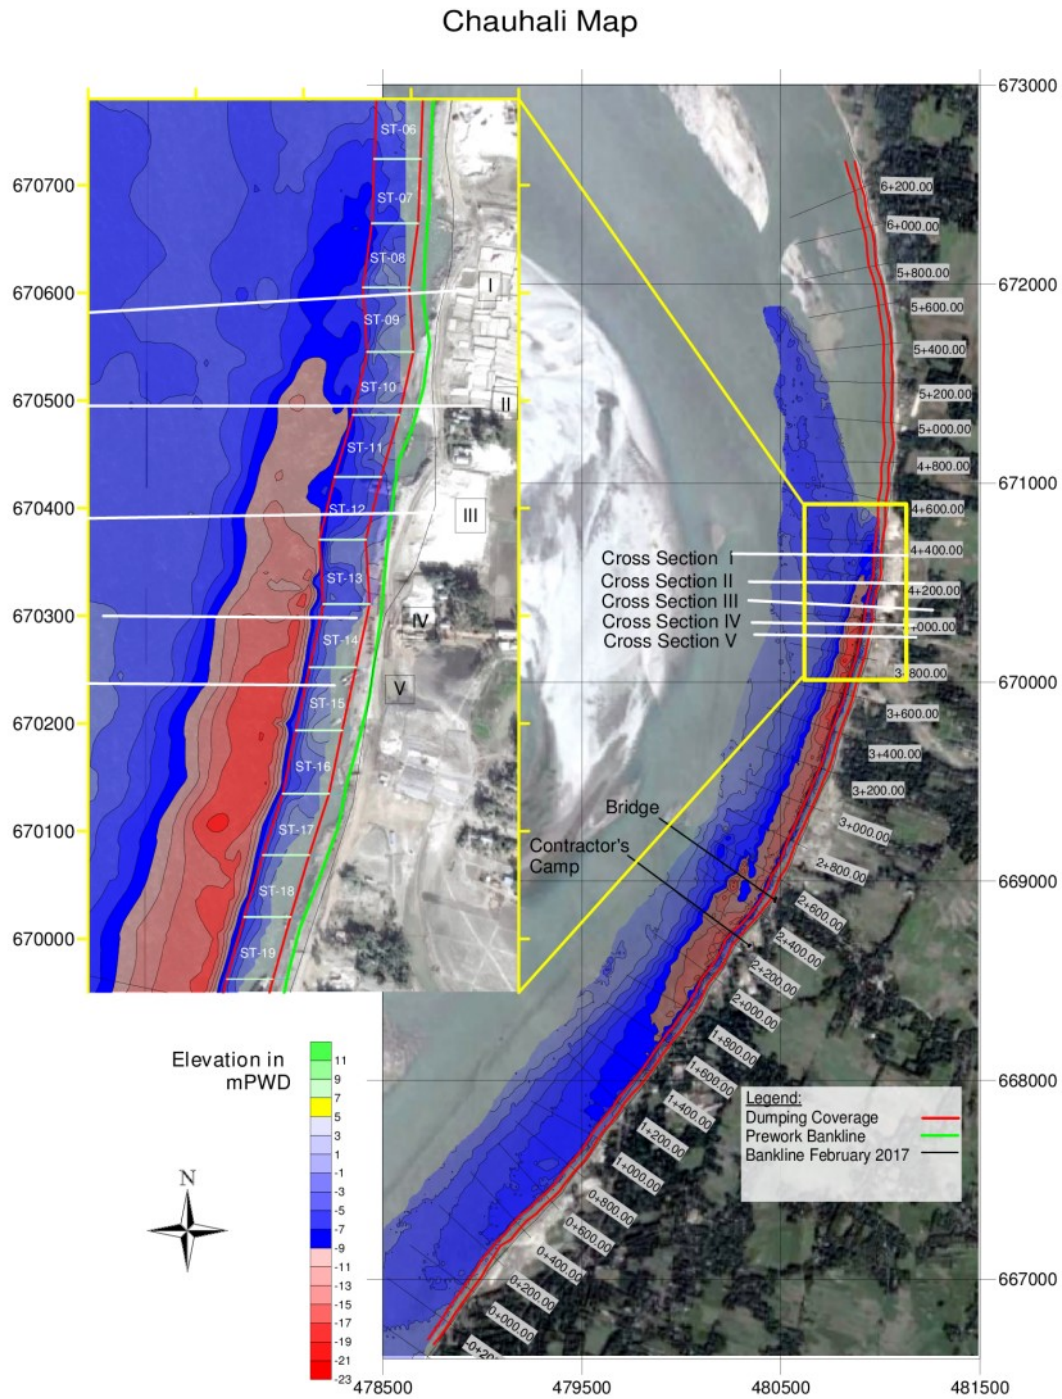
Example upstream

9.1.4 Repair of Failed Wave Protection

Note that the available survey data are not conclusive and do not allow a temporary design. The cross sections nevertheless indicate the need for filling in some areas. The final details have to be decided through diving investigation.

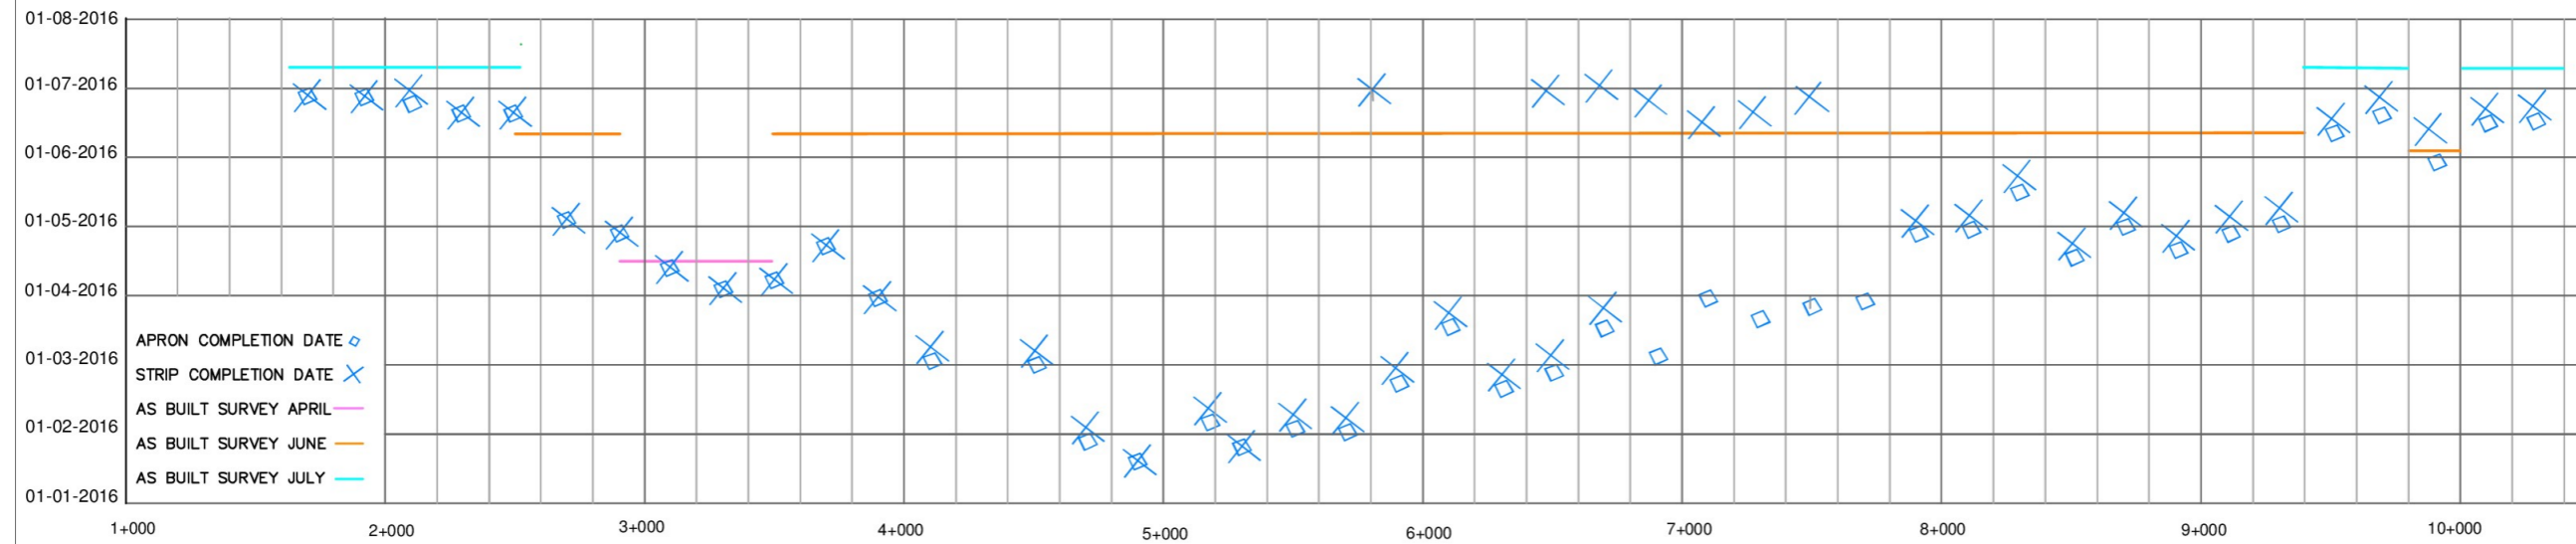
Construction Progress and As-Built Survey

9.2.2 Longitudinal Section - Launching of Apron

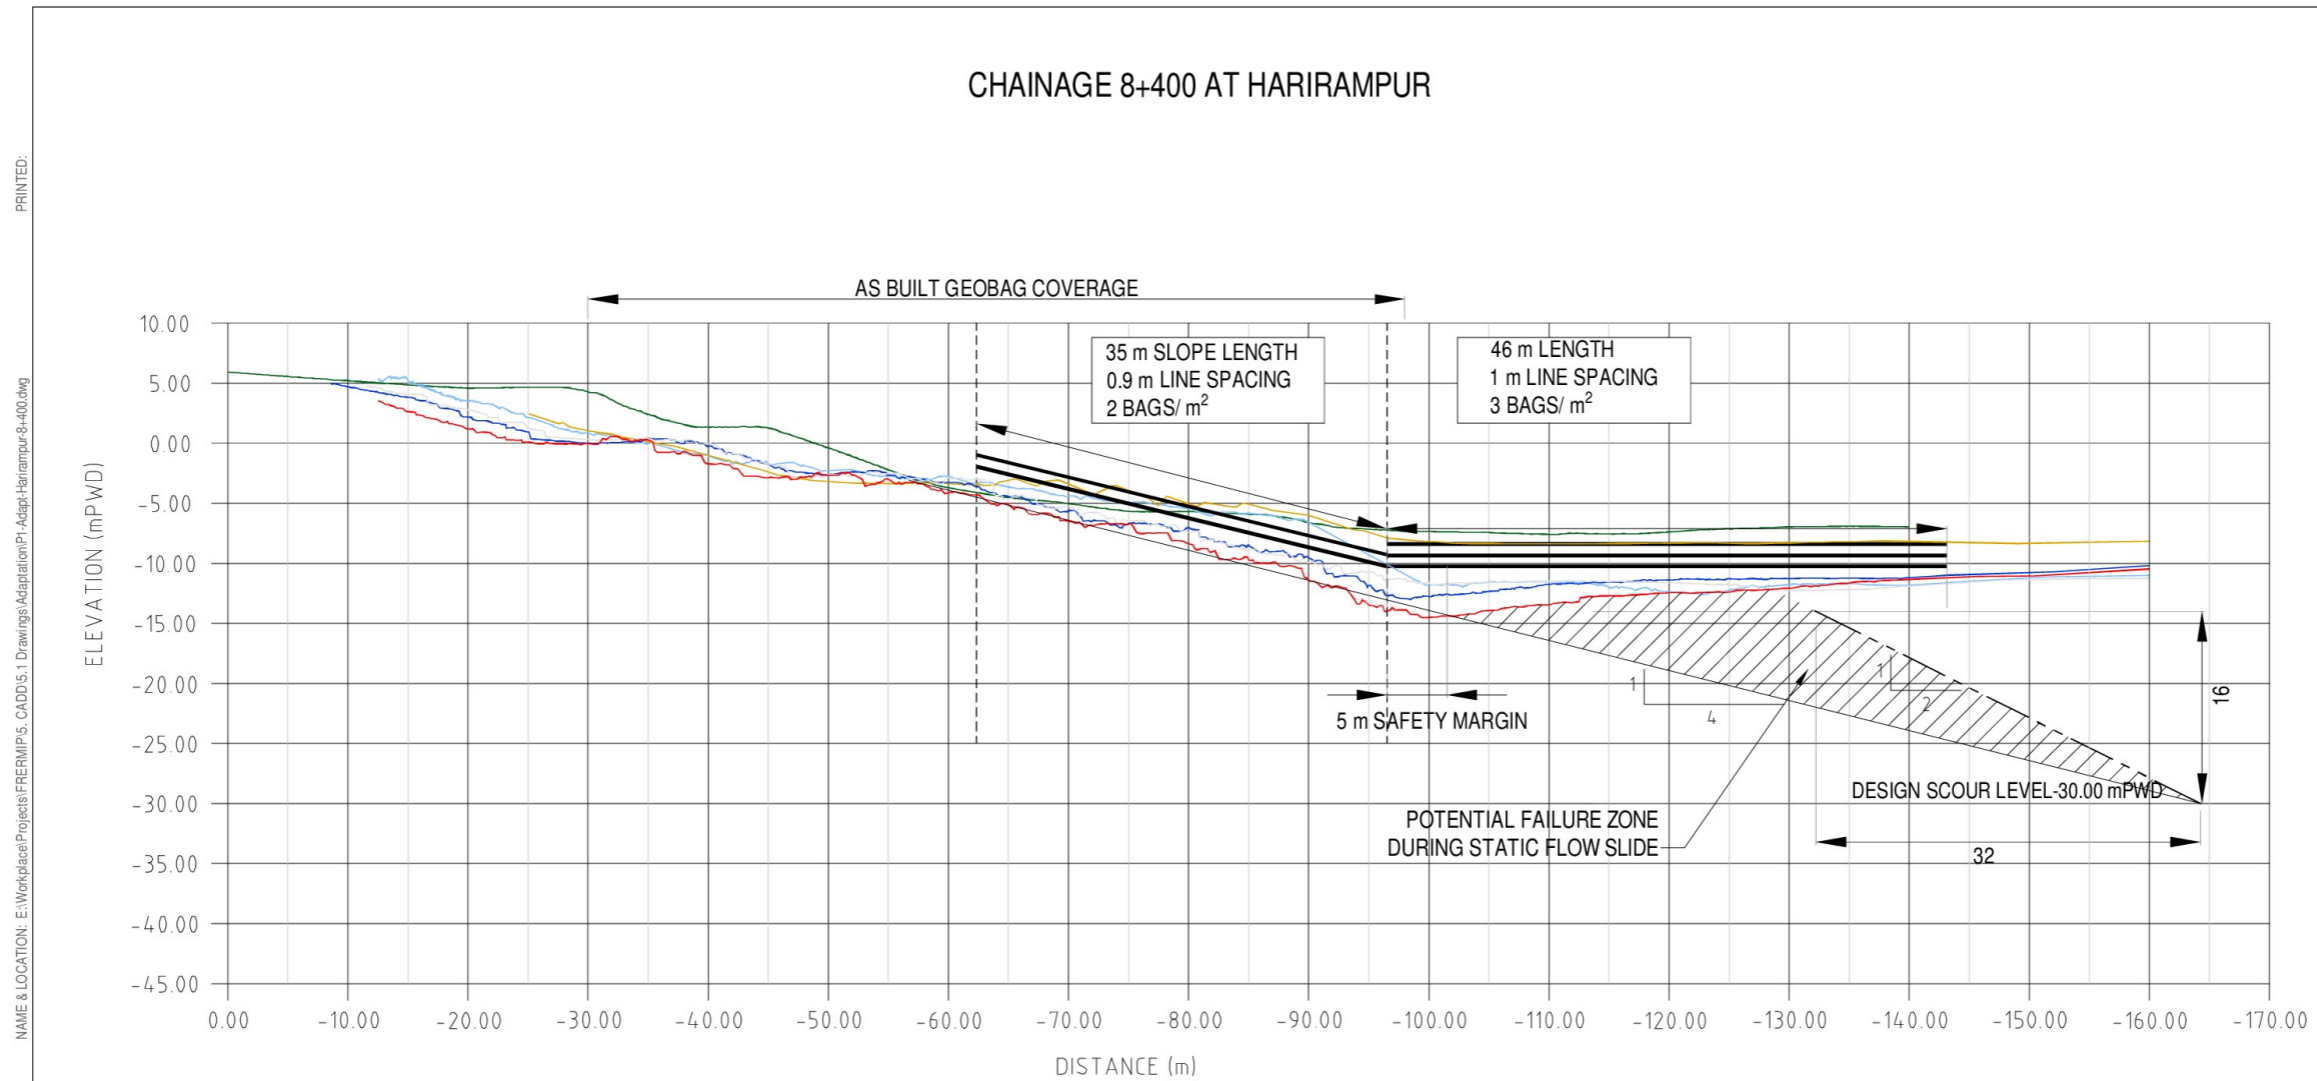
9.2.3 Cross Section – Example Provisional Adaptation Works
