Memo

Re: Site monitoring 2018/19

This memo summarizes river changes in the Lower Jamuna and Padma river at Chauhali, Zafarganj, Harirampur, Chauhali upstream, Enayetpur, Kojjuri and PIRDP during the flood season 2018, including a survey update at Chauhali in January 2019.

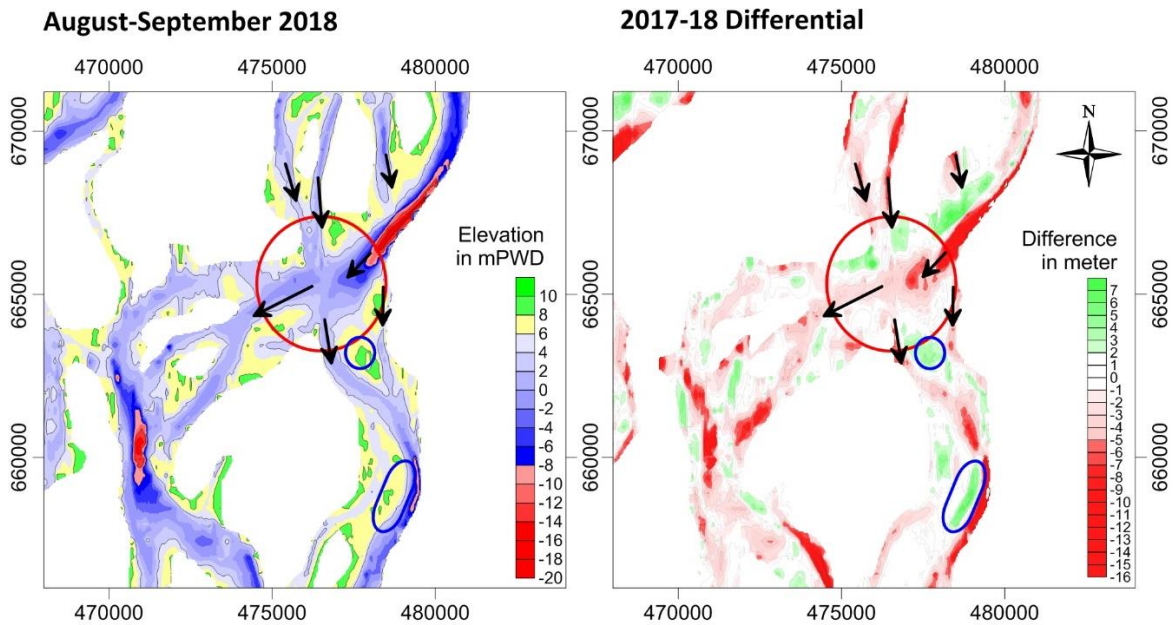
Figure 2-4 Downstream of Chauhali and Solimabad Channel

- (iii) Downstream of the lower Jamuna bifurcation, the 2018 flood season survey shows three cut off channels through the char opposite of the protected riverbank at Chauhali. A new channel has developed downstream of Chauhali forming a four channel junction (marked red in Figure 2-4).
- (iv) The sandbar height splitting the offtake of the Solimabad channel (marked by a blue circle in Figure 2-4) and downstream opposite of Solimabad (marked by a blue ellipse in Figure 2-4) is increasing, narrowing the channel and increasing erosion on the left bank.
- (v) The large sandbar opposite of Zafarganj, observed in 2017 starts eroding (Figure 2-5 black circle).

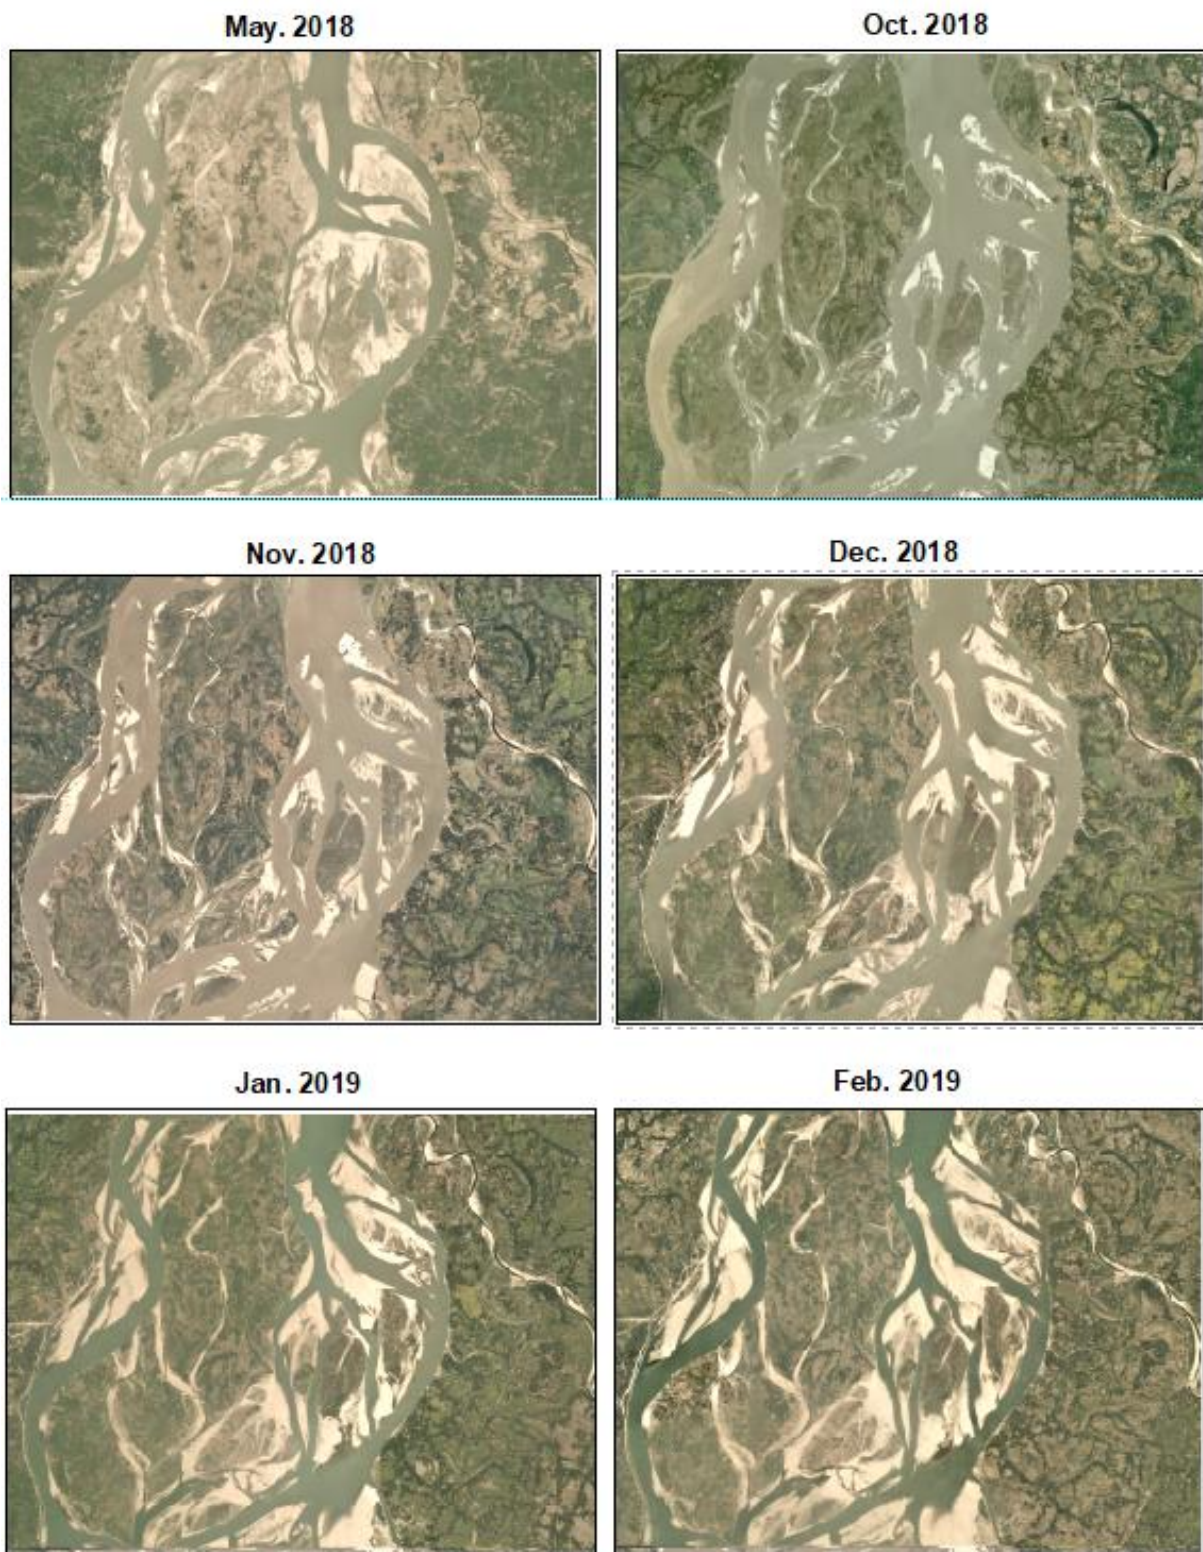
Figure 2-6 Aerial imagery of Lower Jamuna

Satellite imagery (Figure 2-6), a dry season survey from February 2019 (Appendix 6.1) and differential survey maps (Appendix 7.1) show that angular flow can affect the upstream part of Chauhali. Following the high degree of launching that had taken place up to September 2016 between stn 3.95 and 5.0, the launched slope was thereafter buried under 5 to 10m sediment which could again be exposed after the 2019 flood season. At that time adaptation work would be required to increase the apron from 1 layer of launched coverage to 3 layers post adaptation. Regular bathymetric surveys will be required to understand the necessity of adaptation work.

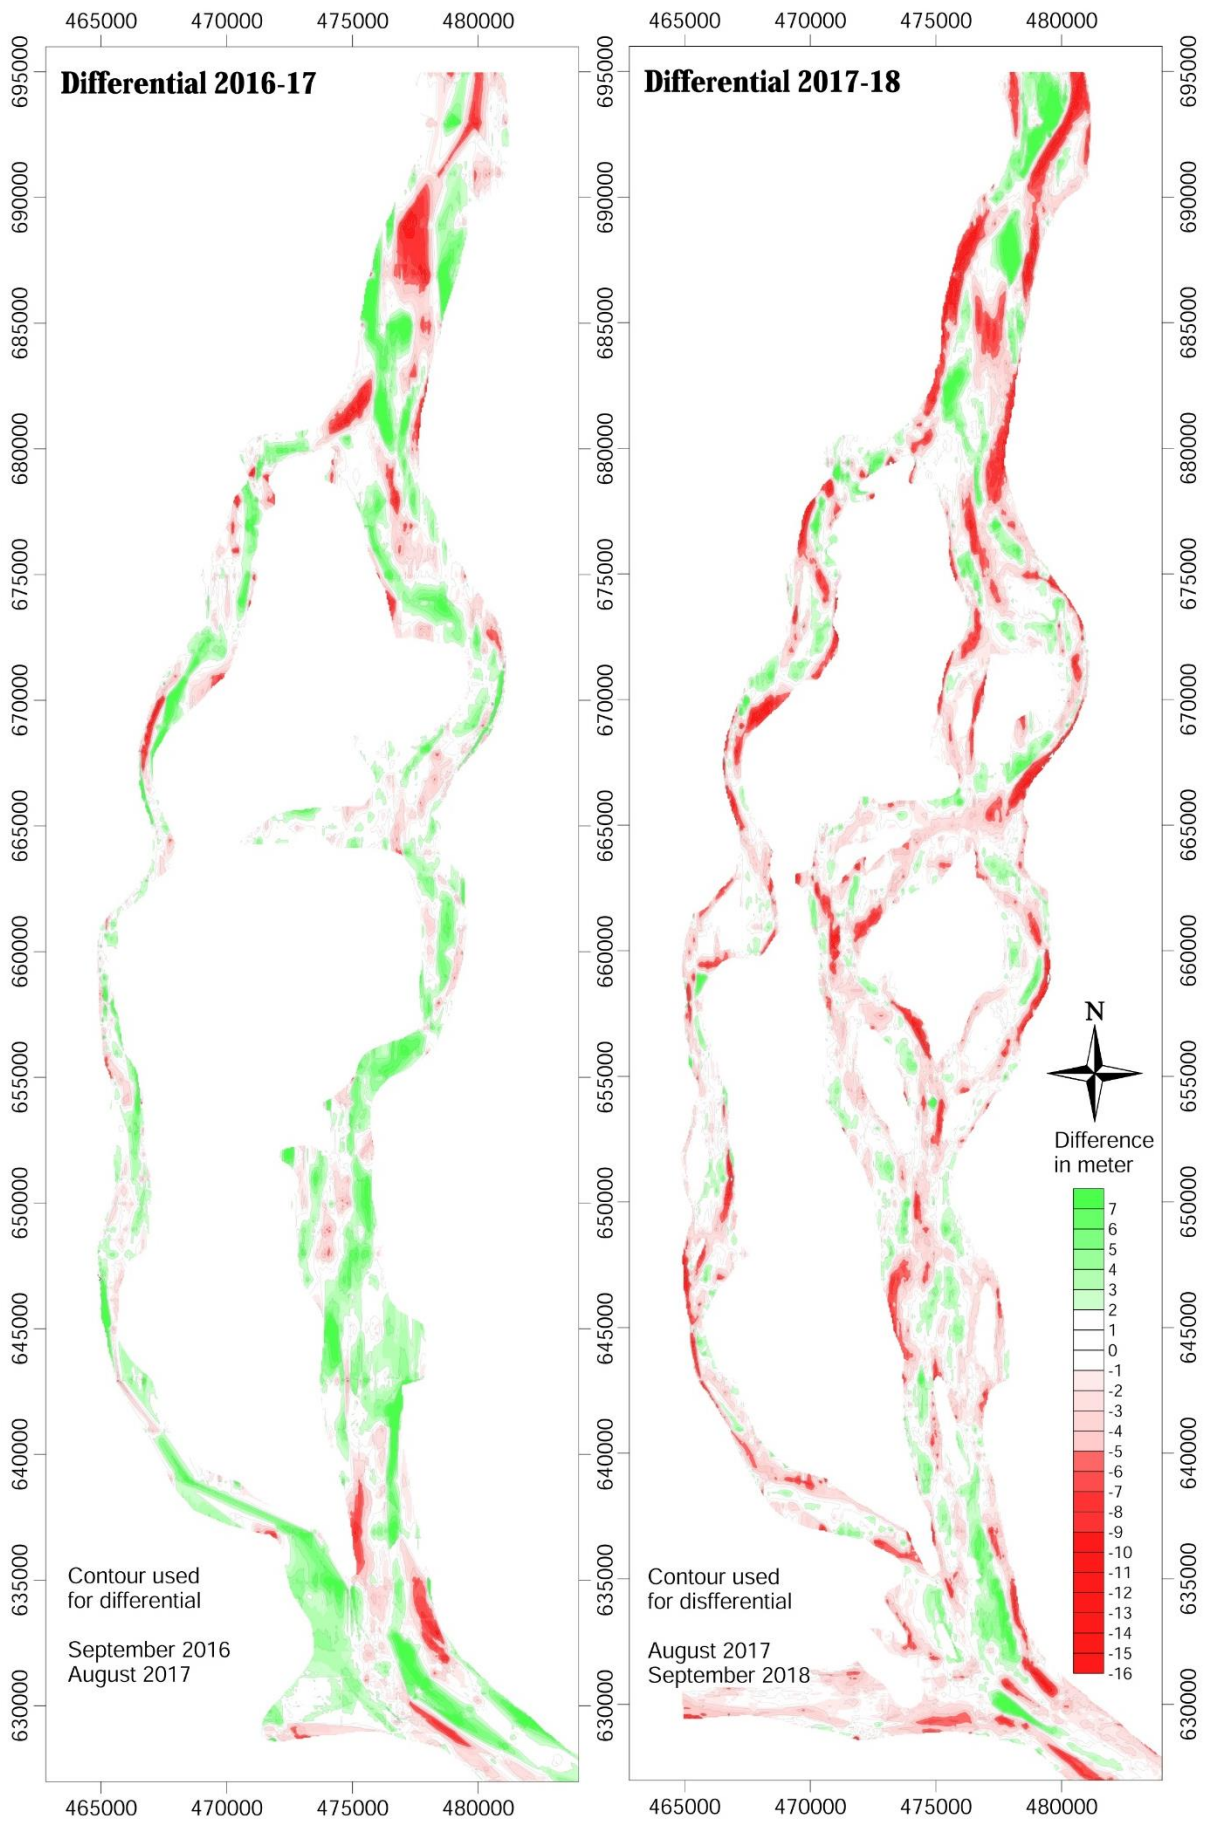
Figure 2-8 Differential map from 2016 to 17 and 2017 to 18

- (i) The differential survey map between 2017 and the 2018 shows the overall deepening of the lower Jamuna right and left channel as opposed to a more aggrading situation the year before (Figure 2-8).
- (ii) Upstream of the Lower Jamuna bifurcation, the height of the mid-channel sand bars increased resulting in deeper channels at both banks (Figure 2-3 section 1). Deepening of section 2 indicates erosion of the left bank, which is planned to be addressed through 12 km of riverbank protection during Project 2.

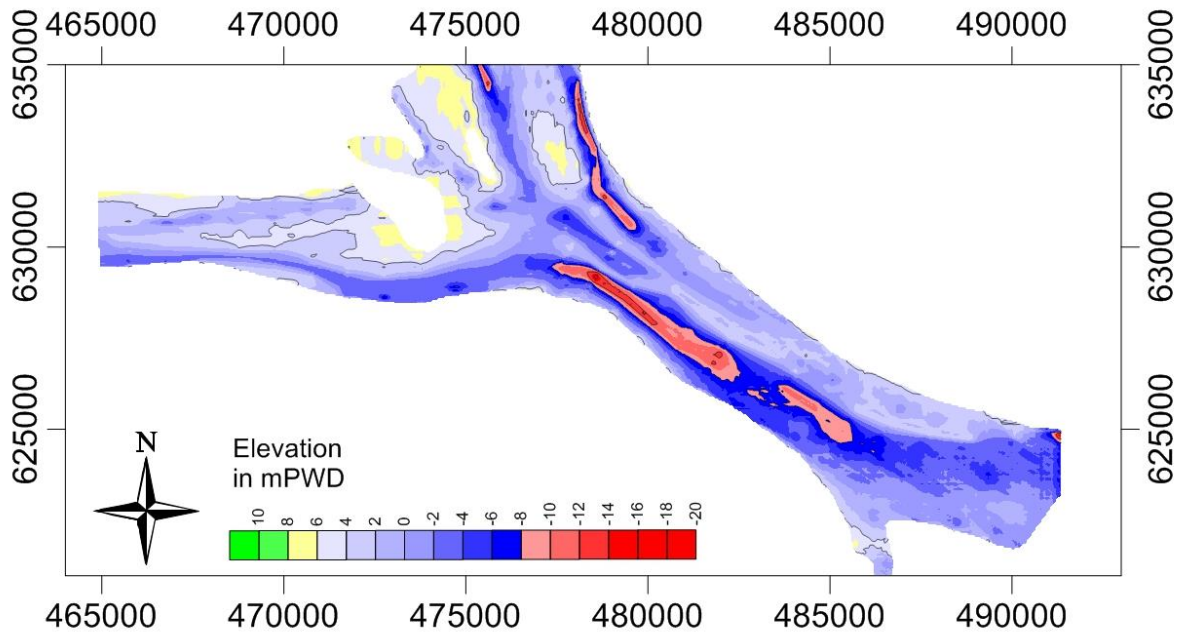
Figure 2-9 The Ganges and Upper Padma from 2016 until 2018

- (i) The dominant influence of the Jamuna, particularly after its higher flood flows compared to the Ganges over the last years (since 2016) manifests in a gently curved channel (Figure 2-9). The deeper part of the channel is at the right bank near Goaland Ghat.

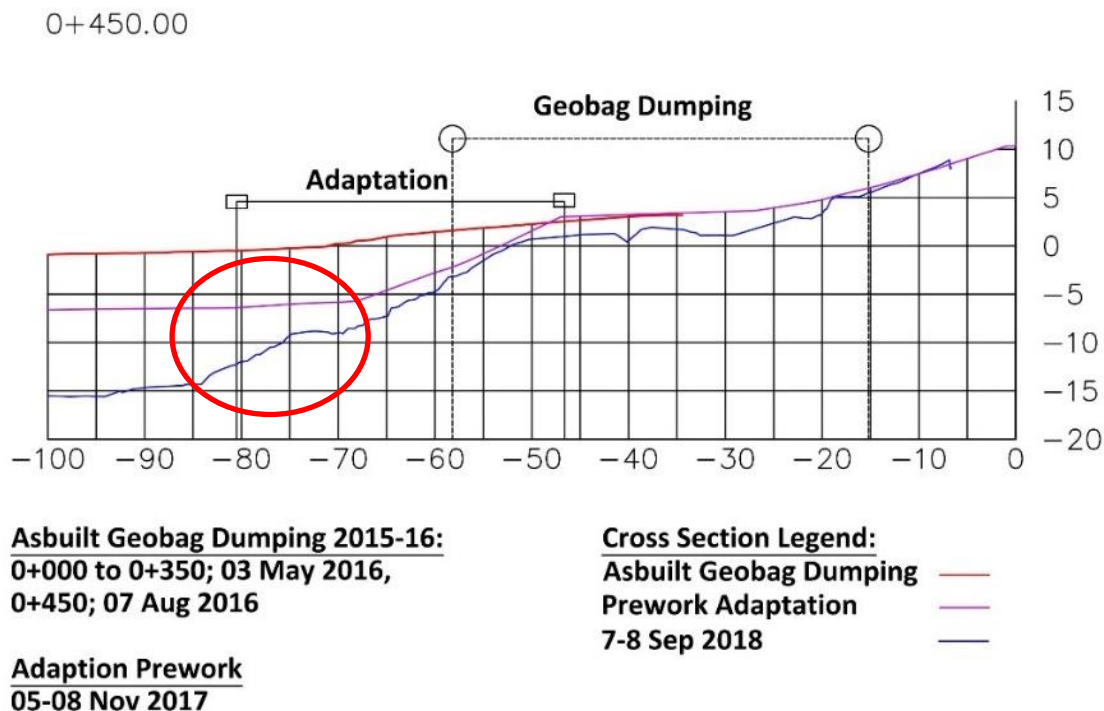
Figure 3-5 Additional launching at Chauhali after adaptation work

- (i) On 4th June 2018, the adaptation work was completed in Chauhali. Adaptation works increased the underwater apron's strength by two layers of bag on top of the initially launched single layer slope coverage followed by a three layer thick additional toe apron of variable length (depending on the distance to the design scour depth). The August and September 2018 surveys show additional launching in the downstream part of the adaptation works. The additional launching has produced a stepped underwater slope (Figure 3-5).

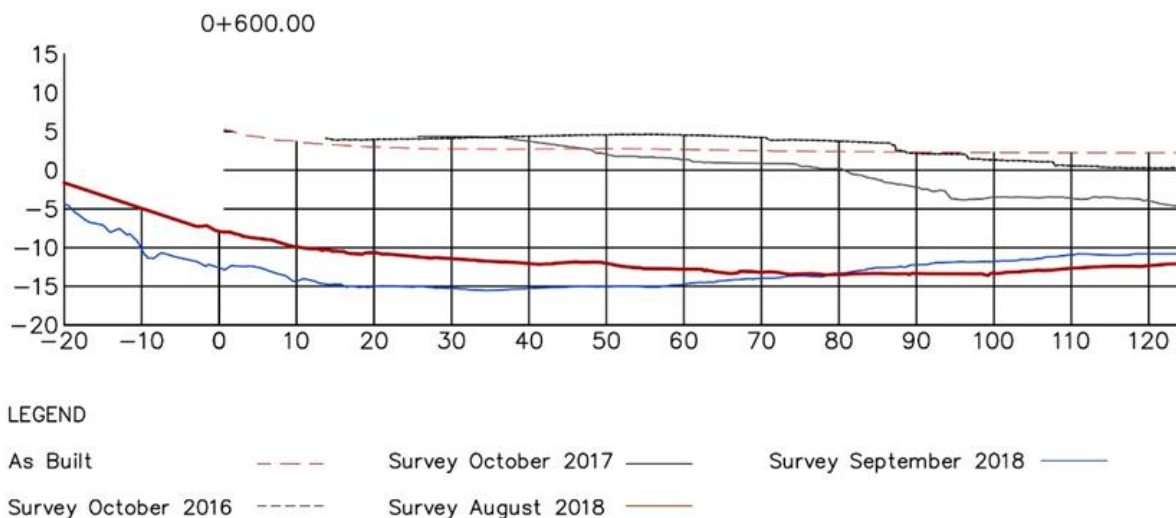
Figure 3-8 Underwater erosion at upstream of Harirampur site

- (i) The sand bar which emerged in the upstream area of the protected riverbank during the 2017 flood season has moved downstream and fills most of the launched part in the bend area (station 4 to 7.6).
- (ii) Upstream of the protection work bankline erosion has started (Figure 3-8).

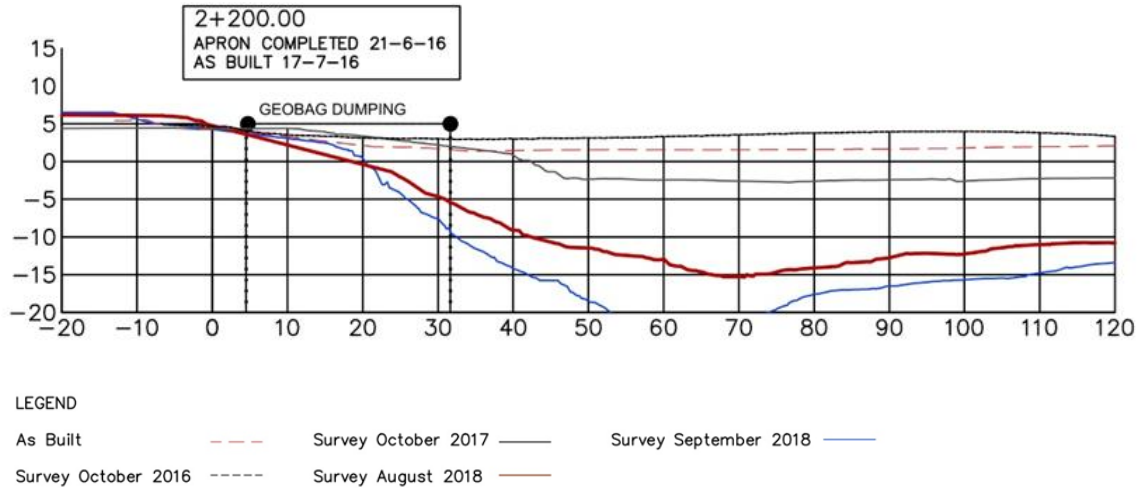
Figure 3-9 Launched section at station 2.2

- (iii) The apron has launched significantly from station 1.6 to 2.8 in 2018. A 25m wide apron was dumped here. 10m to maximum 20m of the apron launched during 2018 flood season, as can be seen in the September 2018's survey (Figure 3-9).
- (iv) From station 3 to 5.4 the apron is still buried under 5 to 10m of sediment.
- (v) From station 9 to 10.4 apron launched 5 to 10m vertically.

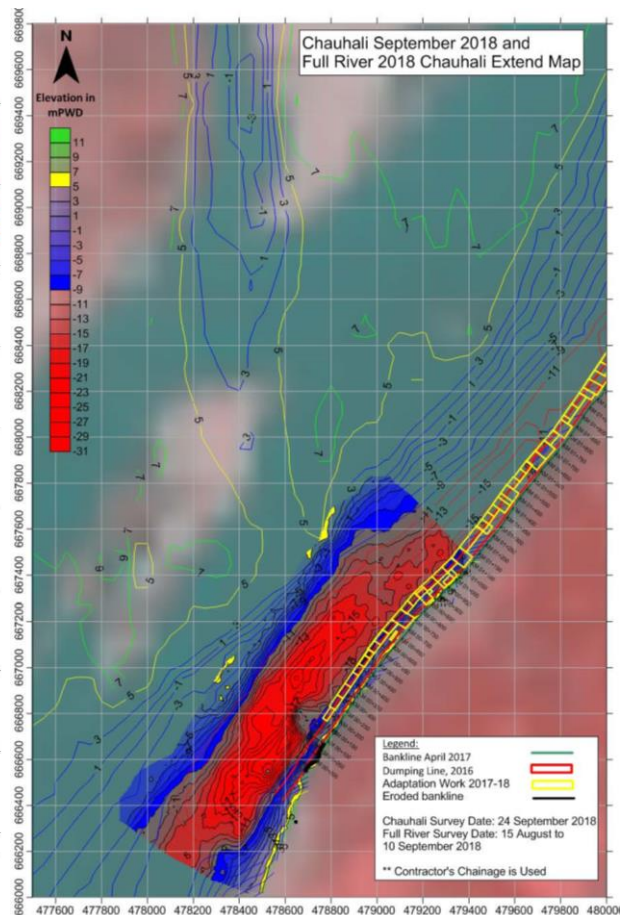
Figure 3-11 General river situation with shortcut flow at Chauhali squeezing the downstream flow at the bank

- (i) A part of the upstream approach flow bifurcating into the right Chauhali channel started shortcutting over the char opposite of the Chauhali riverbank and squeezing the flow along the downstream bank (Figure 3-11). This flow pattern was triggered as shortcut channels had formed over the char, which are still active during the dry season in November 2018.

to avoid discontinuities. The overall channel pattern explained in Figure 9 is likely to prevail during the next flood season, and at least at the beginning of the flood could result in further deep erosion. To this end we recommend to place three layers of geobags over an area of some 9,000m². The total number of bags required is around 27,000.

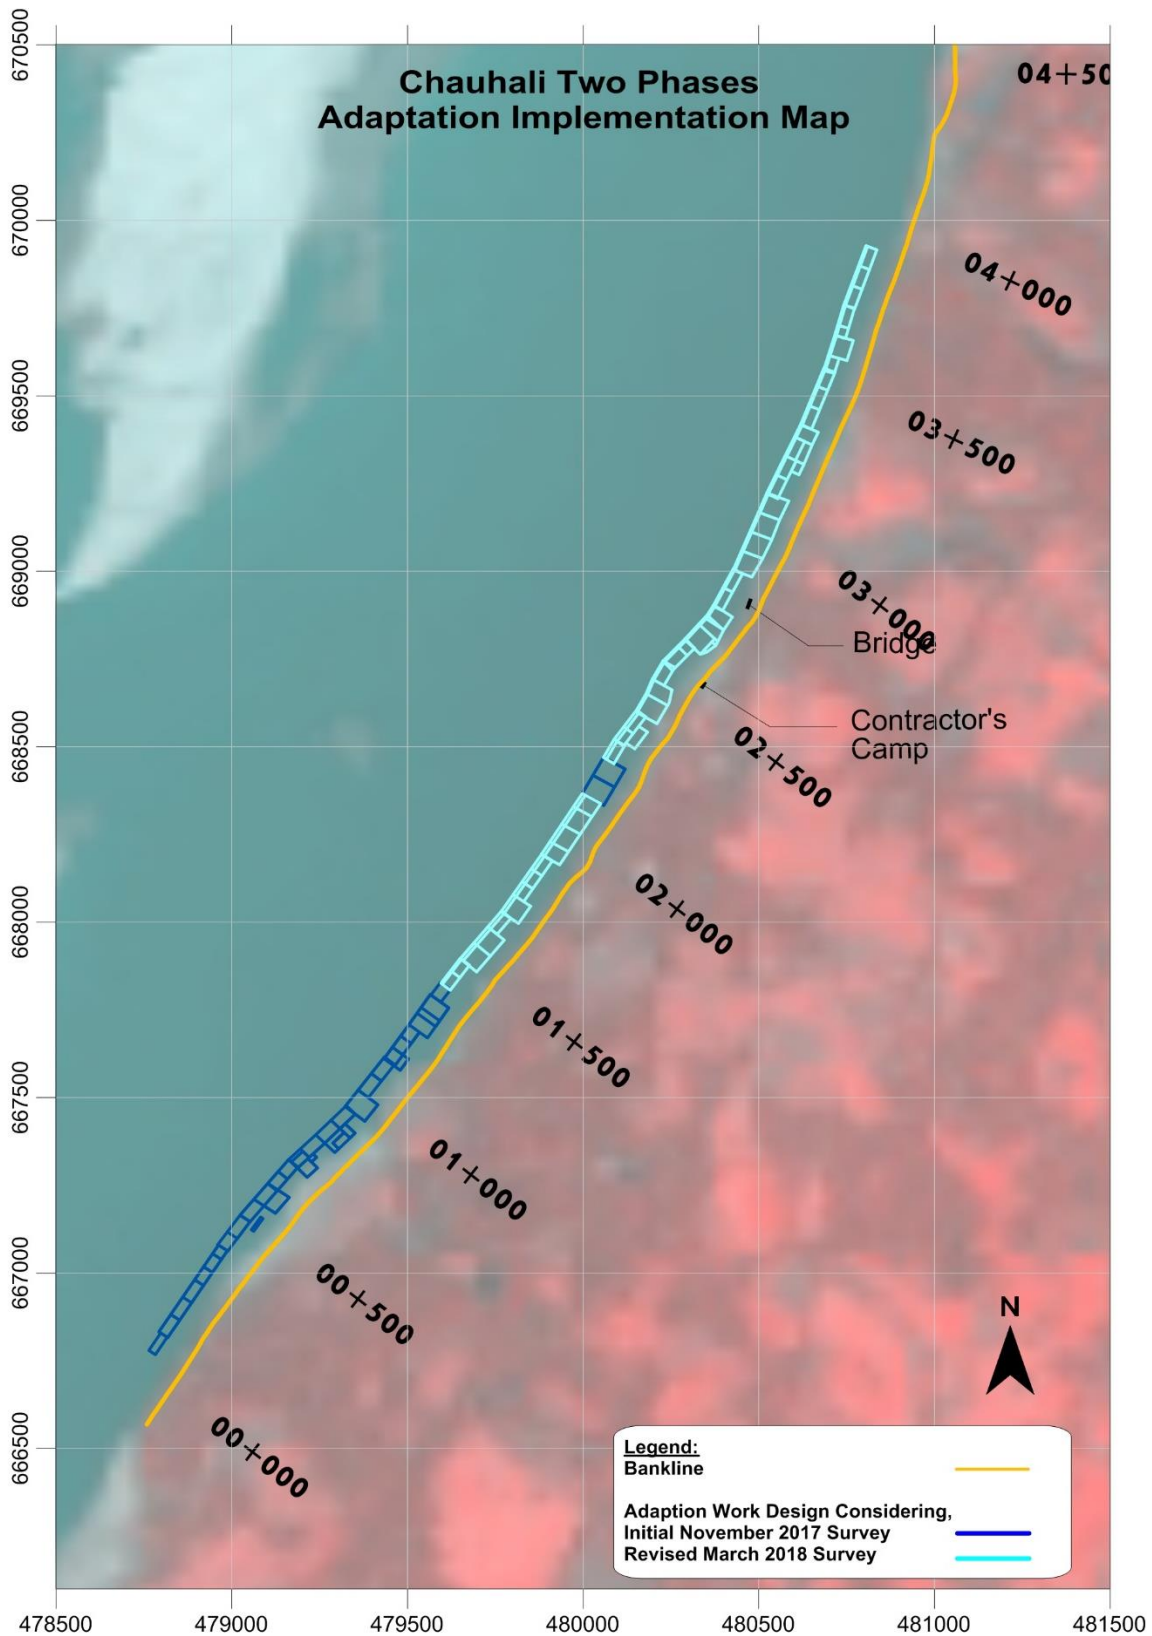
Figure 4-2 Plan view of two phases adaptation work

The BWDB successfully implemented 3.8km of adaptation works at Chauhali during the 2017-18 dry season. The adaptation plan was designed based on the November 2017 multibeam survey. The BWDB Tangail started implementing 1.54km adaptation work from stn 0.18 to 1.52 and 2.2 to 2.4 from the remaining geobags from work packages W6 and W7. After that due to lack of budget, leftover budgets from package W12 and 13 were adjusted with package W11 for implementing the rest length of around 1.96 km. The 1.96km adaptation design was revised considering the March 2018 bathymetry survey (Figure 4-2).
