Memo

Re: Flood monitoring report 2019-20

1 Introduction

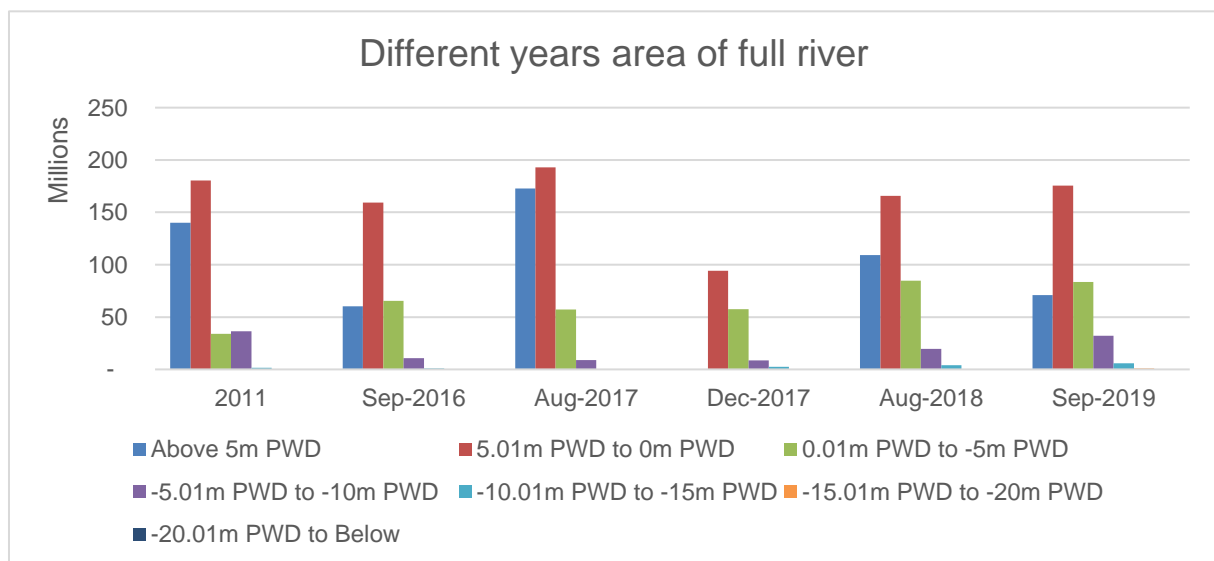
Figure 3-5 Area of different full river surveys

- ii. The below graph in Figure 3-5 shows the river area by elevation. December 2017 survey was a dry season survey, having a corresponding low river area. Overall the area with an elevation between elevation -5mPWD to -10mPWD has increased significantly, while the area above +5mPWD has reduced. This may indicate the concentration of the river in fewer, deeper channels.

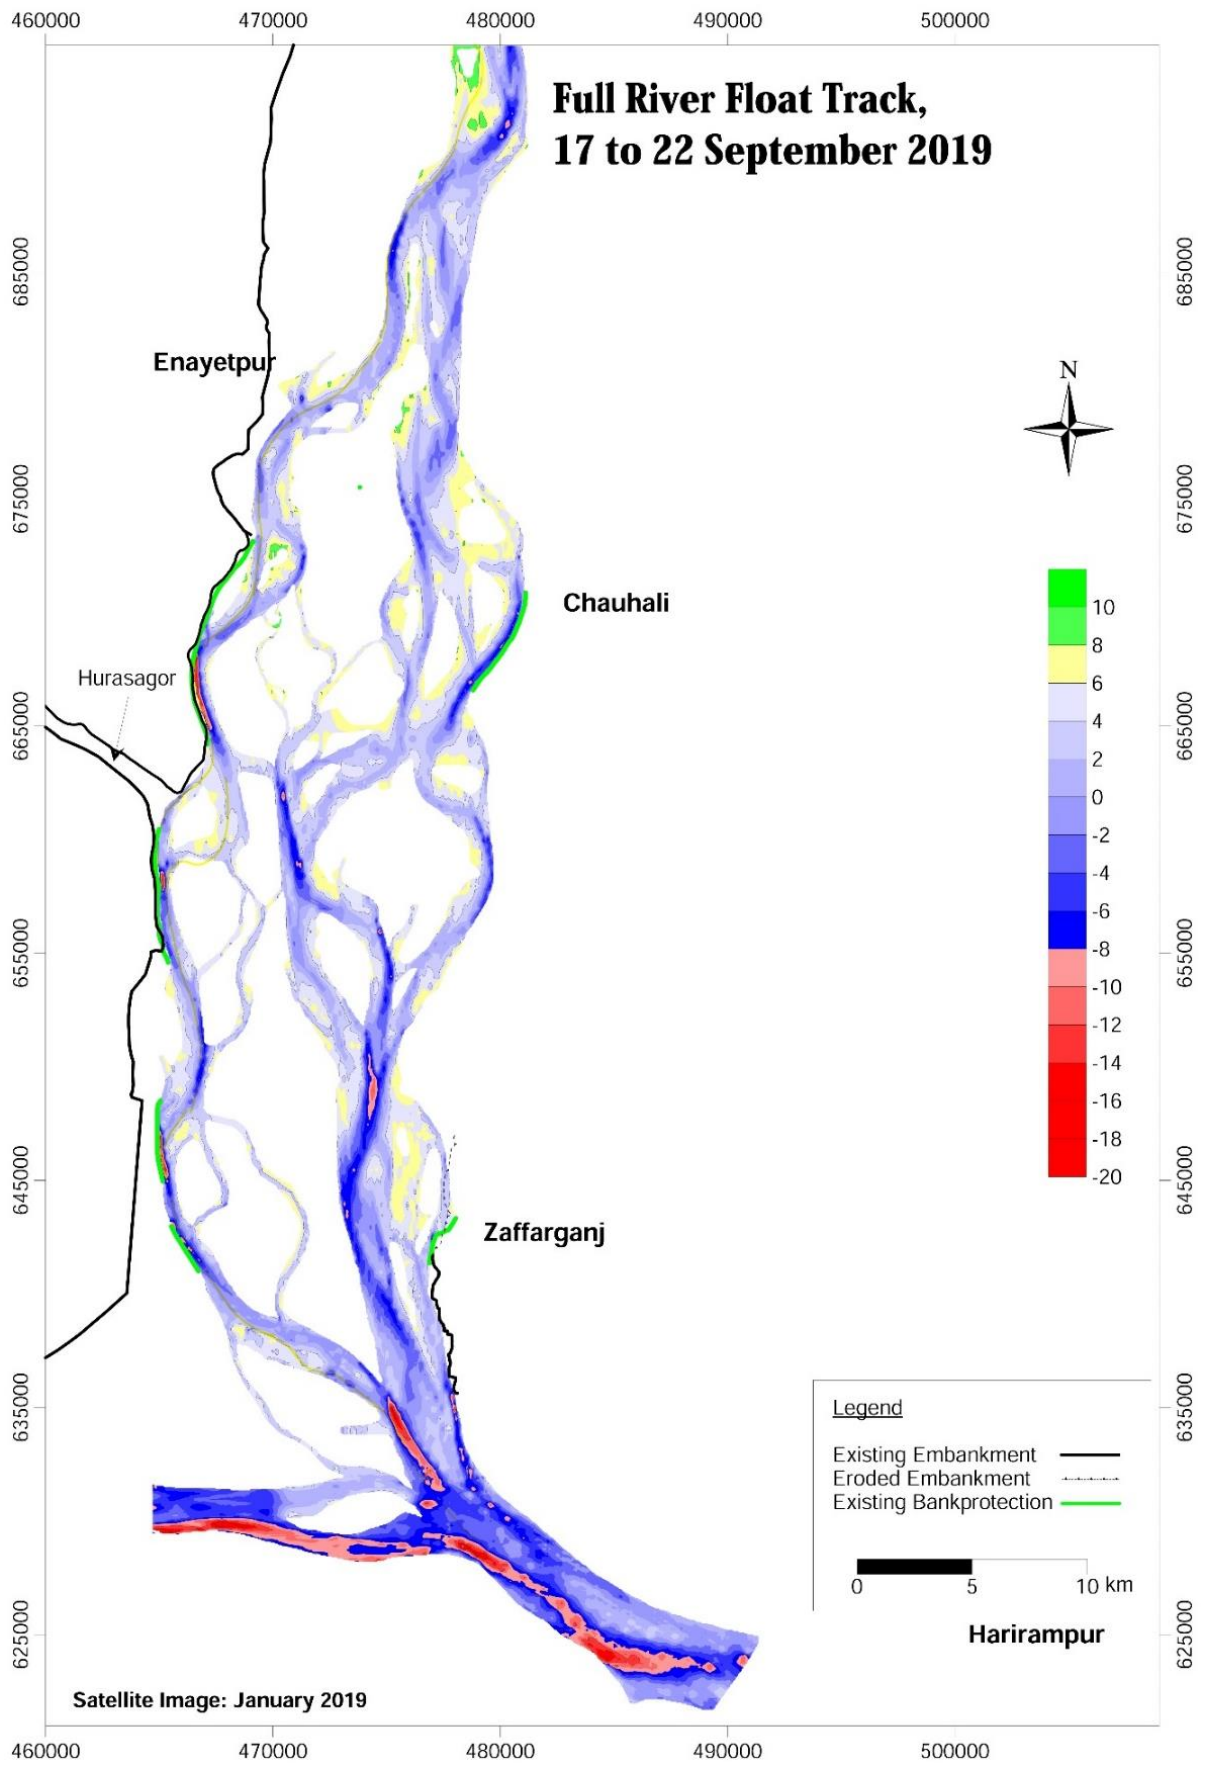
Figure 3-6 Full River Survey 2019

- iii. Figure 3-6 shows the 2019 flood season survey contour map. Figure 3-7 and Figure 3-8 shows the differential map. The map shows deep channels at Chauhali, Kaijuri, and PIRDP, as well as deep confluence, scours at downstream Solimabad and the Jamuna and Ganges confluence. Inflow from the Hurashagar appears to have little influence on the further flow pattern of the Jamuna. The Solimabad bend (at the offtake of the Old Dhaleswari) appears to be silting up again following a deepening in 2017-2018.

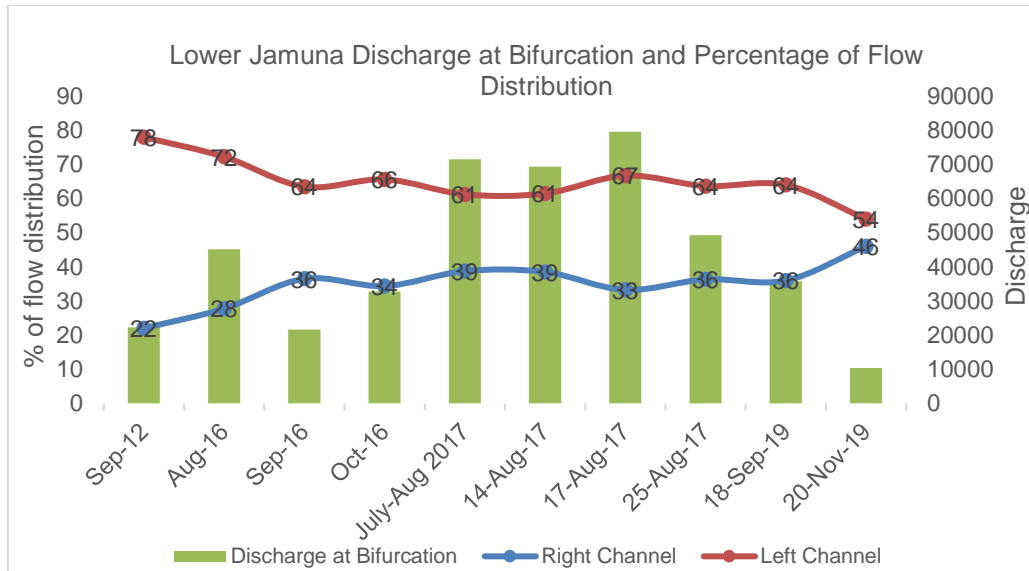
Figure 3-11 Yearwise discharge distribution at Enayetpur bifurcation

- iv. The flow distribution at the main Jamuna bifurcation (near Enayetpur) is that the western channel carries 46% and the eastern channel carries 54% discharge compared to the total discharge. ISPMC has conducted an ADCP survey from 2016 to 2019 and also collected 2012 discharge information from JMREMP. Figure 3-11 shows the development of the discharge distribution at the bifurcation. It shows that after years of dominance of the left (eastern) channel, the distribution is now almost equal.

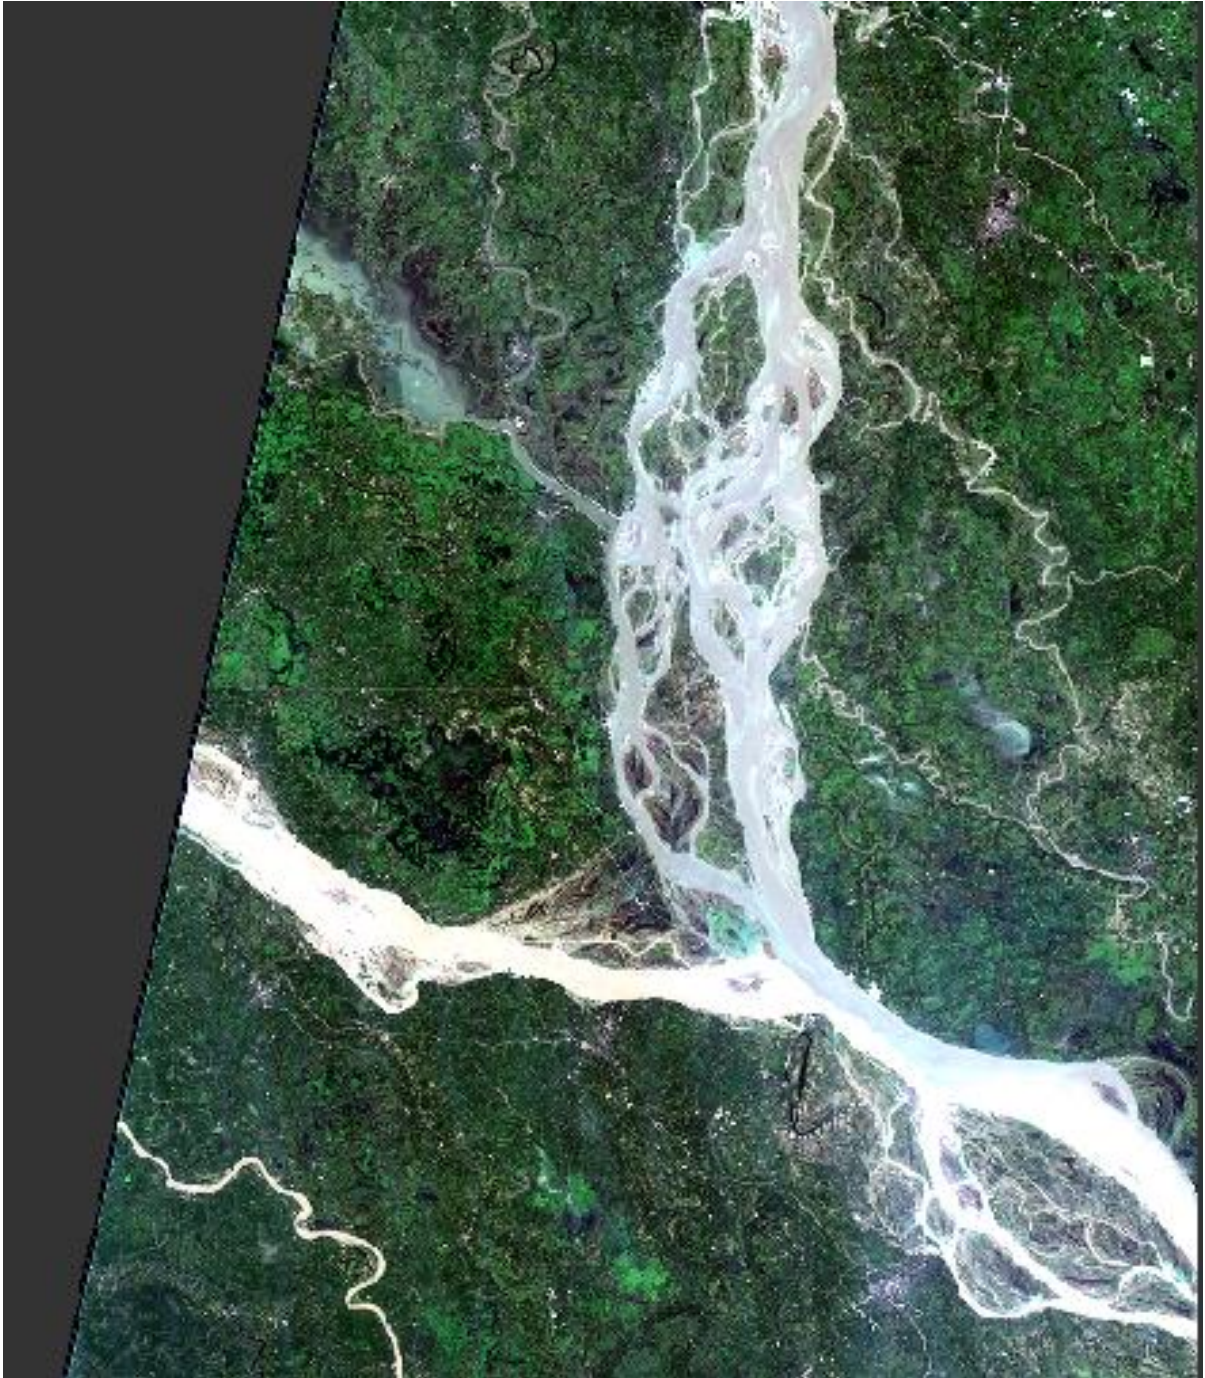
Figure 3-12 Lower Jamuna and Upper Padma rivers in October 2019 (source ESA Sentinel-2 mission)

- viii. The satellite image in Figure 3-12 shows
- The river is in a single channel up until the bifurcation
 - The eastern (left) channel seems dominant

- The western channel follows the protected banks and flows straight beyond the Hurashagar confluence after that multiple channels are crossing the char

- There appears to significantly backlog of water in the Hurashagar upstream of Baghabari
 - The waters from the Hurashagar do not initially mix with the Jamuna waters

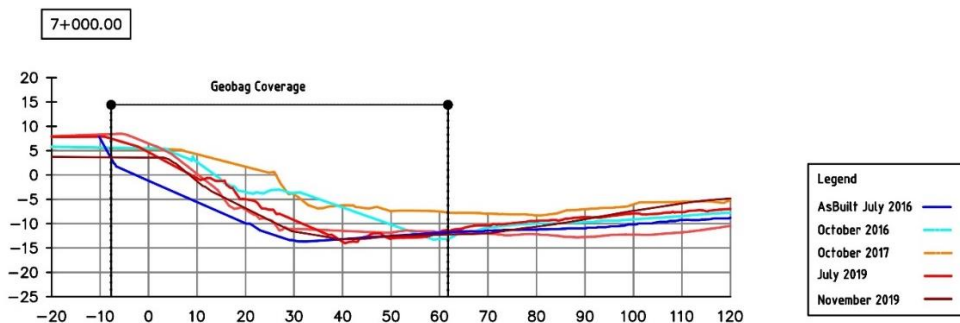
Figure 4-3 Riverbed development beside the Primary School at Zafarganj

- (i) It appears that the situation is overall stable and no large scour is emerging.
- (ii) There is a small scour at the protrusion in about the middle of the works, which is slowly but gradually deepening. However, this scour is yet to significantly surpass the depth during implementation
- (iii) Cross-section near the Primary school area shows that the initial apron was placed on a deep bed elevation and after that, that portion was sedimented. The overall progress of that place is shown in Figure 4-3
- (iv) The slope near the primary school is ver steep (about 1V:1.5H see Figure 4-4), which is typical for slopes at protrusions like spurs and natural hardpoints. Steep slopes pose a significant geotechnical risk, in particular when the slope launches further, creating a longer slope at the same steepness

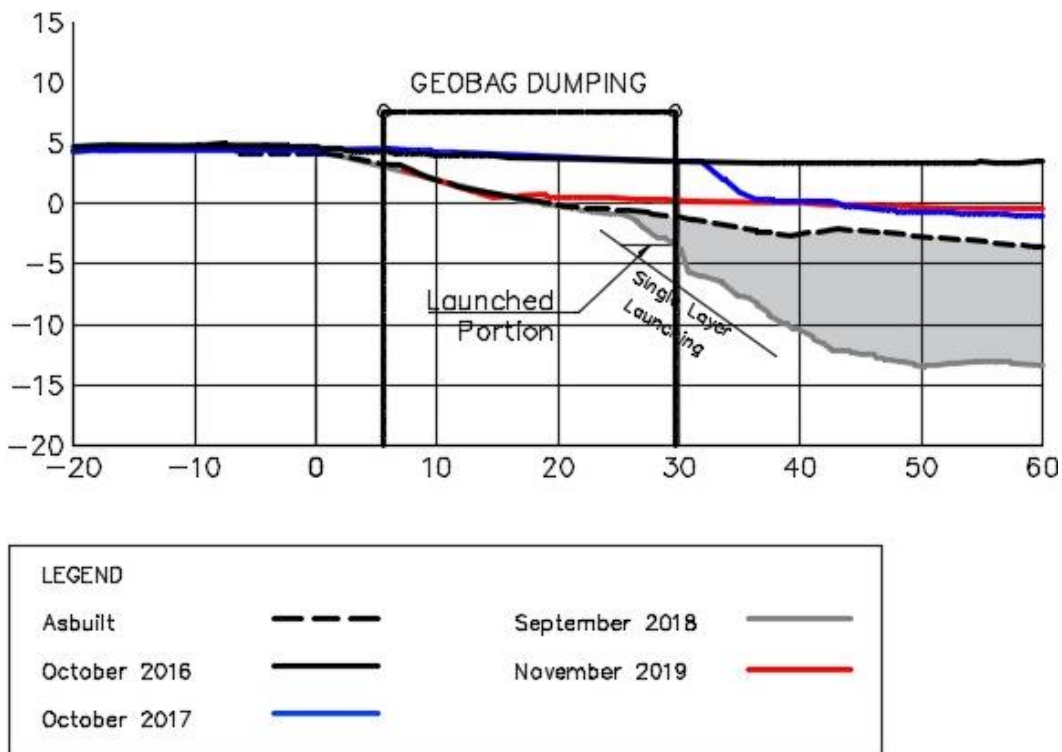
Figure 4-5 Riverbed development at upstream portion

- (i) The scour hole is reducing in overall length and is separated into different smaller holes
- (ii) The total depth of the scour hole has reduced slightly
- (iii) Upstream of the placed protection, the riverbank came under increased attack since the 2018 flood season, which led to erosion over a length of about 3,000m, including damaging some part of the riverbank protection works. This erosion has the potential to outflank the protection works, despite the erosion rates being mitigated by the cohesiveness of the soil.
- (iv) During the construction period there was a char at the upstream portion. That time from Stn 1600m to 3000m smaller apron was placed. After dumping that place was silted upto 5m during October 2016. During September 2018, after third year from the construction this portion started launching. Again in November 2019, this portion sedimented by roughly 10m.

- (v) Additional bank protection and underwater protection will be required from 1600m to upstream to protect the existing work and mitigate upstream erosion.
- (vi) During apron placement in 2015-16, there was a sandbar at the upstream portion. That time only 20m apron was placed. It launched in 2018 but again sedimented in 2019. This section needs to monitor during the 2020 flood season. Adaptation work would be needed to strengthen existing work.

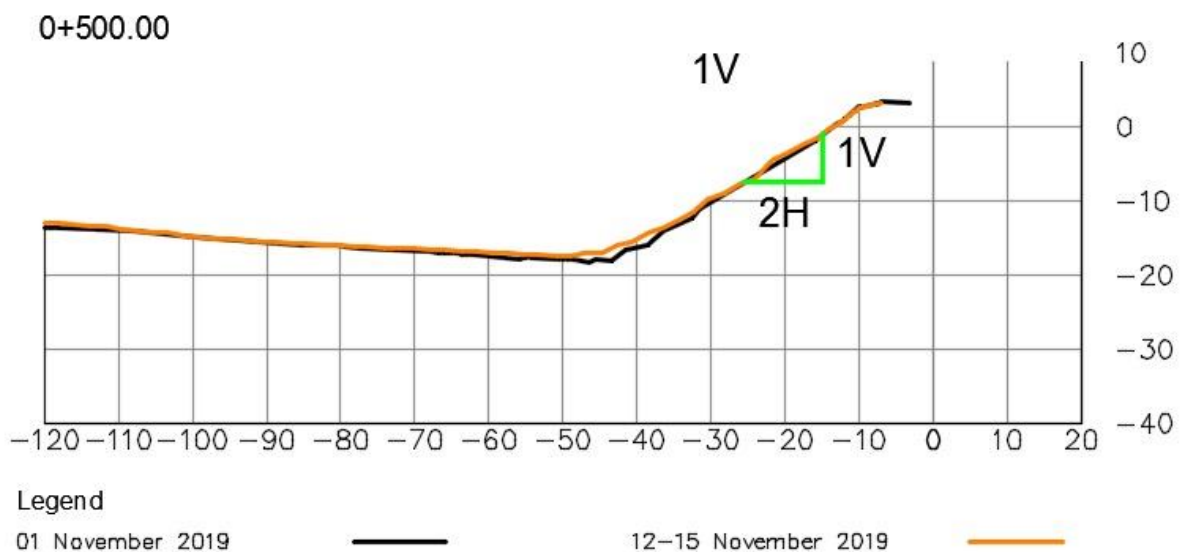
Figure 4-6 Launching at Stn. 0.5km

- (i) Multibeam and single beam both survey shows a ratio of 1 vertical and 2 to 2.5 horizontal slope near the bank from Stn 0.4km to 1.8km and 4km to 5.2km. This slope indicates launching of apron material. Figure 4-6 shows a typical launched section at Nagarbari revetment and Figure 4-7 shows a 3D view of underwater launched slope.

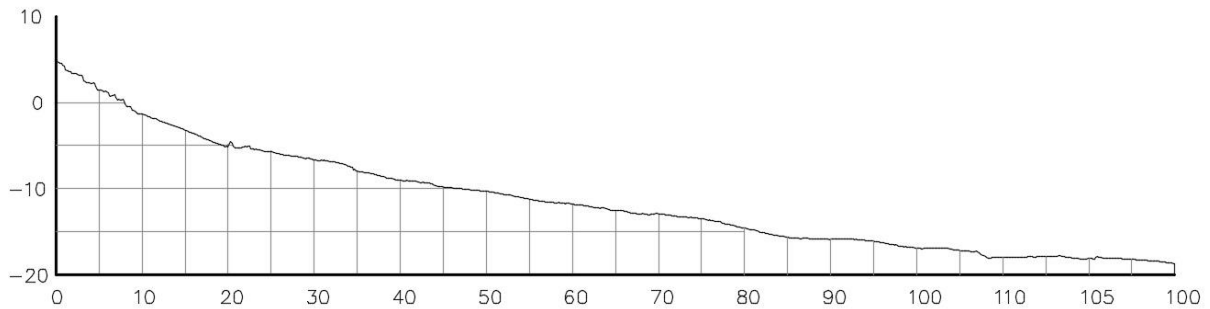
Figure 4-9 Deep scour at stn 0.5km

- (i) At Stn 0.4, 150m from bankline an underwater spur shape dumping causes a deep scour at Stn 0.5. Satellite image shows heap of boulders dumped at that location. The point marking shows heap of boulders dumped in 2016, visible also in 2019. A detailed image is provided in Appendix 8.6.

- (ii) Boulder's heap at stn 0.4km makes spur like erosion at downstream which results deep scour at stn 0.5km and this deep scour which is 100m far from the bankline affect underwater slope.

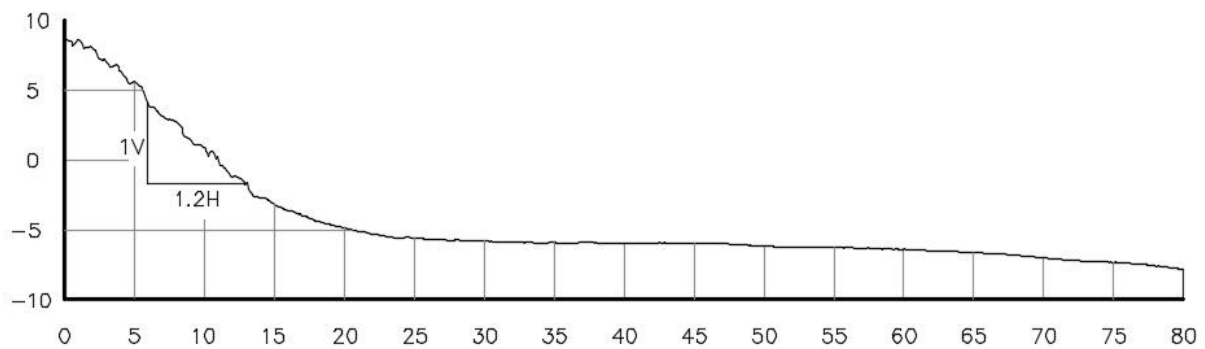
Figure 4-10 Step slop at stn 0+600

- (iii) At this site stones are used for preparing the under water apron. Sample cross section at stn 0.6km shows 1V:1.2H steep underwater launched slope.

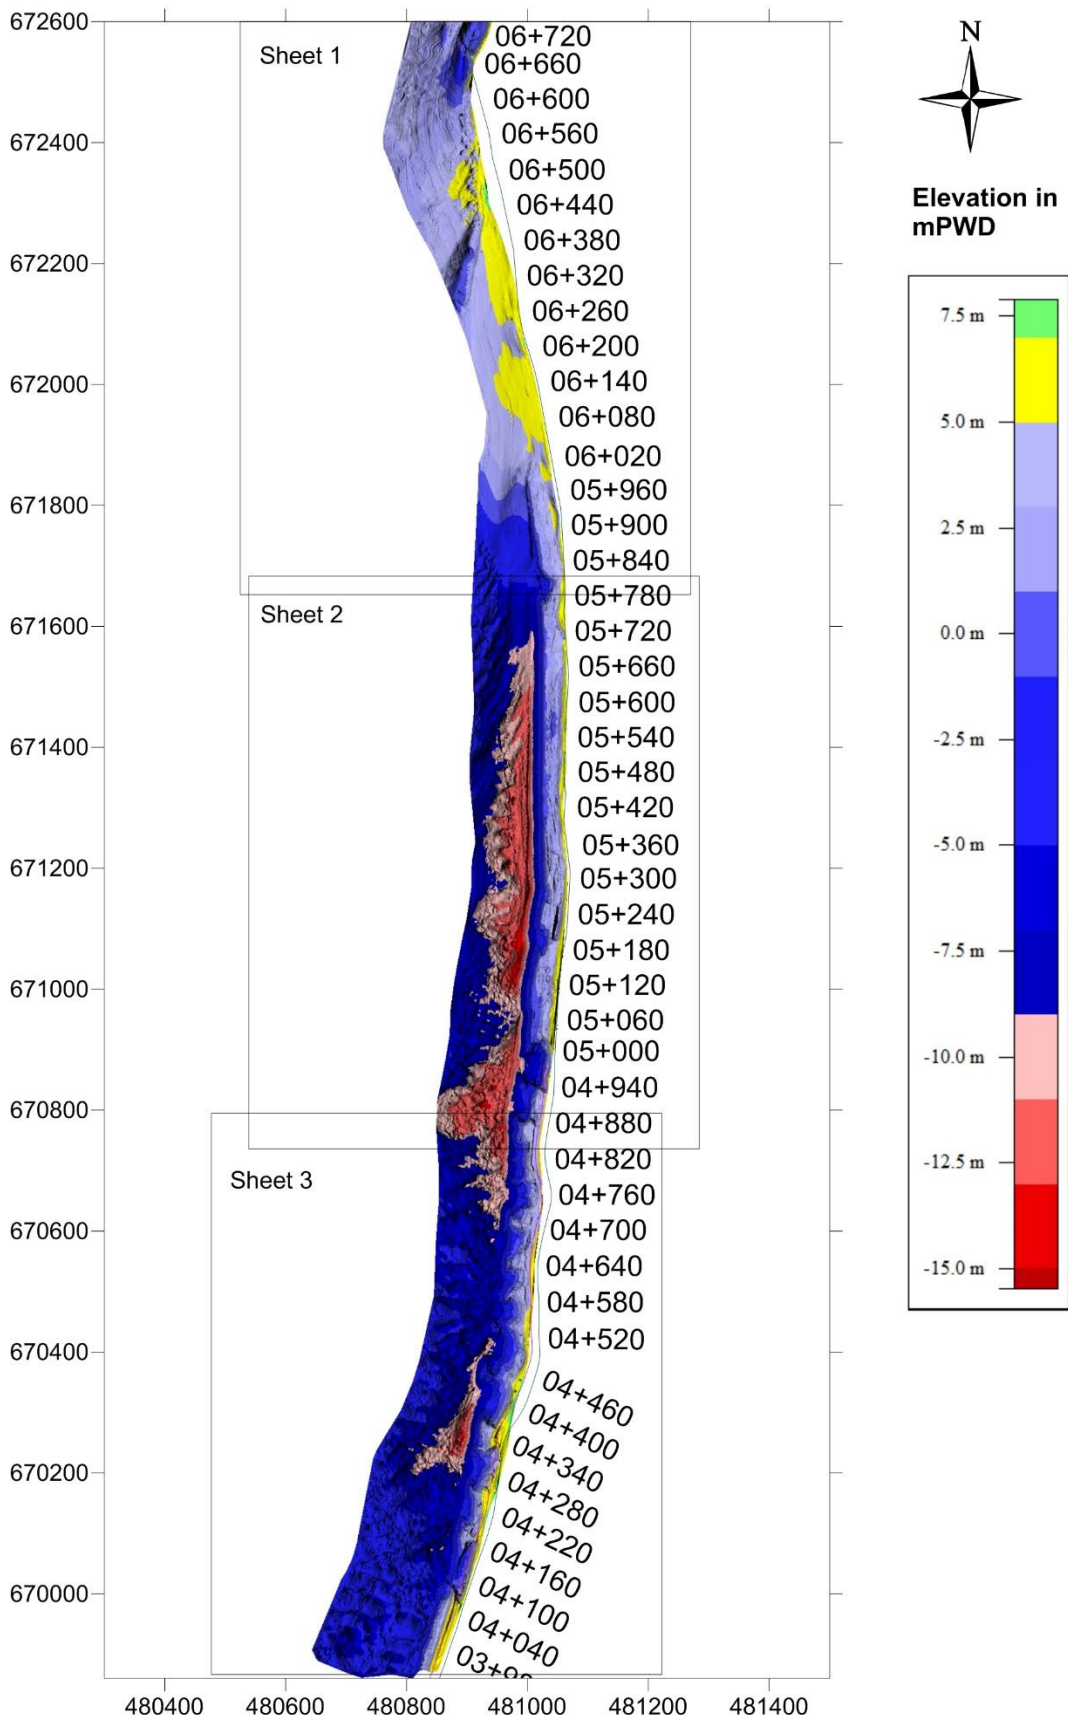
Chauhali Multibeam Survey, 23 June 2020

There is a bankfailure and underwater erosion near the outflank at km 6+700. In this location apron is buried under sediment and except the outflank no other erosion observed.

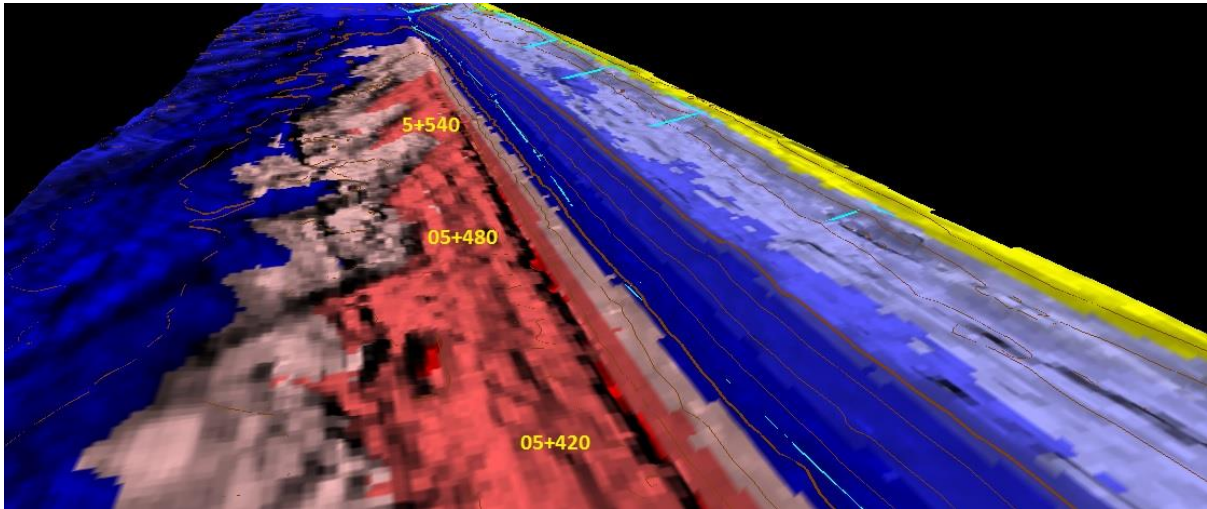
Figure 8-2 Underwater launched slope beside temporary protection

. From plan view and 3D view it shows that the apron beside the protection upstream of 5+000 is in significantly better condition compared to the apron from km 4+000 to km 5+000.

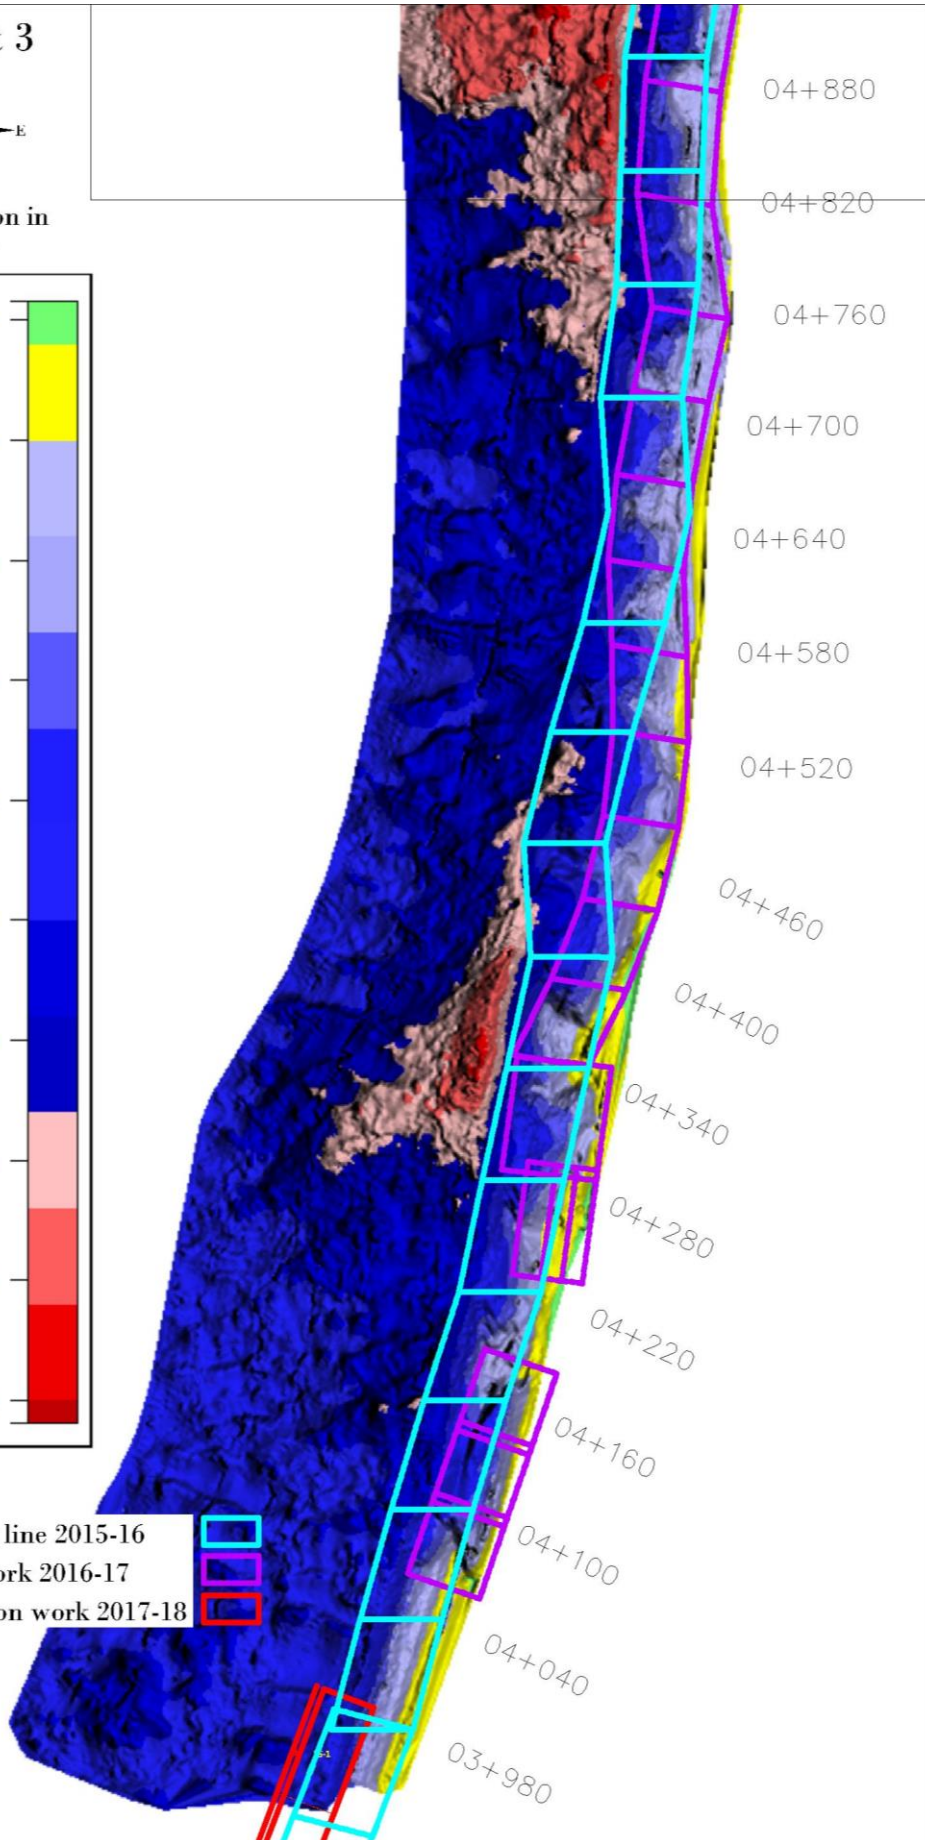
At this location erosion was observed during the 2016-17 flood season. After 2017 flood this location starts filling and recent survey shows new scour but still the launched slope is not completely exposed. From the plan view eroded location, dumping plan, repair strips and location of the adaptation work can be seen.

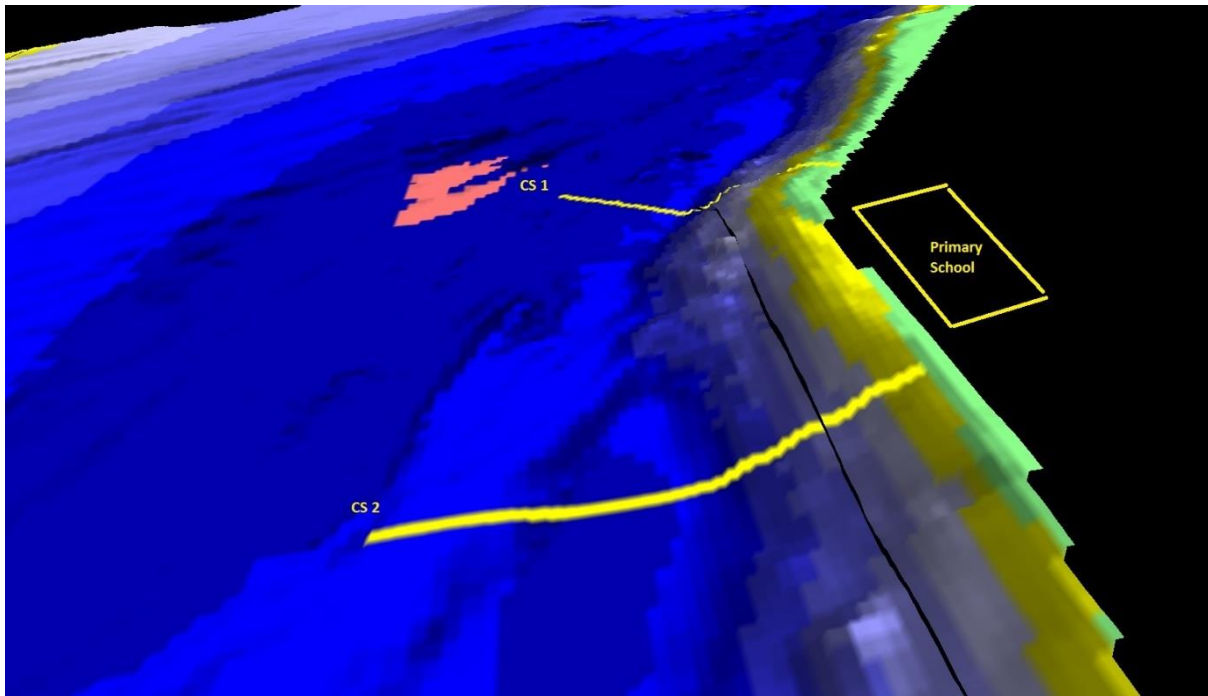
Beside the primary school at Zafarganj site, the underwater slope is very steep. 3D view shows the slope near the school and cross section shows roughly 1V: 1.5H underwater slope, which is typical for protrusion scours. The scour hole has not yet fully developed but it is likely that it will increase in depth and size over the next seasons.

Figure 8-5 3D view of underwater situation near the primary school area

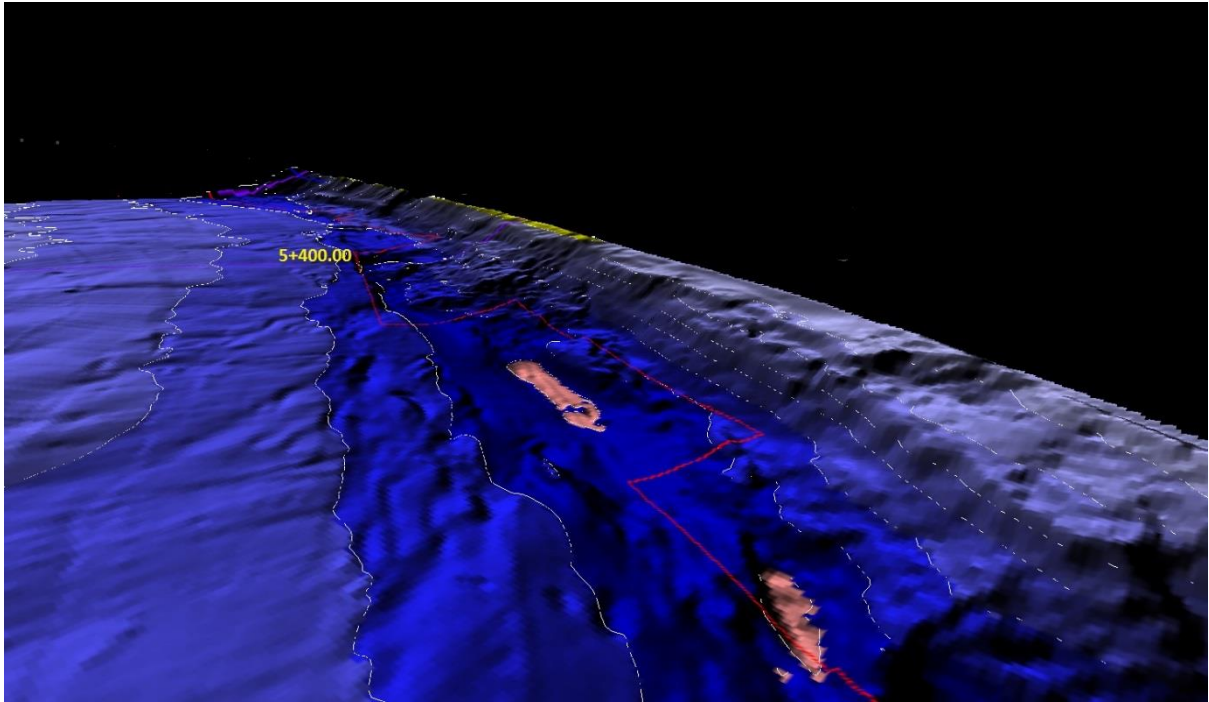
Figure 8-8 Underwater launched slope at 5+400.00

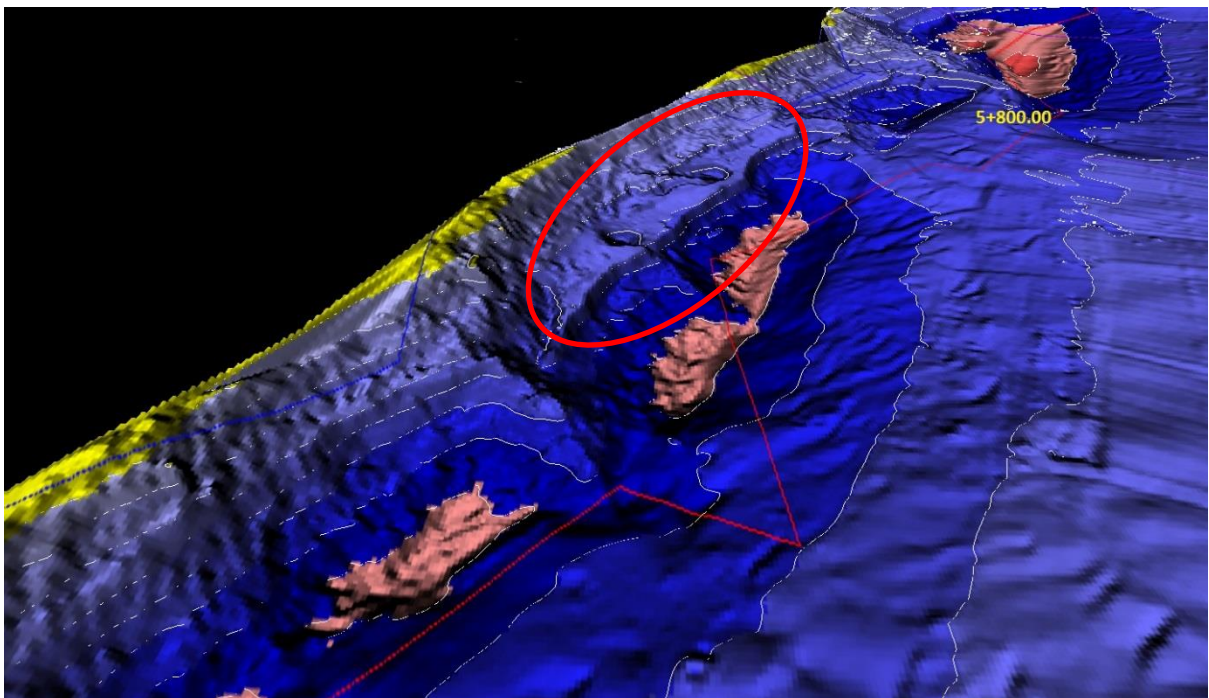
Figure 8-9 Underwater launched slope with sediment on top

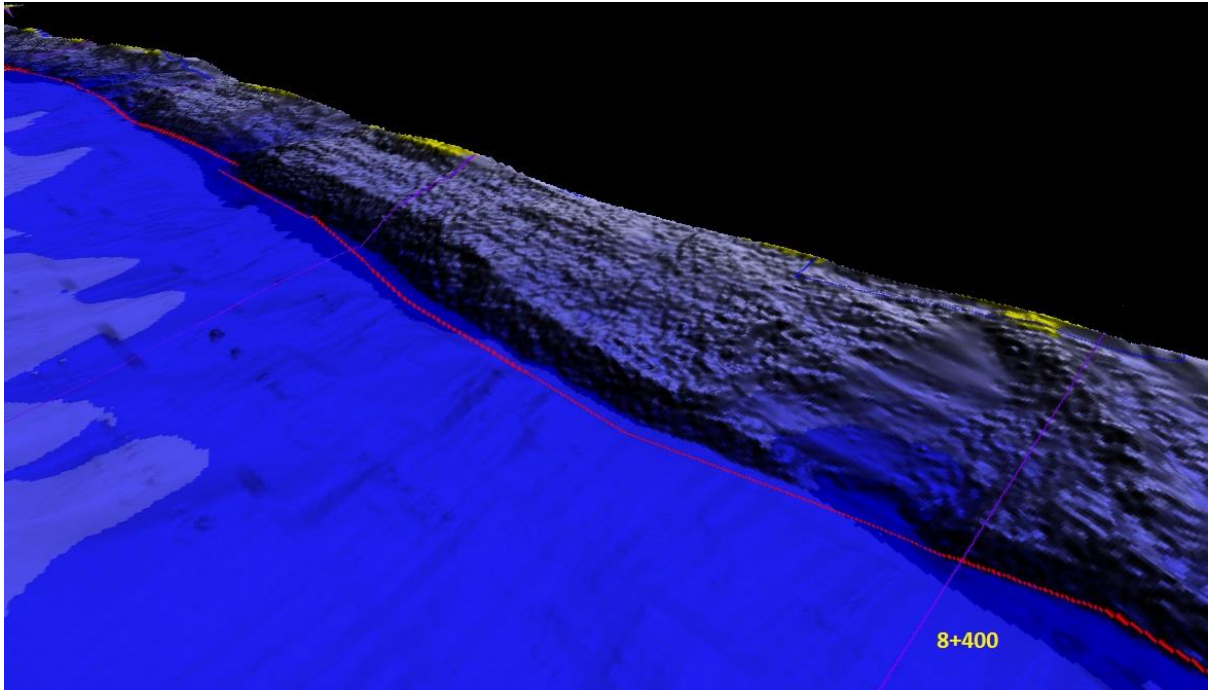
Figure 8-13 Launched slope at km 8+400

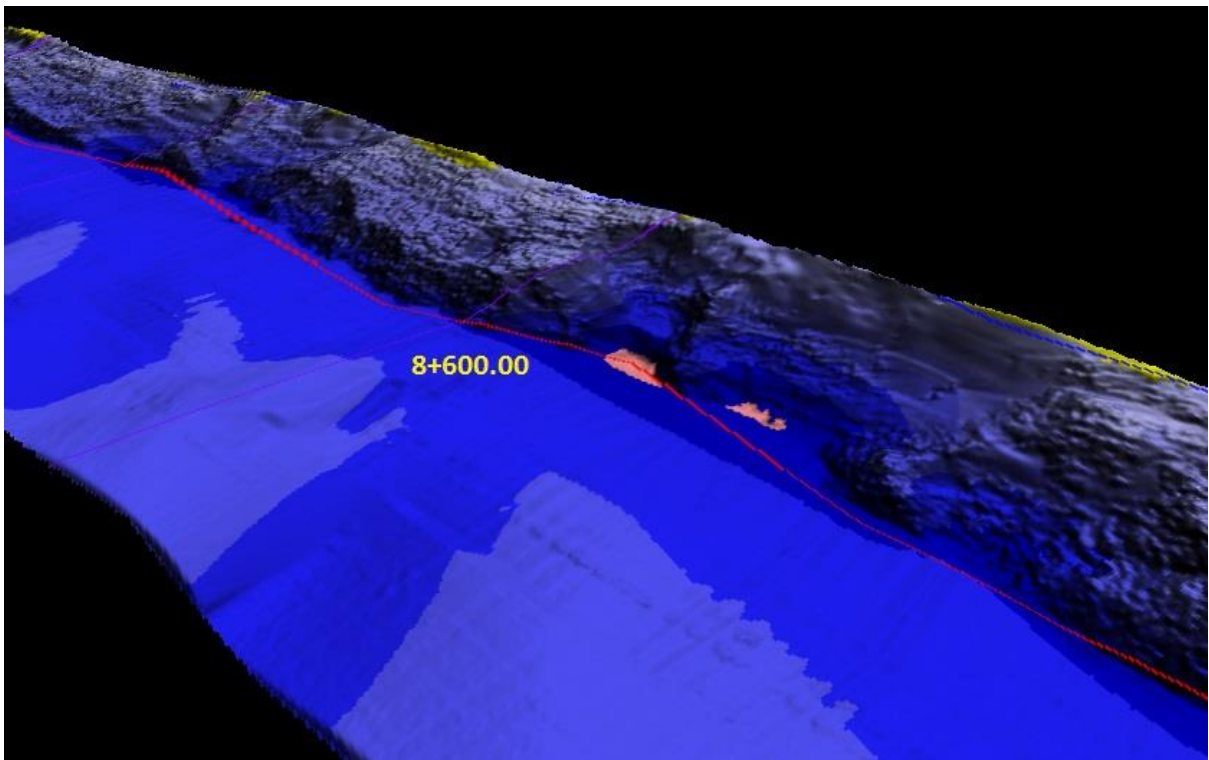
Figure 8-14 Slip circle at km 8+600

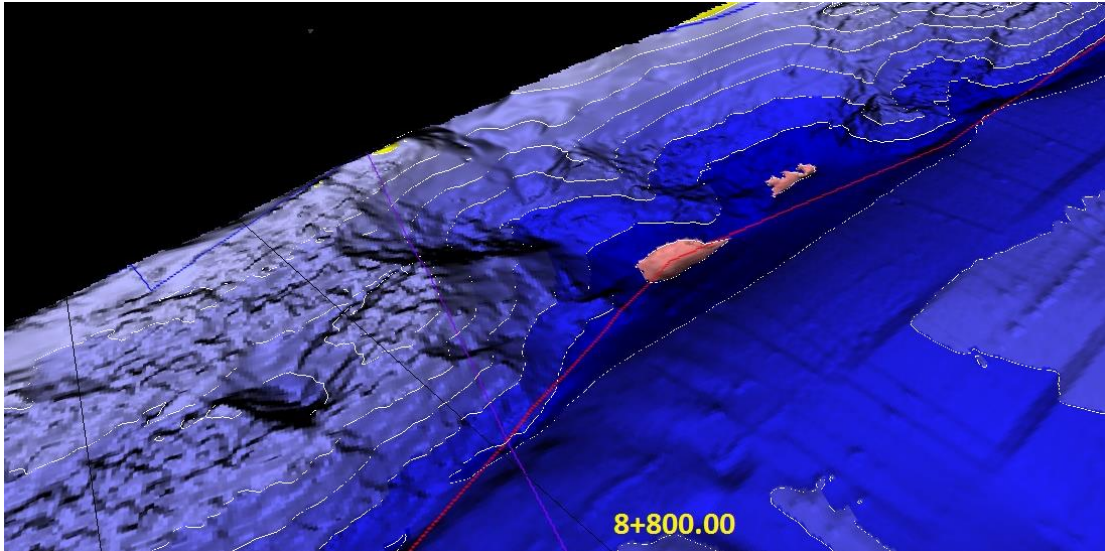
Figure 8-15 Underwater slip circle at km 8+800

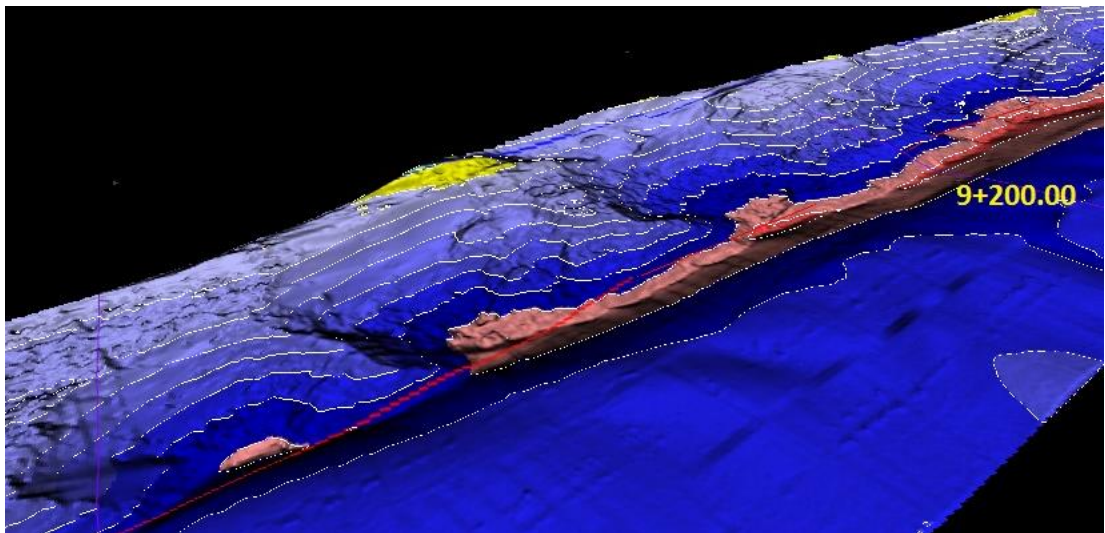
Figure 8-16 Underwater slip circle at km 9+200

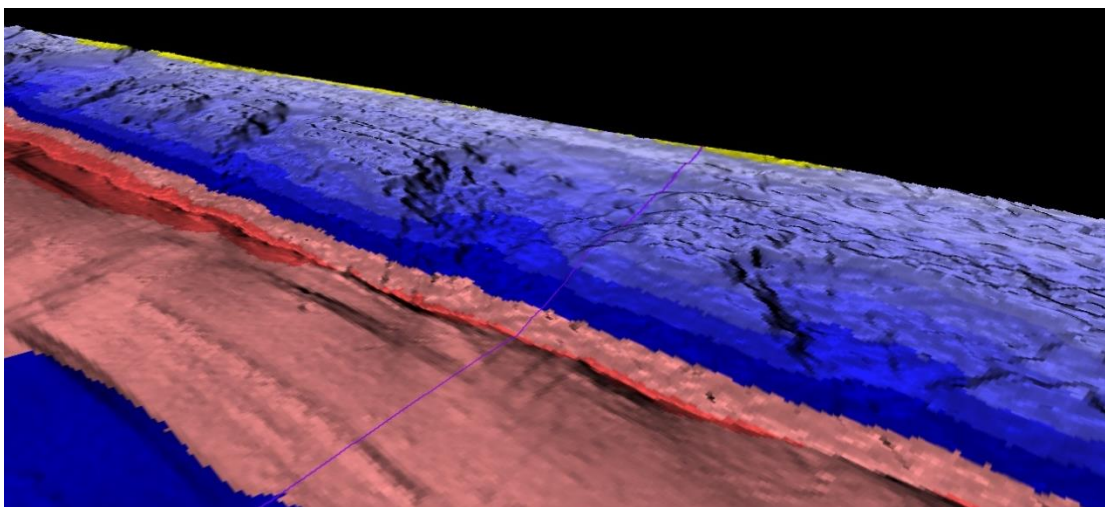
Figure 8-17 Underwater 1V:2H launched slope at km 9+400

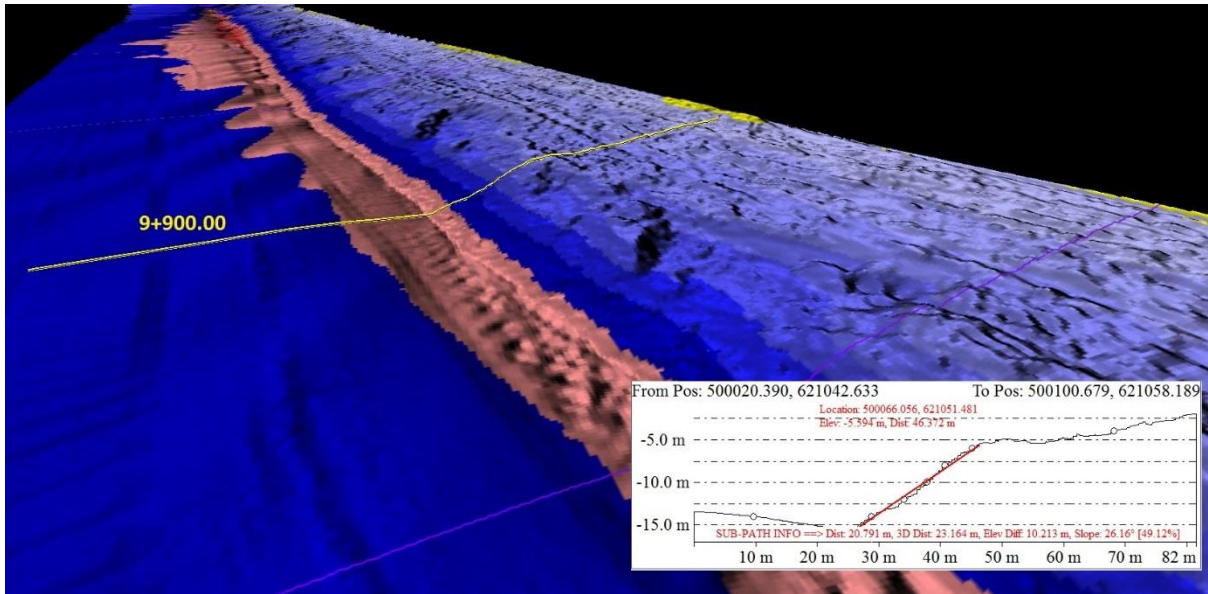
Figure 8-18 Underwater 1V:2H launched slope at km 9+900

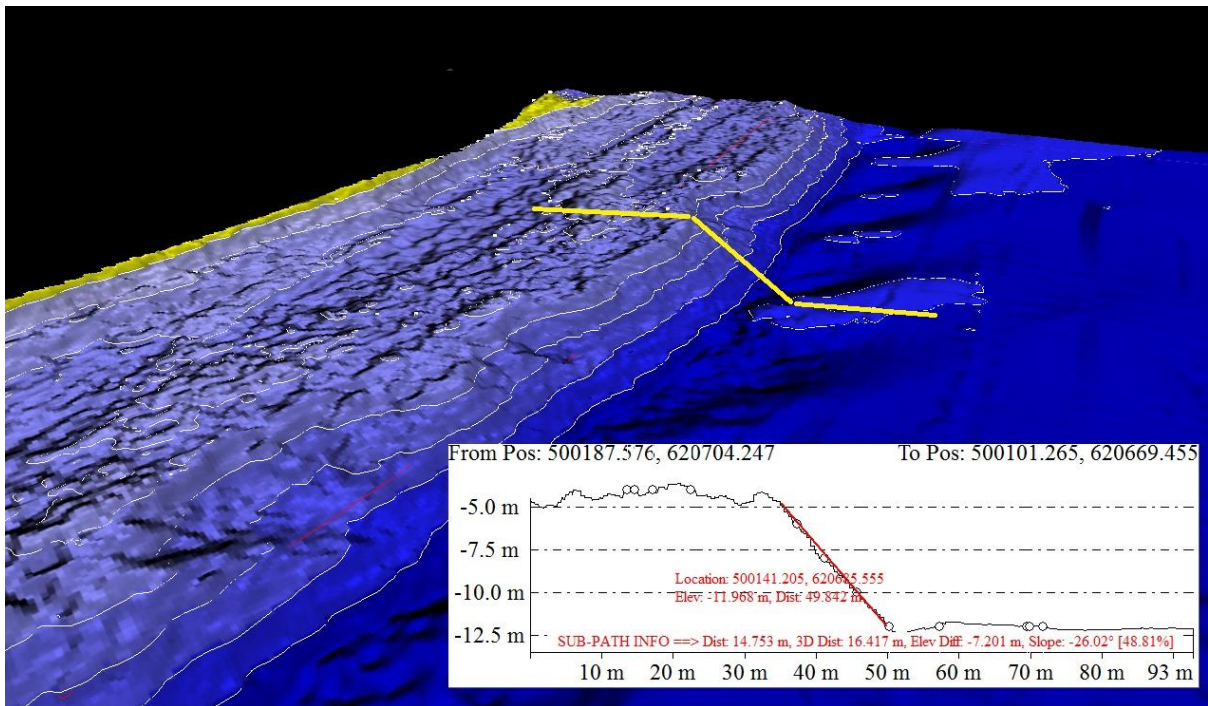
Figure 8-19 Underwater 1V:2H launched slope at km 13+000
