Memo

Re: Flood monitoring report 2019-20

1 Introduction

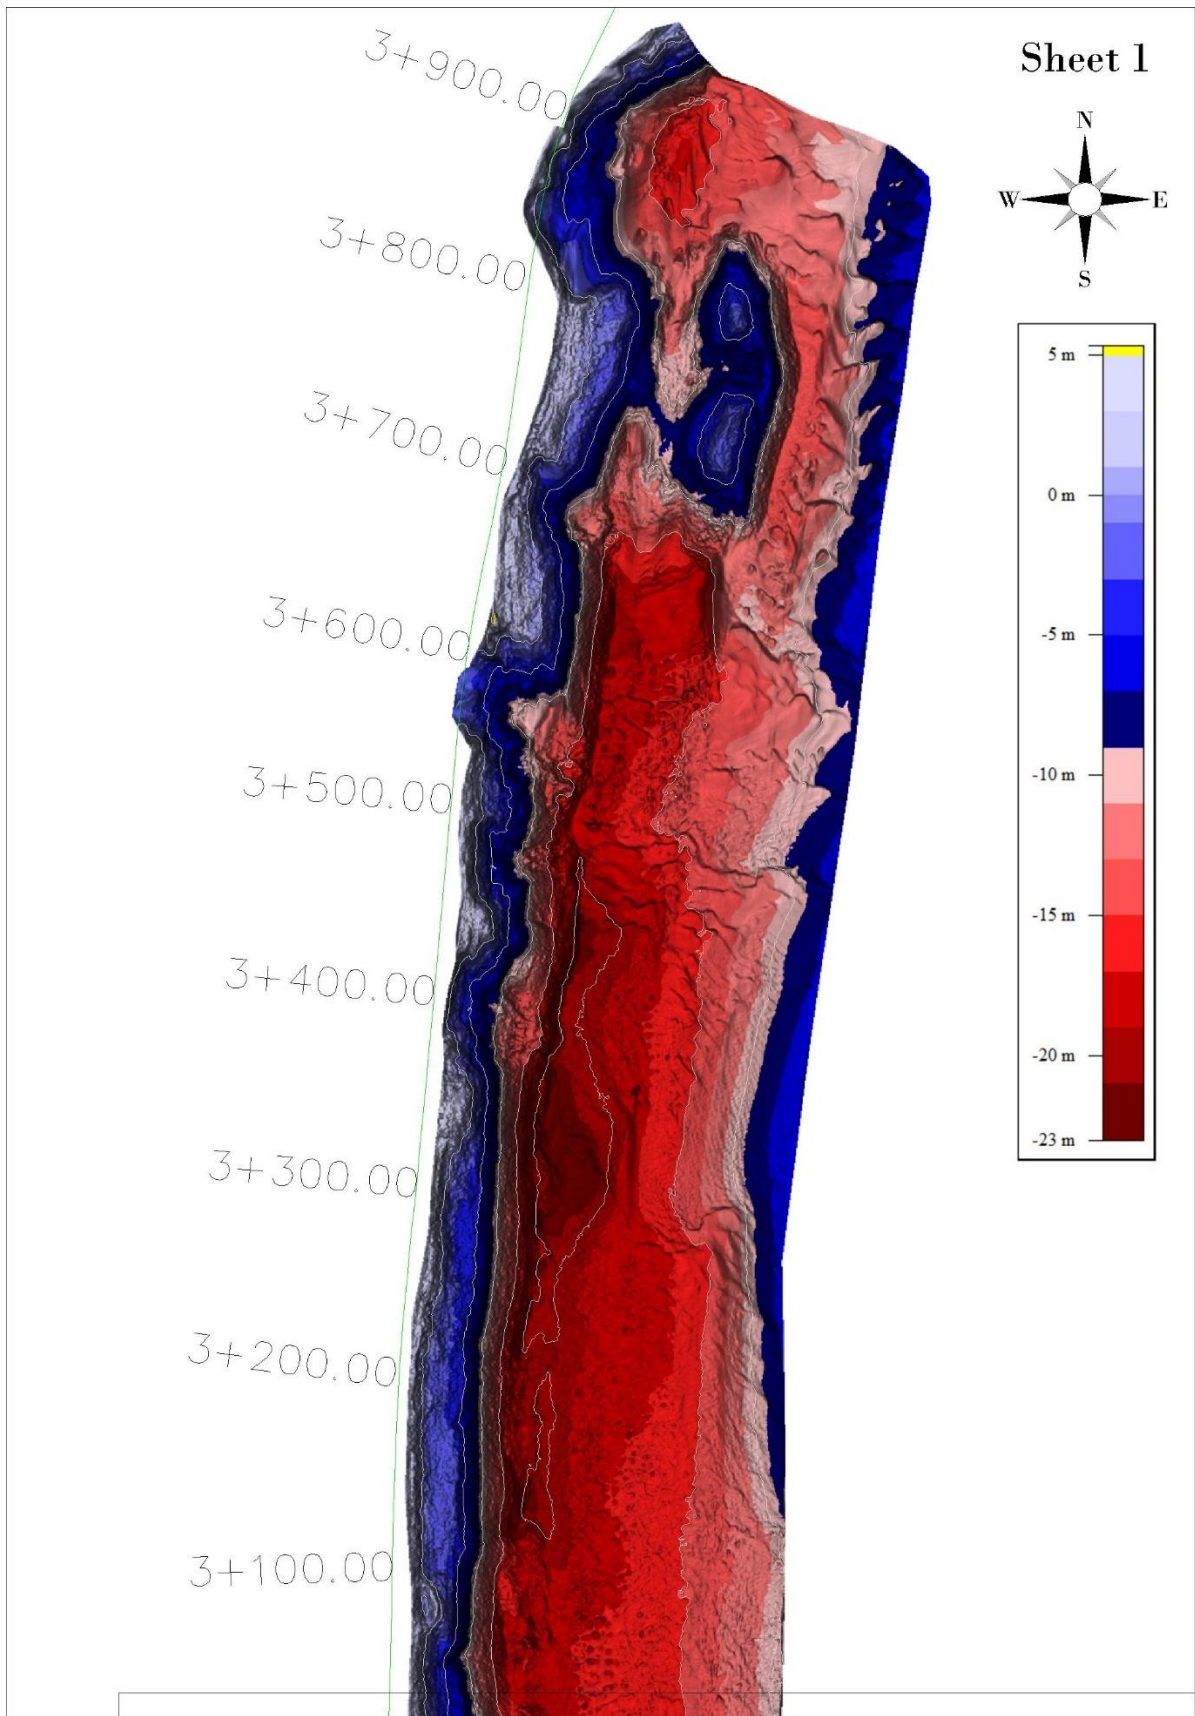
At this location near km 3+800, 100m from the bankline one big hump observed. This natural earth formation could be clay which did not eroded. This hump could disturb the flow which might aggravate the underwater erosion located from 3+700 to 3+300.

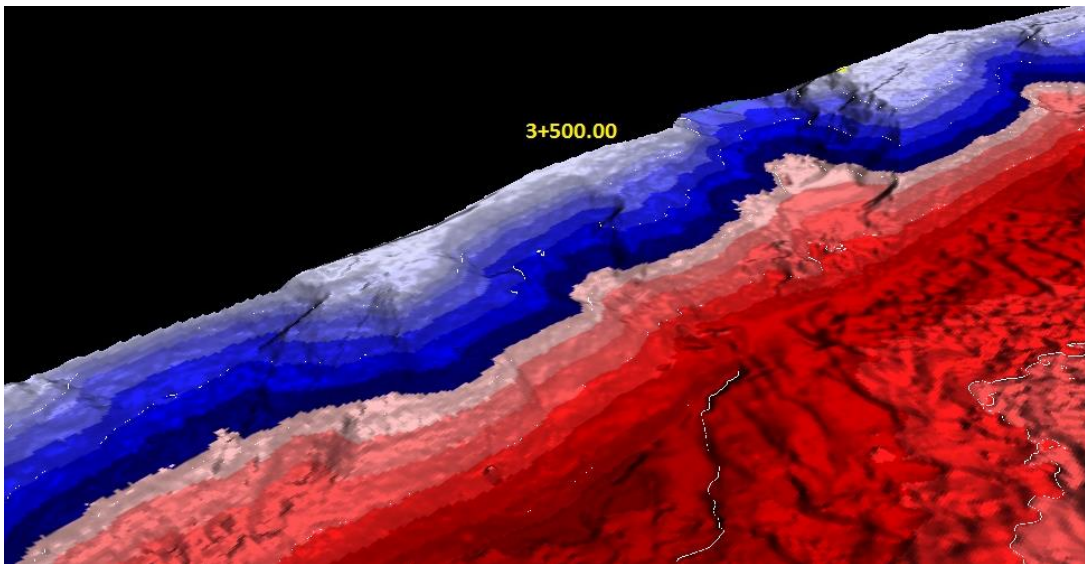
Figure 8-21 Underwater erosion

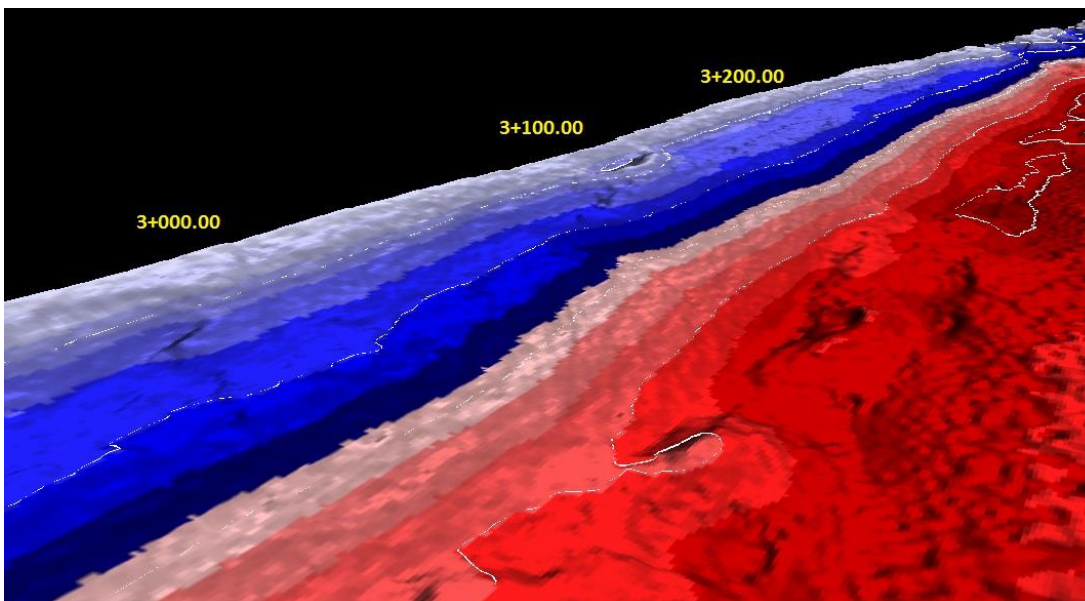
Figure 8-22 Under launched slope with geobag coverage

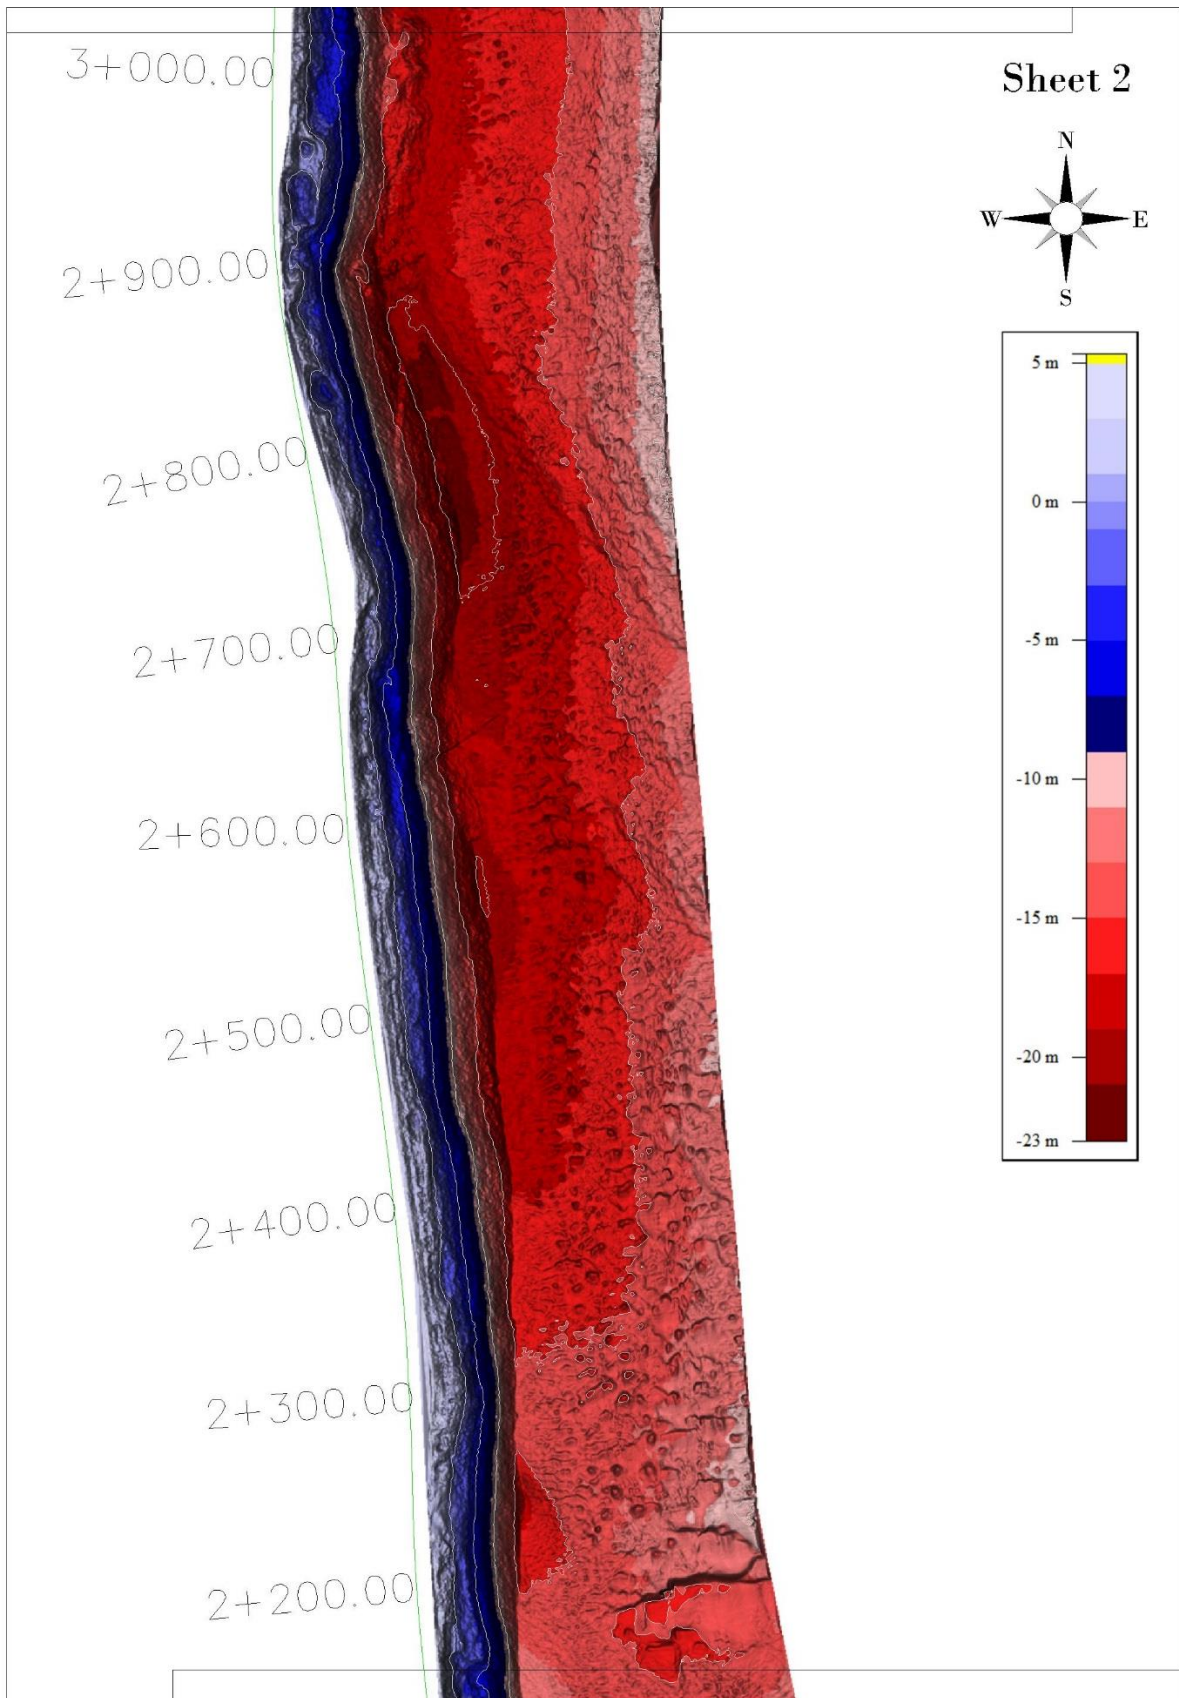
At this location two pockets in dumping observed at km 2+900 and 2+800. Other location shows nicely launched slope.

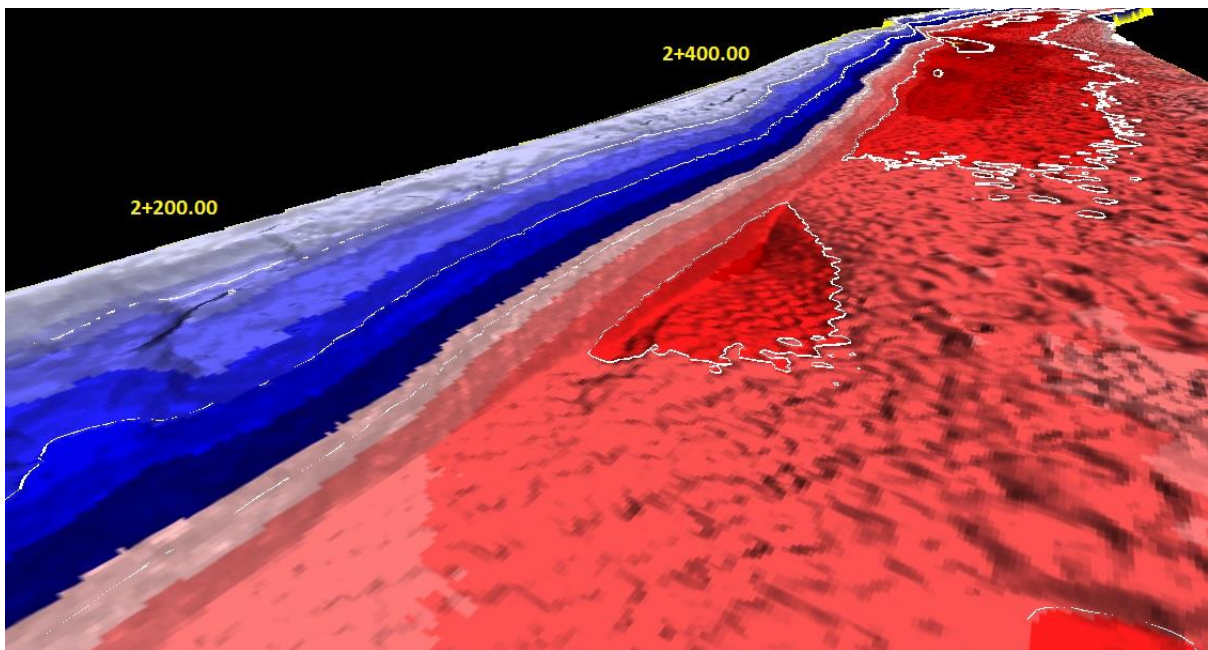
Figure 8-24 Underwater launched slope

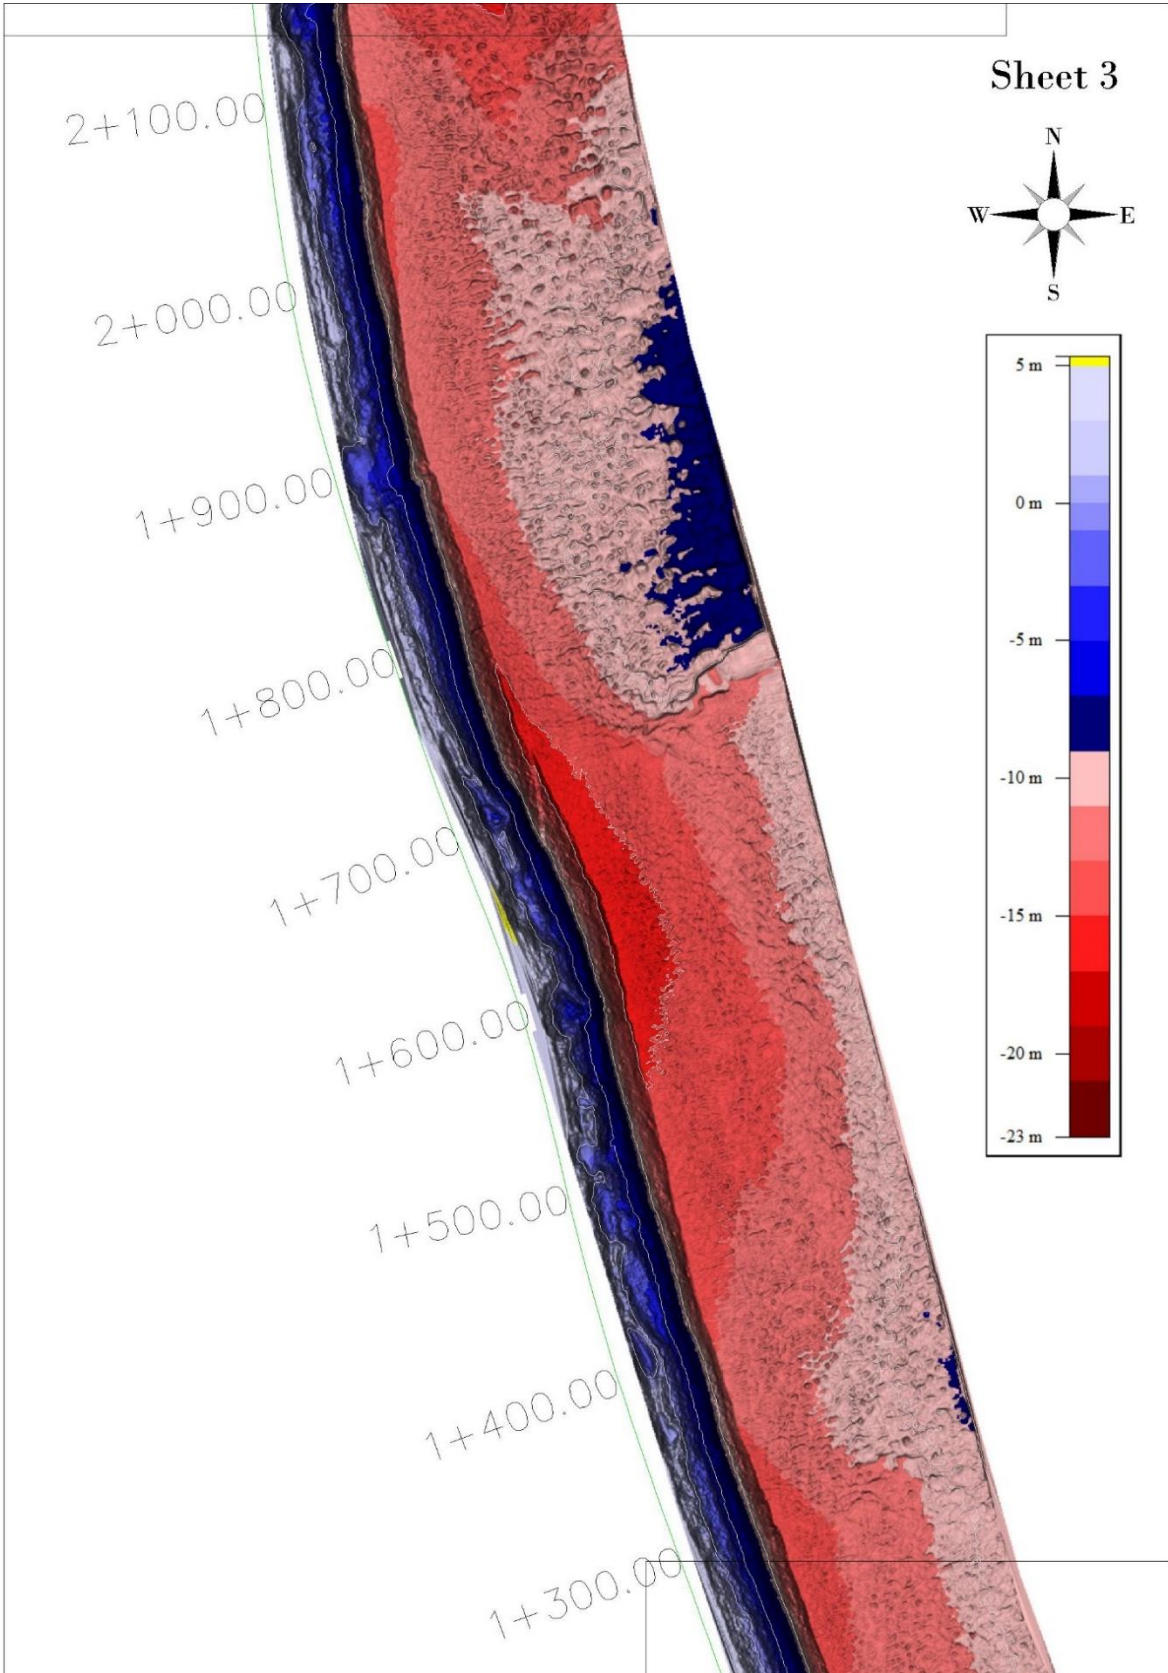
At this location, pockets in dumping observed at three places, those are at km 1+700, km 1+600 and km 1+400. One slip circle observed at km 1+900 .

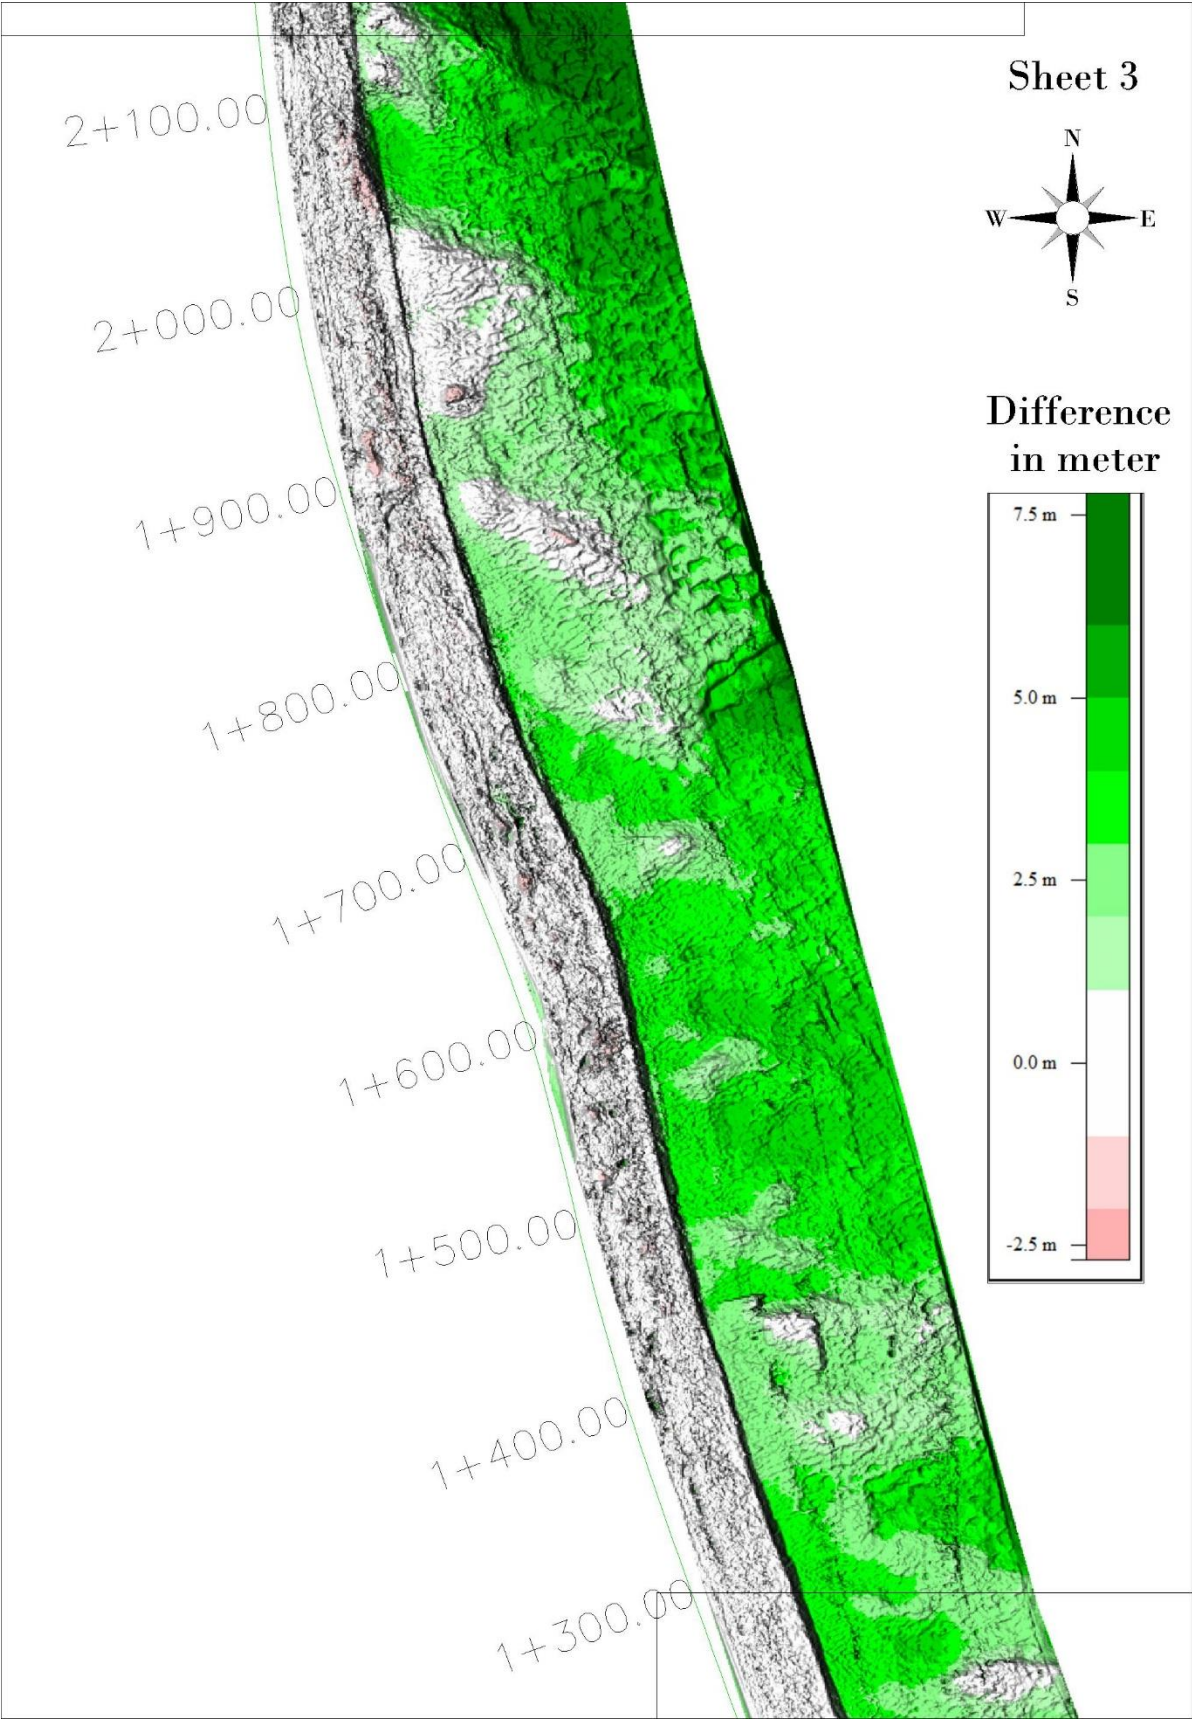
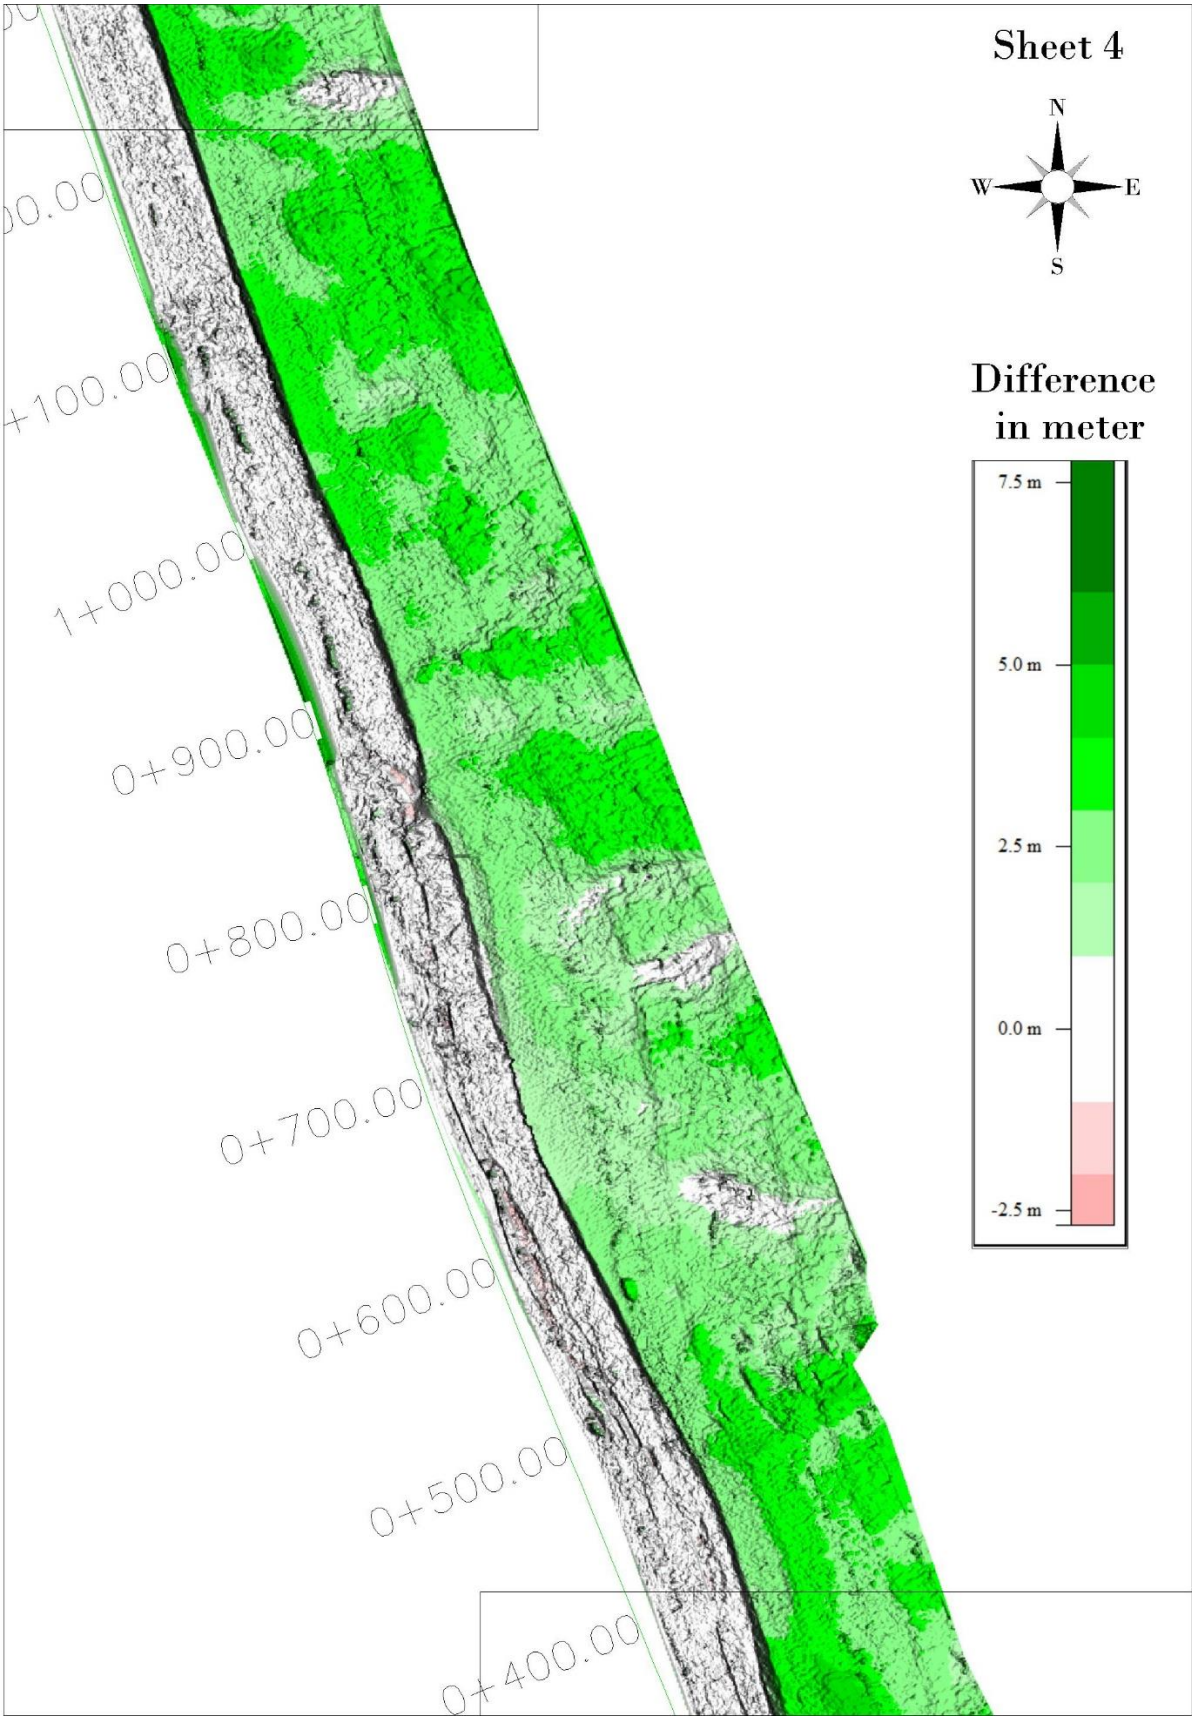
**Kojjuri Multibeam Survey, Differential Map
05-06 November 2019 to 22 June 2020**

Kojjuri Differential Survey: November 2019 to June 2020 differential does not show any changes in the launched slope. After the slope, sedimentation observed. Sediment starts moving when the velocity increase during flood season. Normally it is better to compare flood season month's data to identify changes at the apron.

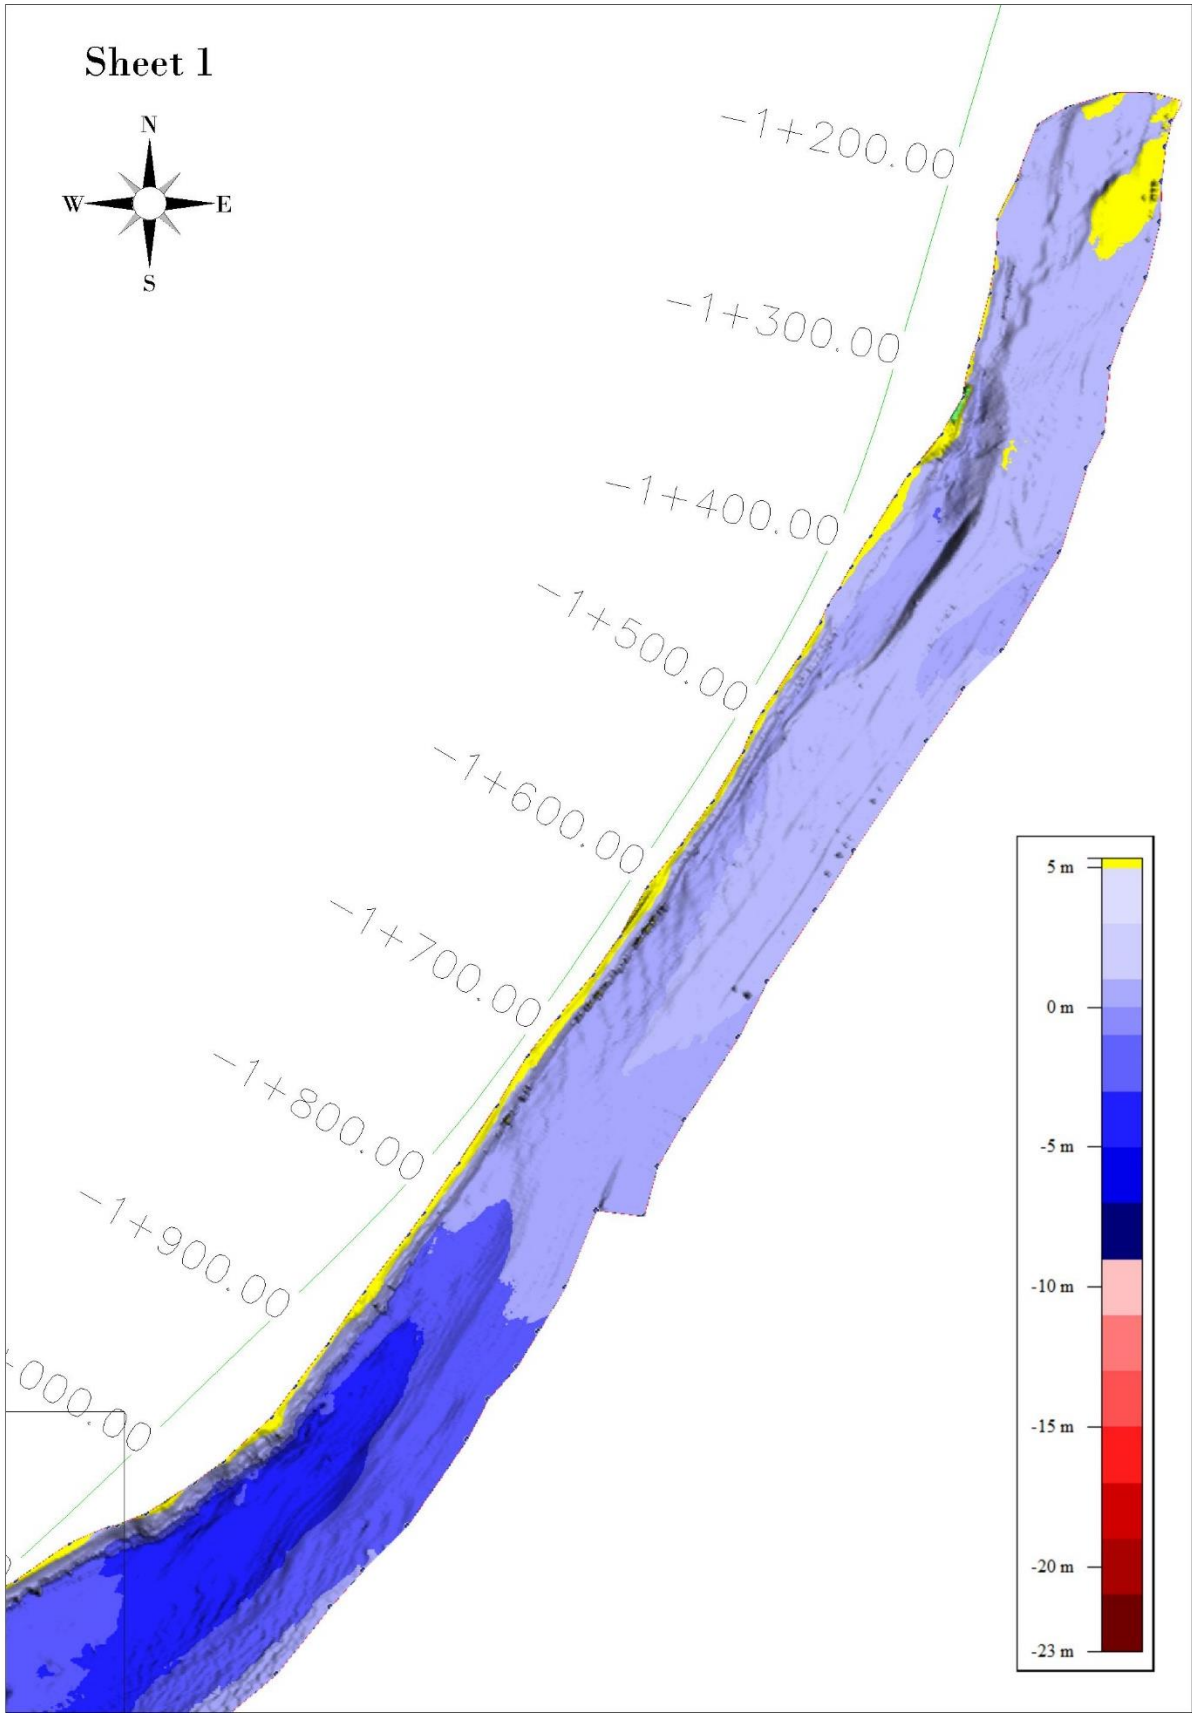
Overall the channel is not very deep. From km -1+800 to above the average depth of this channel is 4mPWD. Downstream of km -1+800 to entrance of Hurasagor channel, average depth of the channel is -5mPWD. Only deep scour is observed at km -3+200.

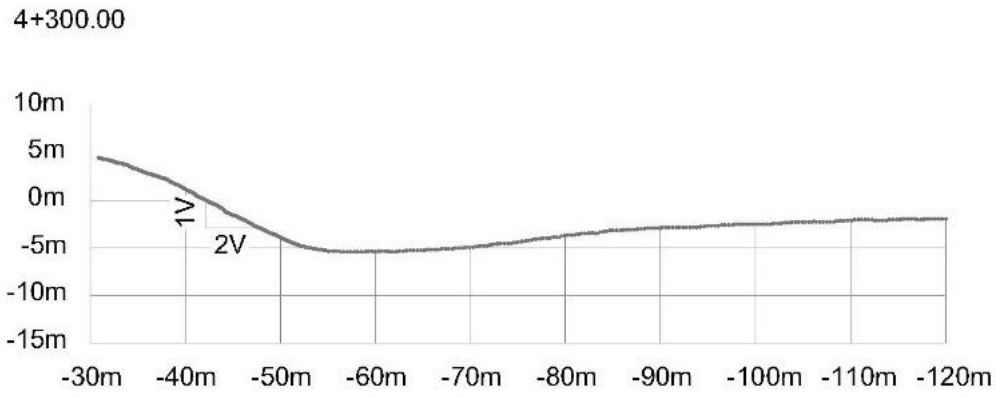
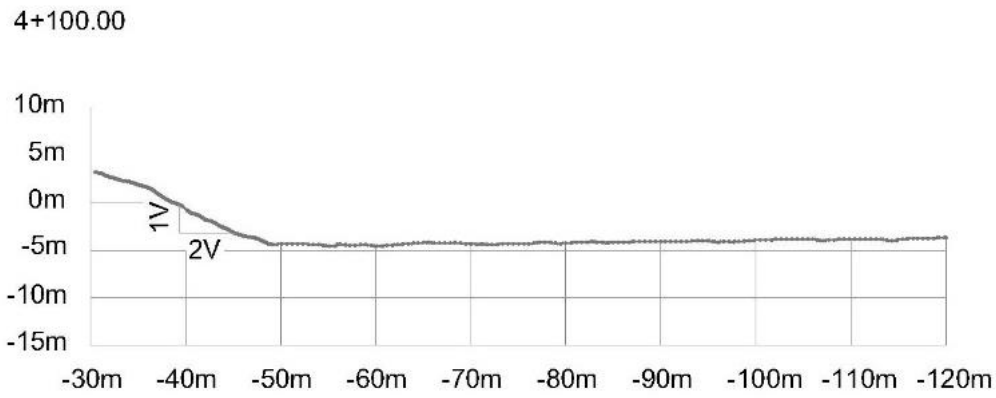
Figure 8-36 Cross sections at station 4,100 and 4,300

At location 1 sheet 1 (Figure 8-35), two representative cross-sections have been taken (Figure 8-36). In all cases the cross-sections show 1V:2H slopes, which agree with typical launched slopes. Close to the low water line, there are some pockets probably resulting from the excavation of the transitional berm. The 3D view clearly depict that the connection in these places might have been imperfect (Figure 8-37). Diving investigation would be required to verify connection of apron and upper slope. One underwater failure can be seen at km 4+000 (Figure 8-38). Given indications of rapid scour and

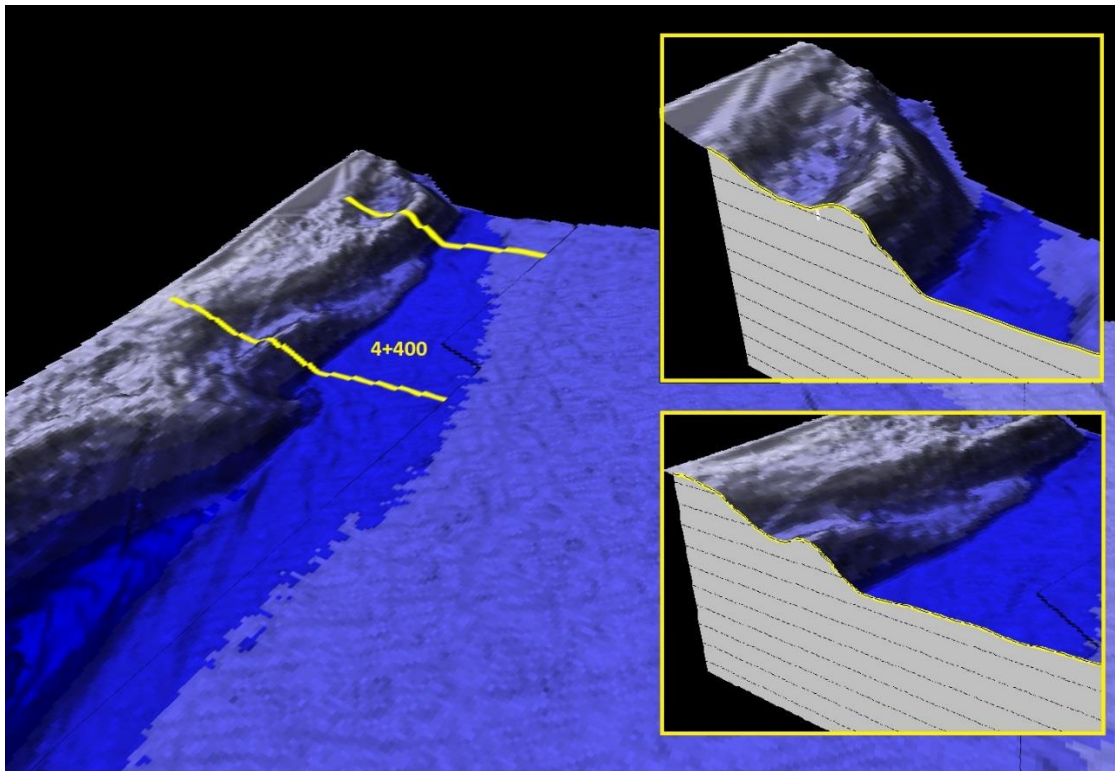
Figure 8-37 : Pockets between slope and underwater apron

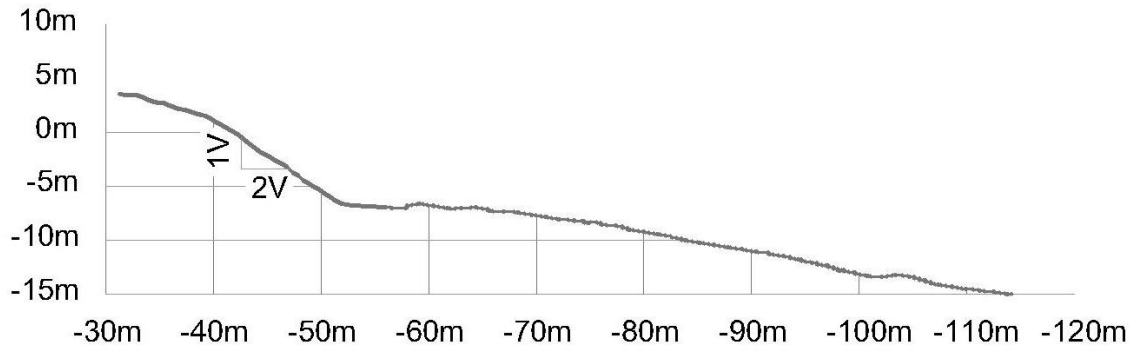
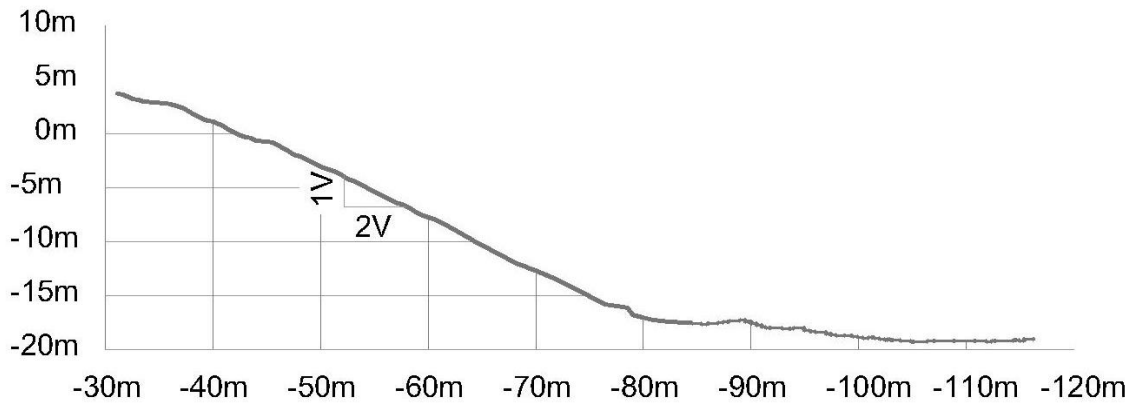
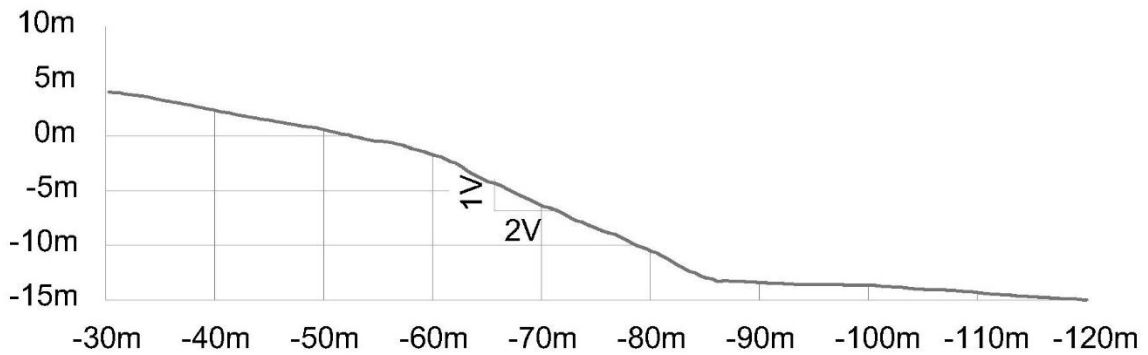
Figure 8-40 Cross sections at Stations 3,500, 3,700 and 3,900

Three cross-sections have provided for sheet 2 (Figure 8-39). The cross-section in Figure 8-40 show 1V:2H slope which represent typical launched slopes. The channel approaching between station 3,900 and 3,800 makes a sharp bend at station 3,750. In this area the deepest slope is observed apparently with the launching quantities exhausted (Figure 8-41). Upstream and downstream the apron is still visible. Also here adaptation works will be required.

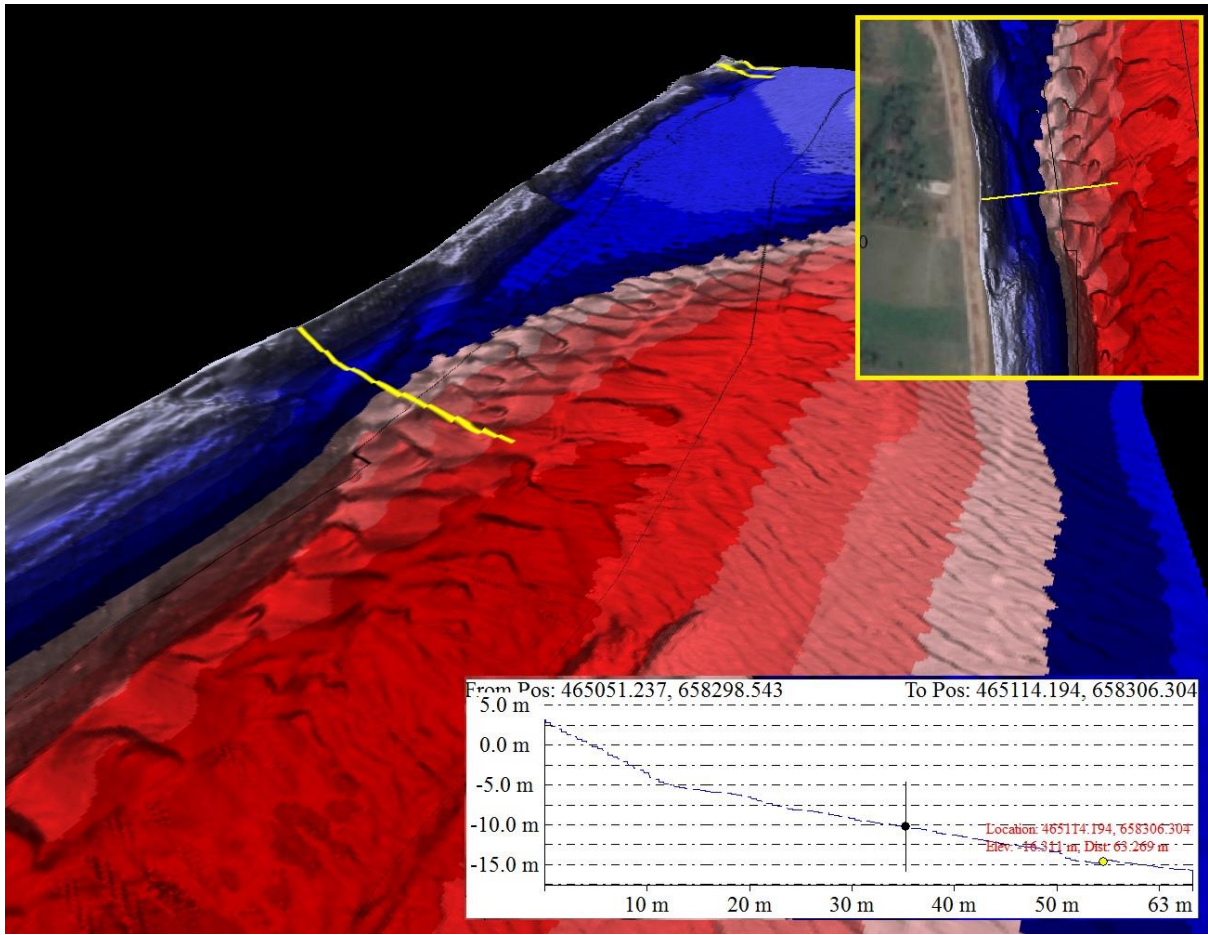
Figure 8-41 : Steepest slopes at station 3,700

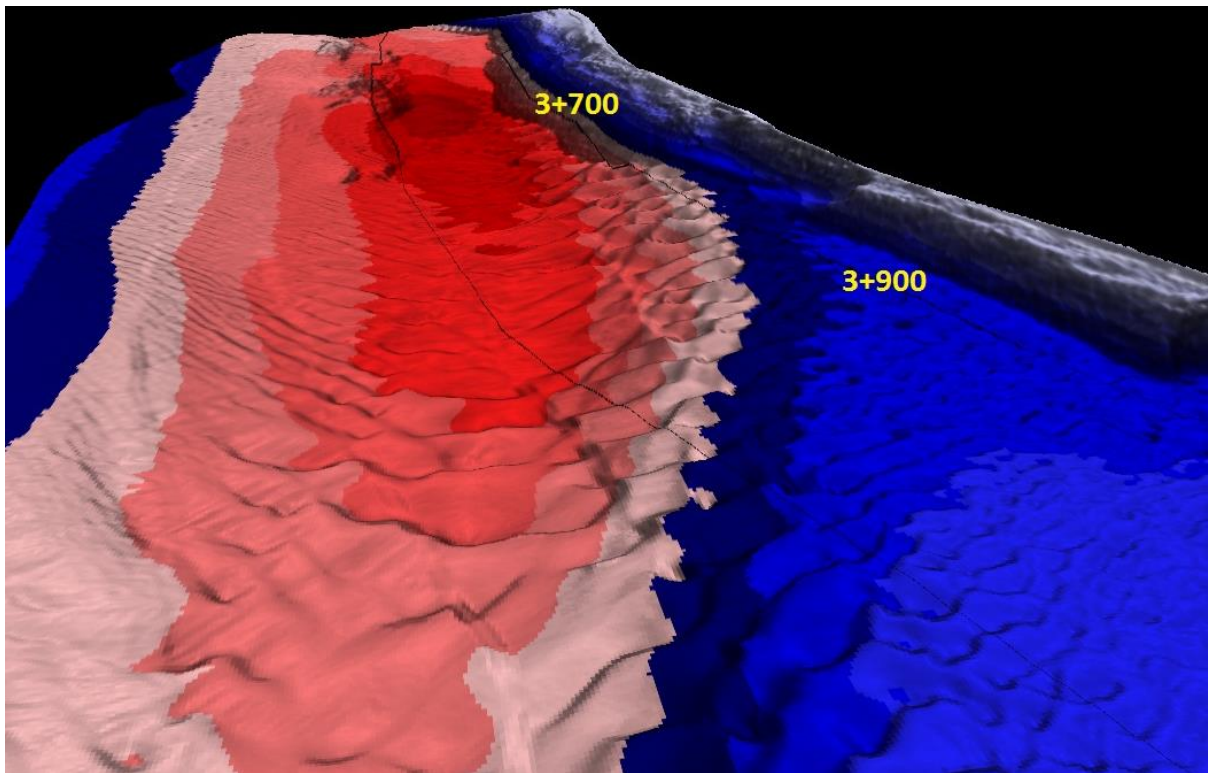
Figure 8-42: Deep channel after the bend

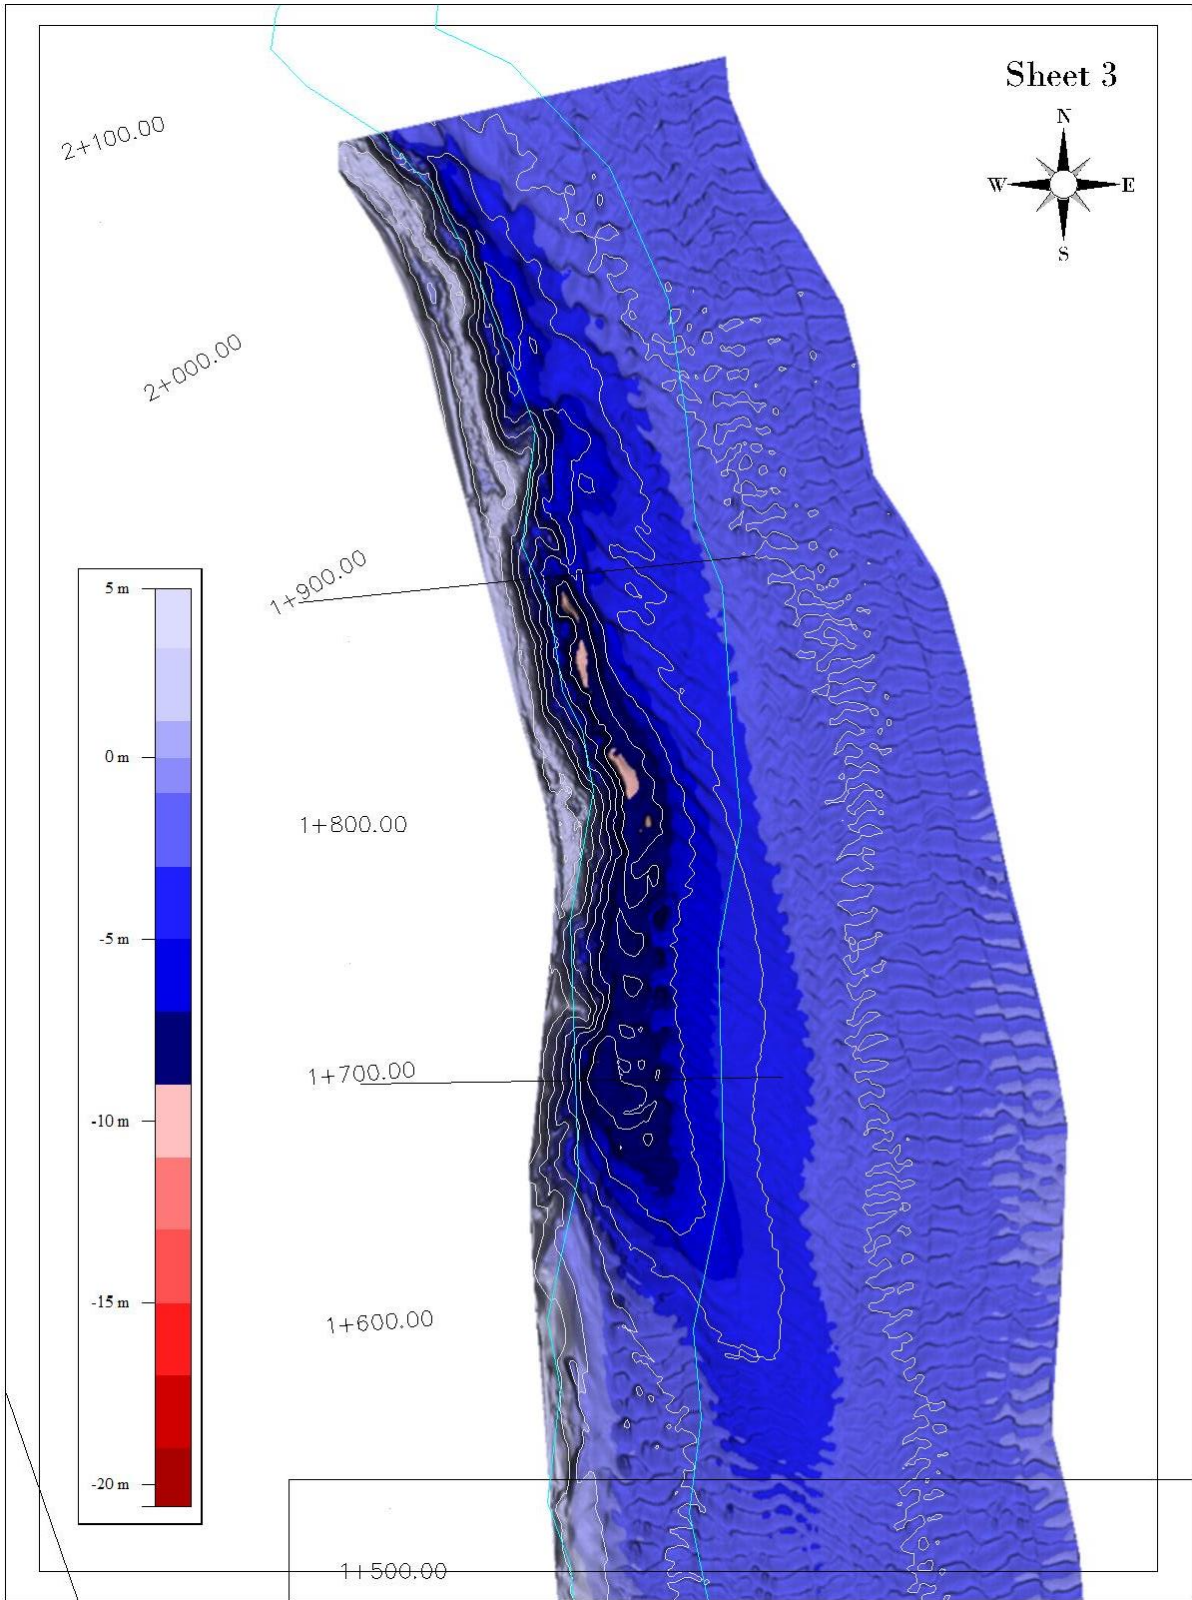
Figure 8-43 Sheet 3 of the multi-beam survey

Further downstream the situation is different; sheet 3 to 6 cover this area. Sheet 3 (Figure 8-43) shows a deeper channel from Station 1,900 to 1,700. The apron was placed here at a deep bed elevation, on average at --12m+PWD. The cross sections (Figure 8-44) in this area of sedimentation do not allow a clear assessment of the launching behavior. The 3D view in Figure 8-45 indicates again some pockets at the transition between upper slope and lower slope. These pockets could be a result of imperfect excavation during the construction of the upper slope in 2008.

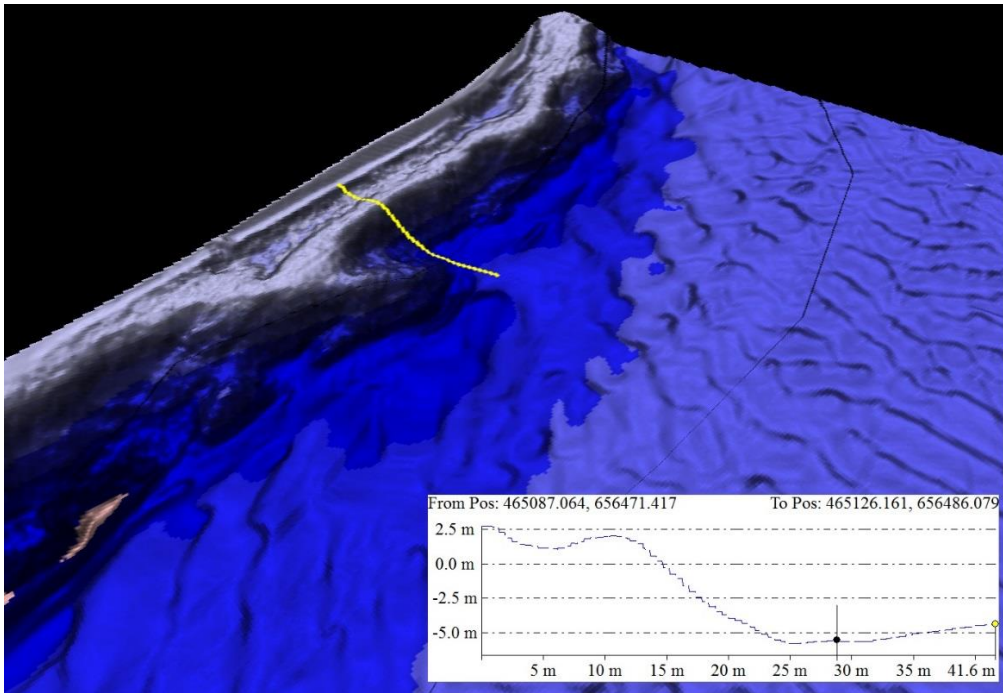
Figure 8-45: Location with apparently a pocket along the transition from upper to lower protection
