Memo

Re: Flood monitoring report 2019-20

1 Introduction

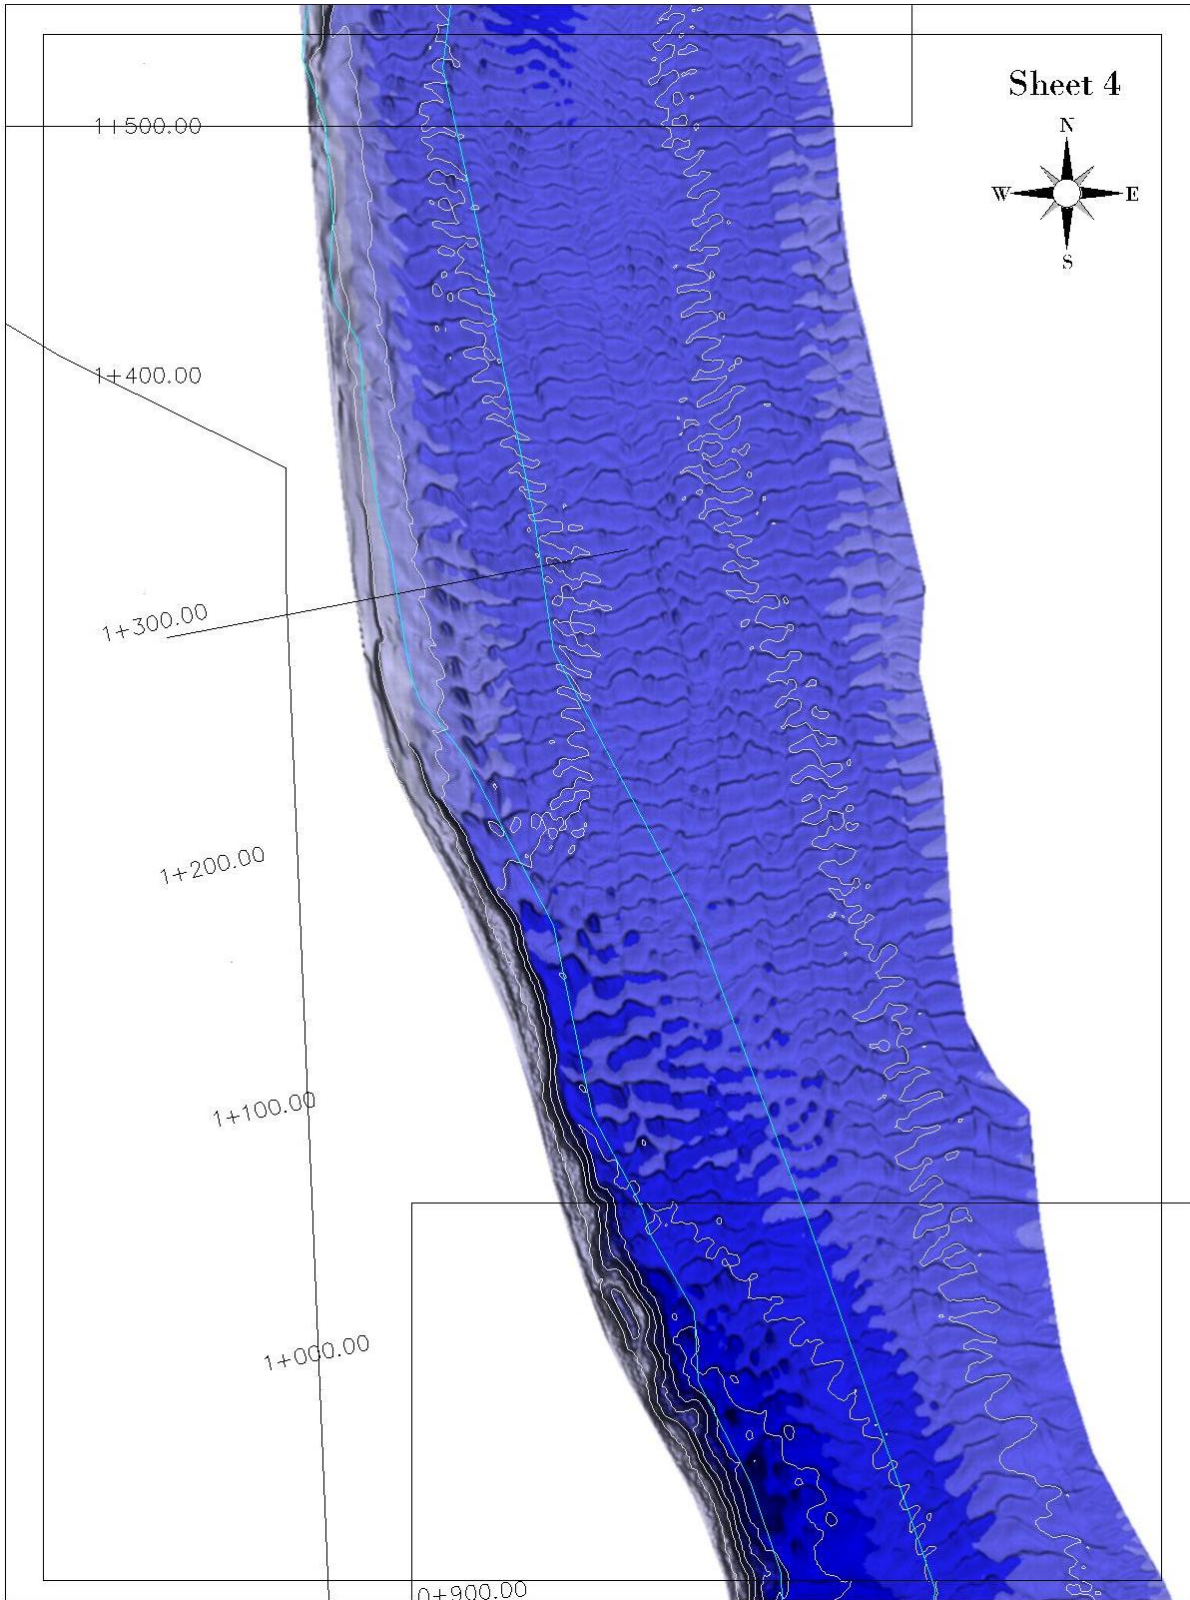
Figure 8-46 Sheet 4 of the multi-beam survey

The apron in sheet 4 (Figure 8-46) was placed during 2004 dry season at deepest bed levels. The average apron was placed at -10m+PWD. Now the underwater slope is covered with sediment. The sample section in Figure 8-48 demonstrates this. Again, at the transition from upper to lower slope the multi-beam survey identified a pocket at Station 1,000 (Figure 8-49).

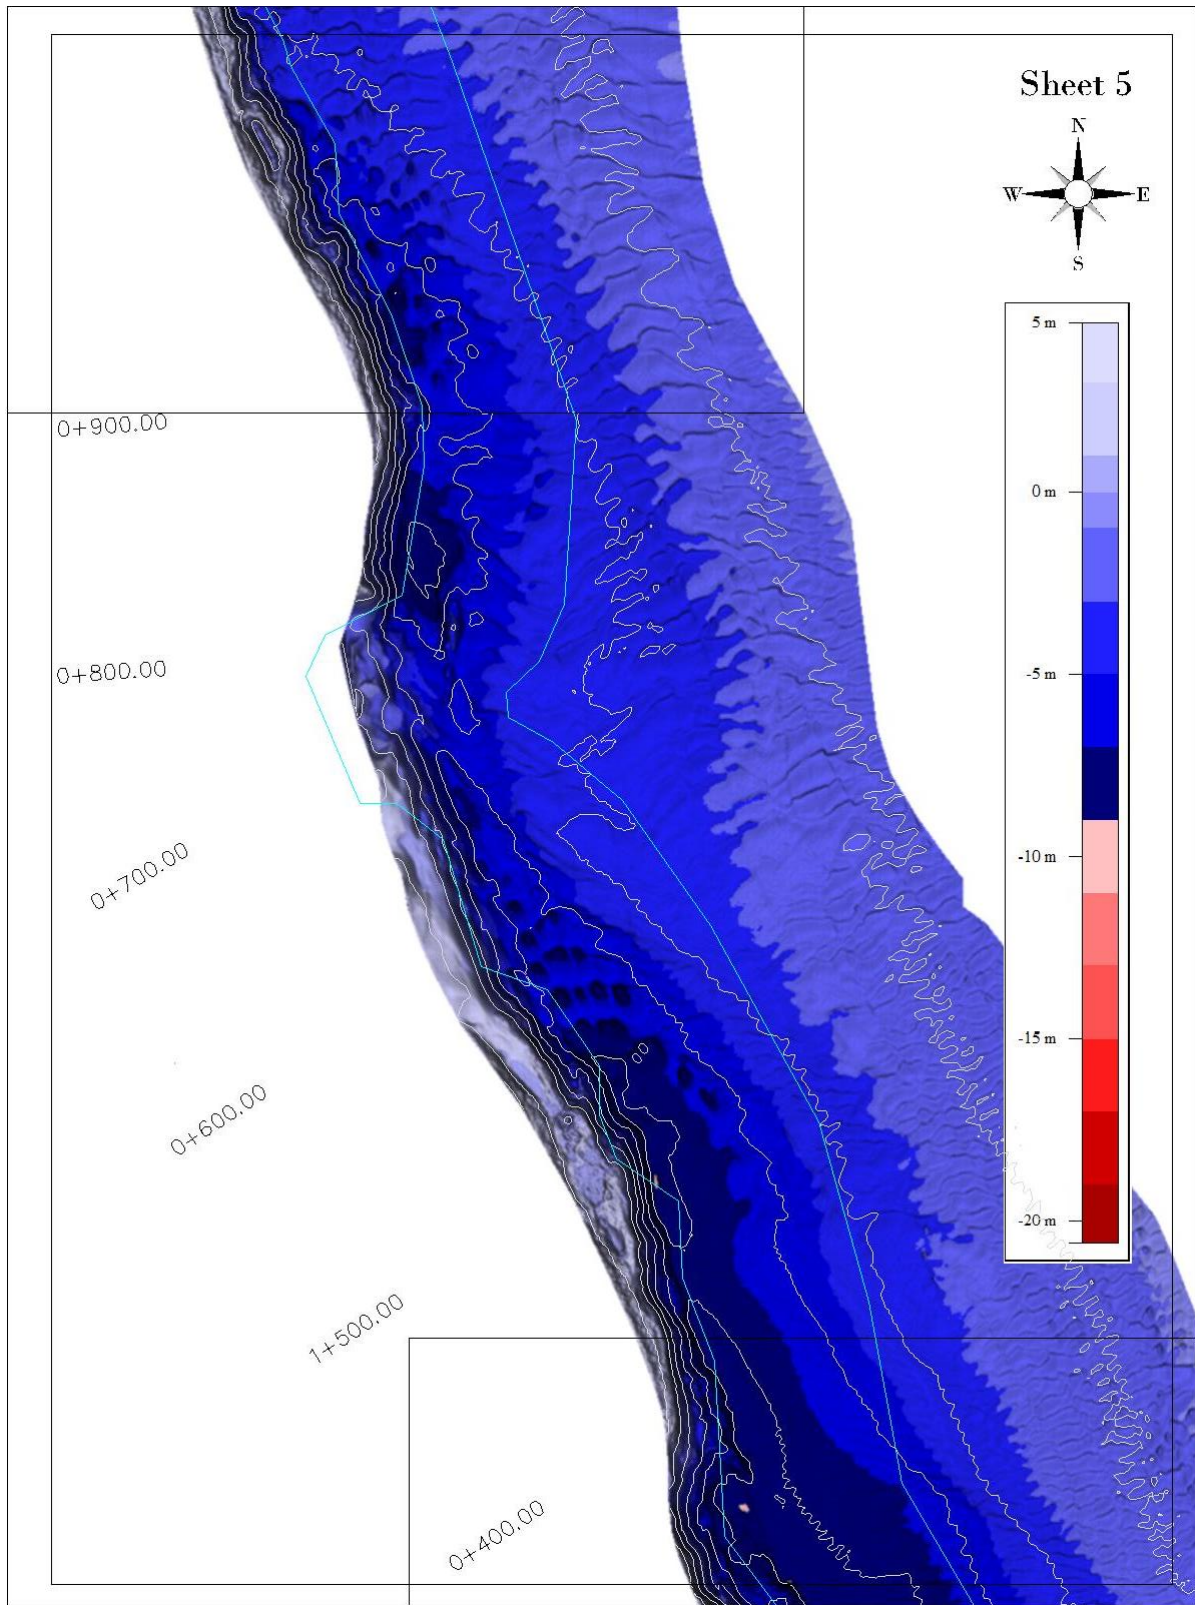
Figure 8-47 Sheet 5 of the multi-beam survey

In sheet 5 (Figure 8-47) the apron was placed during the 2004-05 dry season at the recorded lowest bed level between -14mPWD at Station 1,400 and -12mPWD at Station 400. Also here the launched slope is covered with sediment.

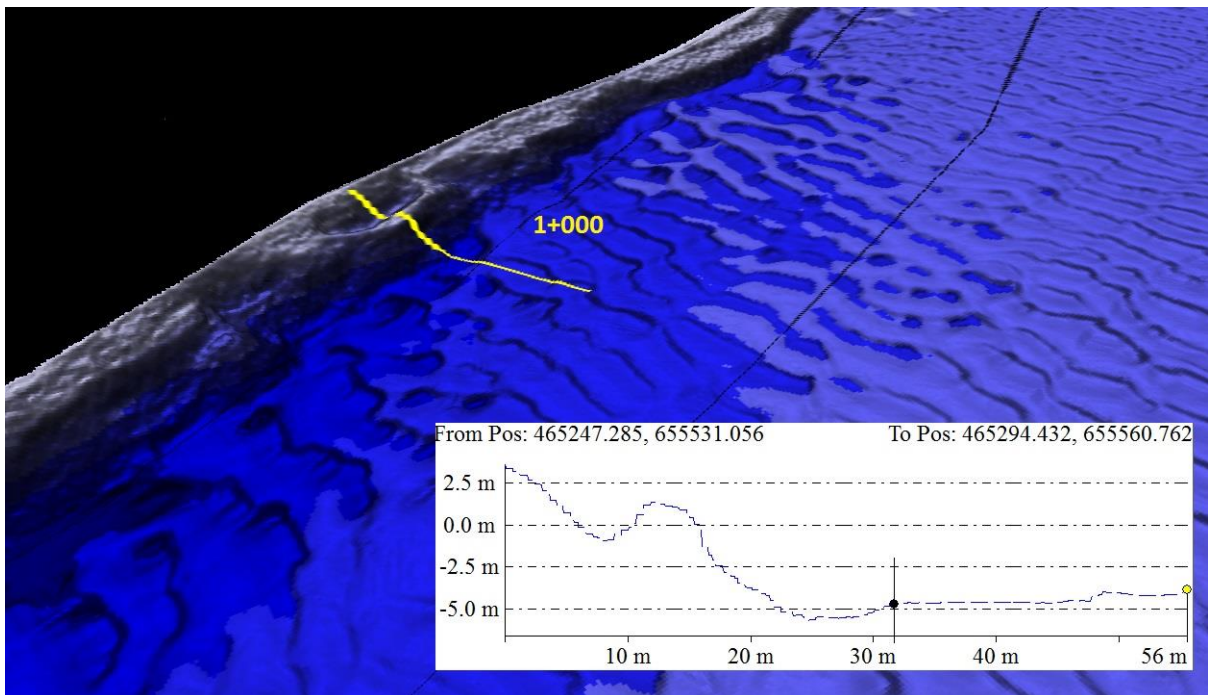
Figure 8-49: Pockets at transition from upper to lower slope

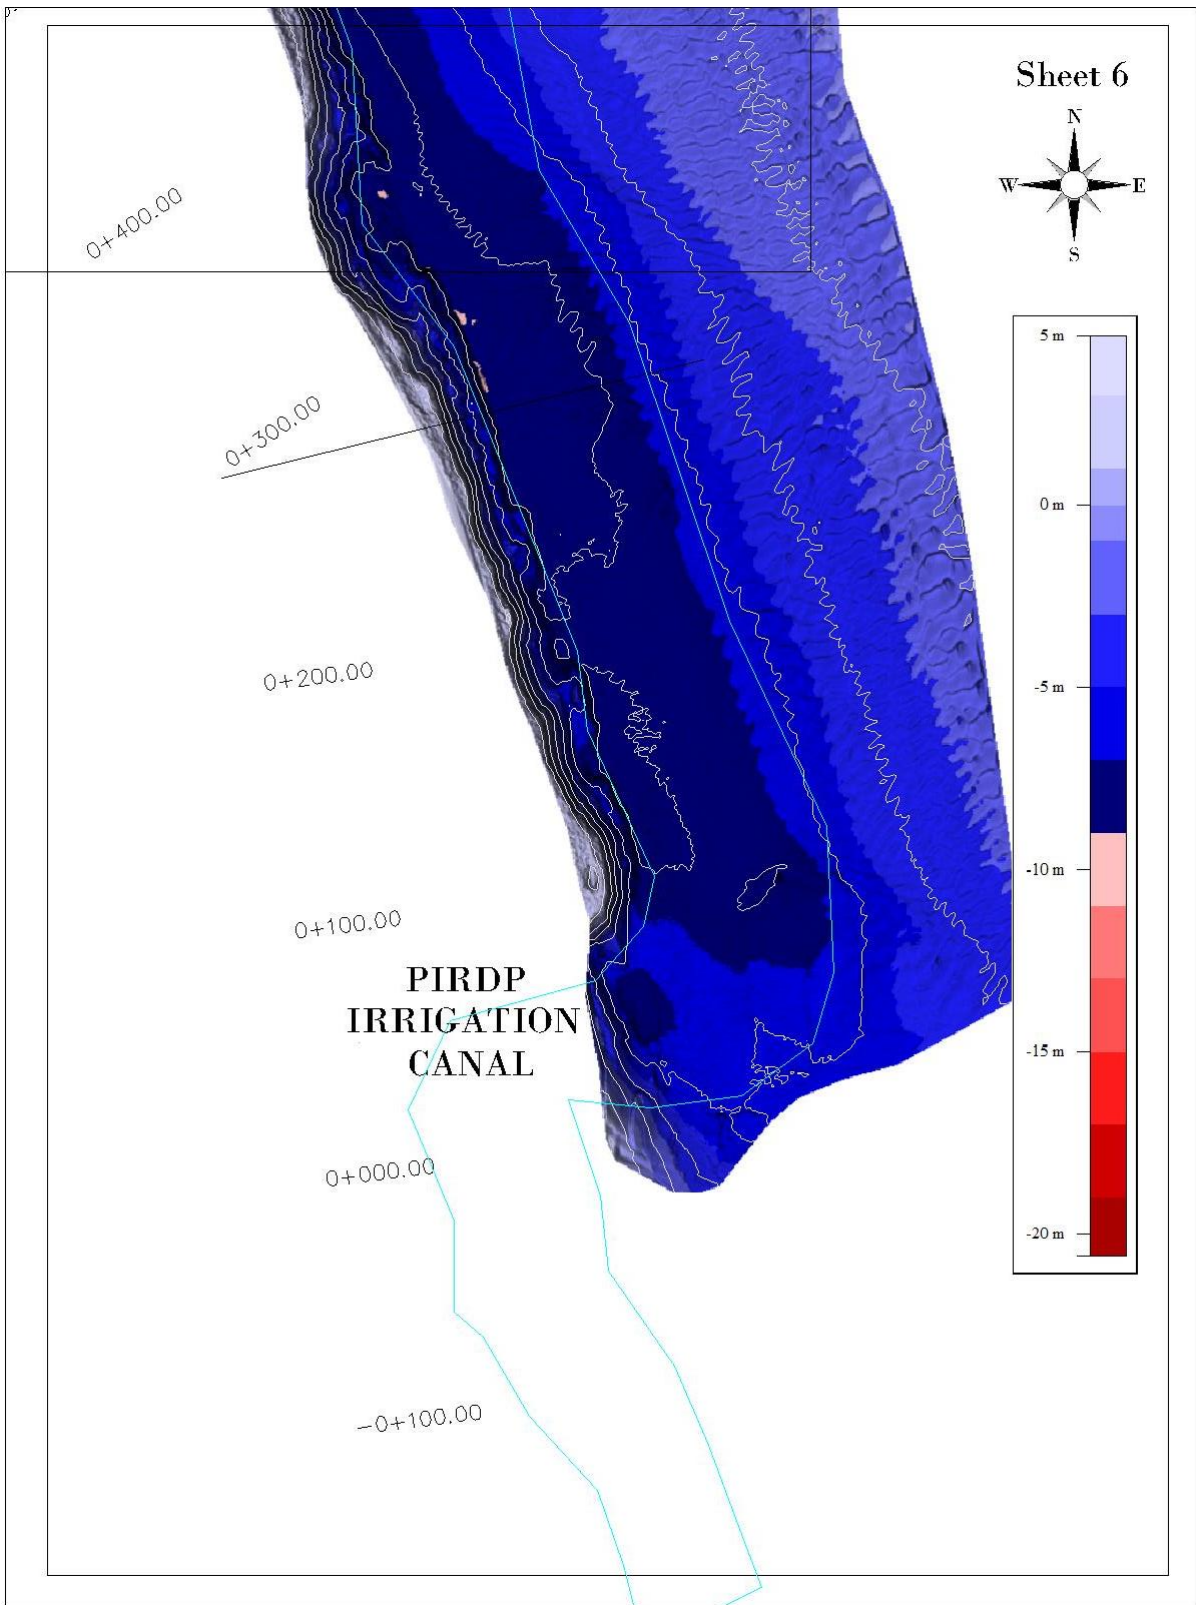
Figure 8-50 Sheet 6 of multi-beam survey

The most downstream part of the PIRDP protection (Figure 8-50) was constructed at deep bed levels in 2004. Cross section at Station 300 (Figure 8-51) indicates the upper protected slope however most of the cross section appears to be sedimented in. In 2005 the first ever “adaptation works” was built here (from Station 0 to 1,000. The cross section at Station 150 (Figure 8-52) indicates secondary launching, as clearly visible step. At Station 200 launching appears to have exhausted the provision

of the apron or rapid scouring has led to a flow slide through the second apron of the adaptation works (Figure 8-52).

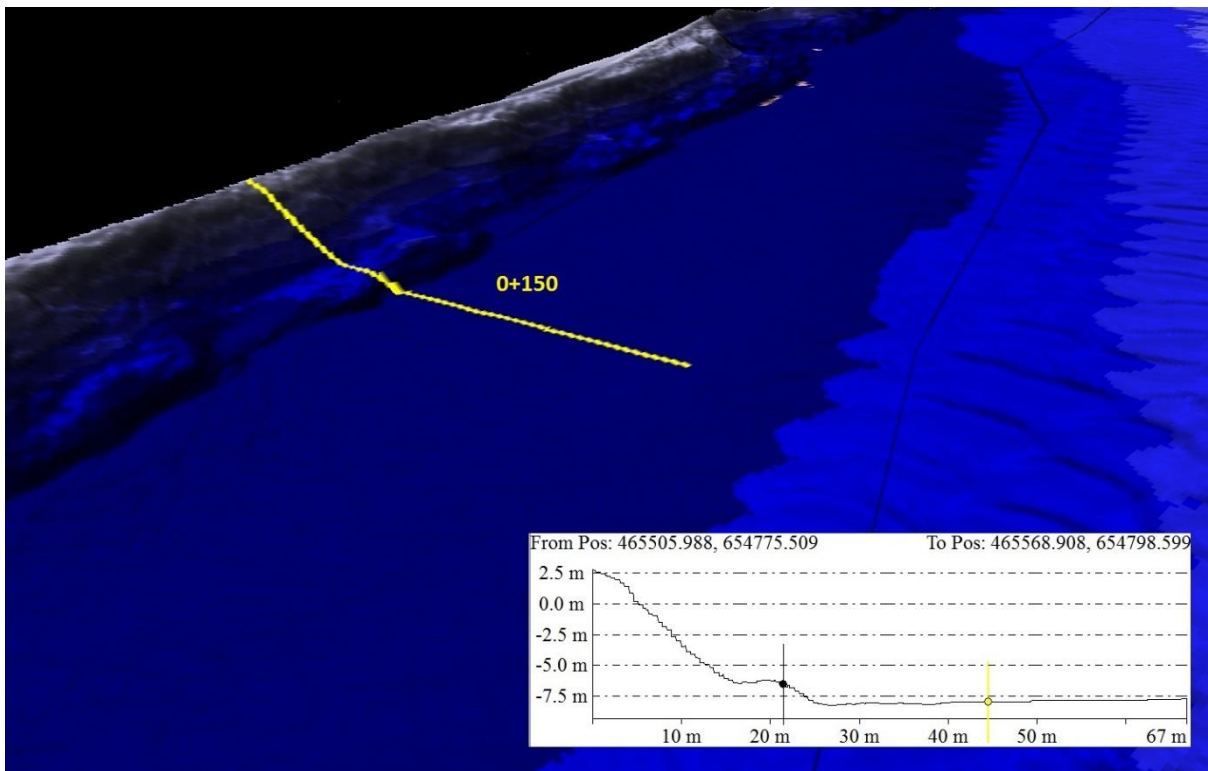
Figure 8-52: Step shape launching after the adaptation work

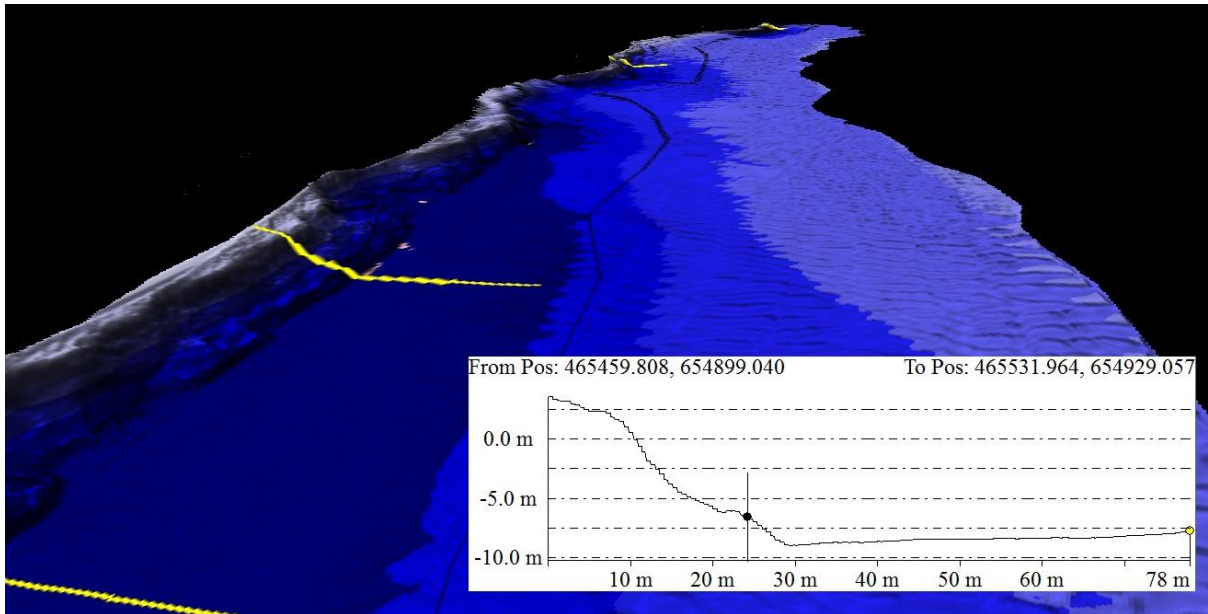
Figure 8-53: Step shape launching after the adaptation work

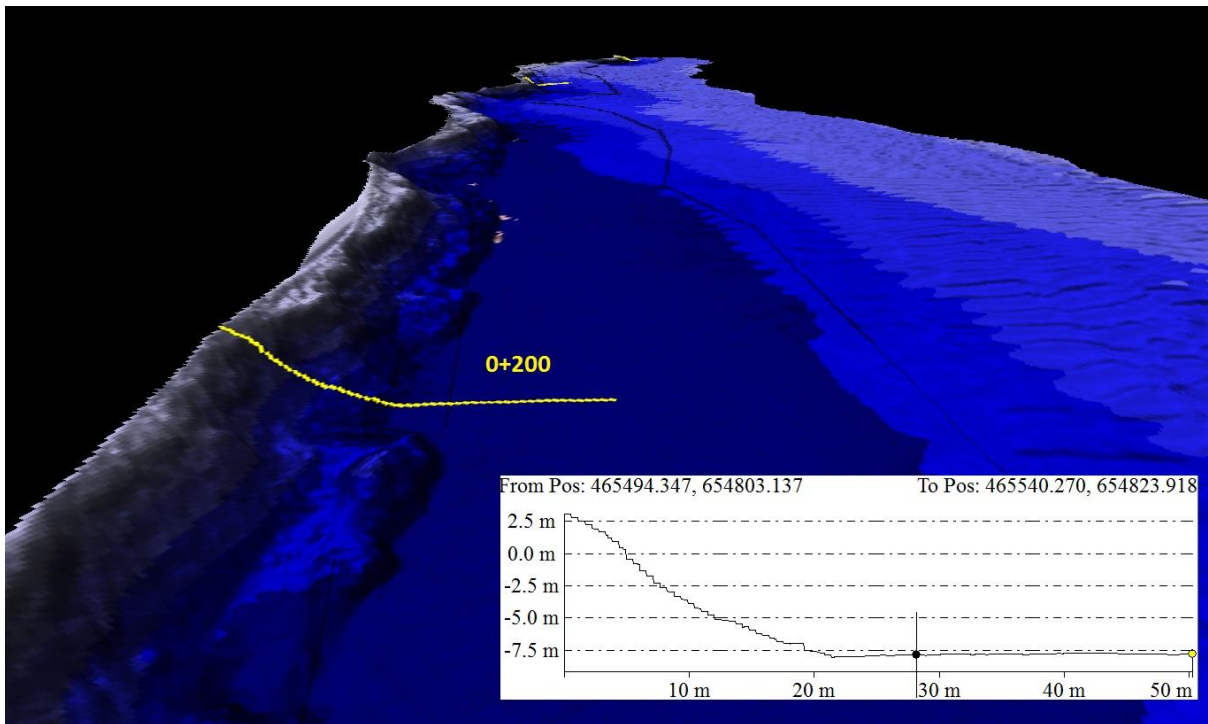
Figure 8-54: Potential flow slide from rapid scouring through the secondary apron.

In summary, the works appears to have performed quite well despite localized aggressive river attack triggering flow slides. The lack of ten years of data hampers the understanding. However, more regular multi-beam surveys could improve the situation. Naturally, adaptation works would be required at a number of locations.

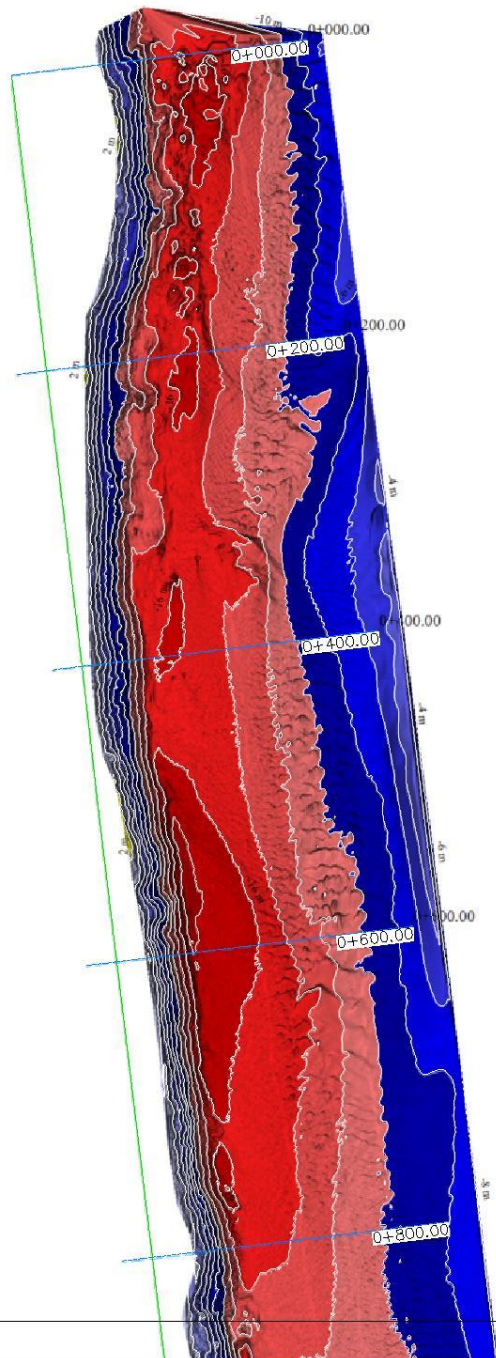
At this location roughly 1V:2H launched geobag slope observed. No underwater erosion observed. Two 3D view shown below shows the launched slope.

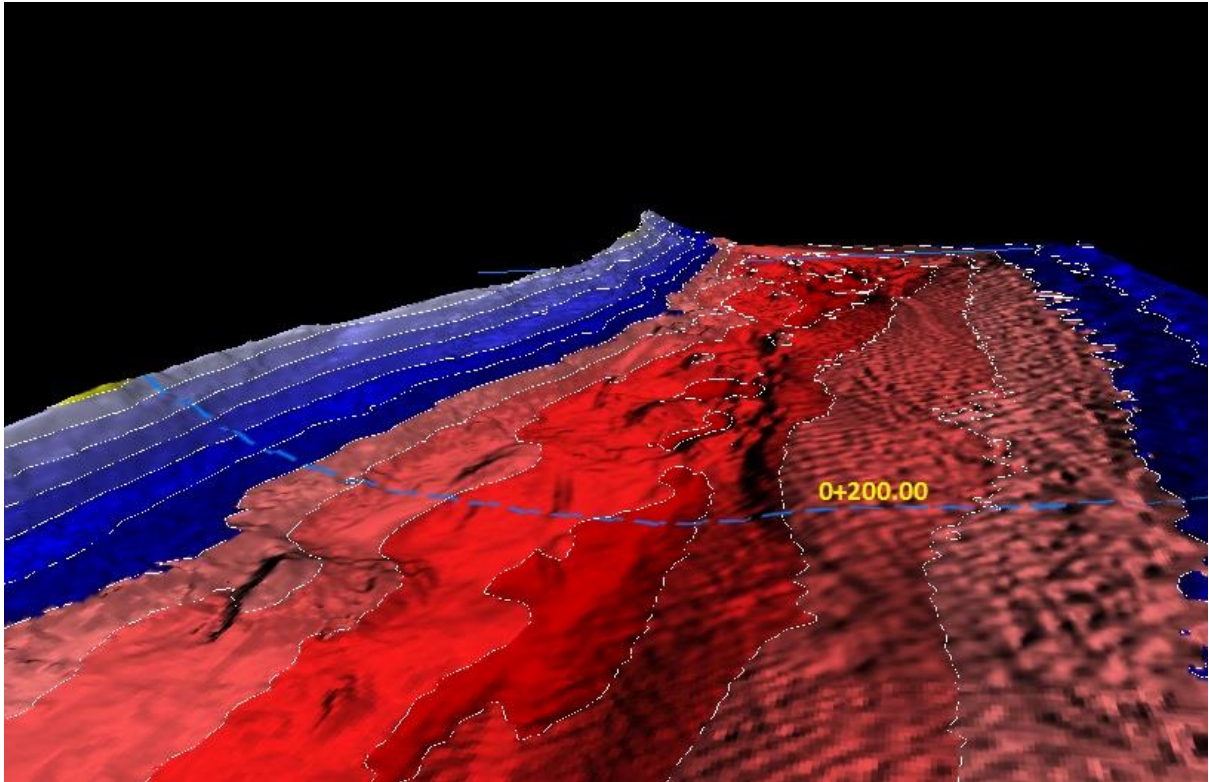
Figure 8-55 3D view of underwater launched geobag slope

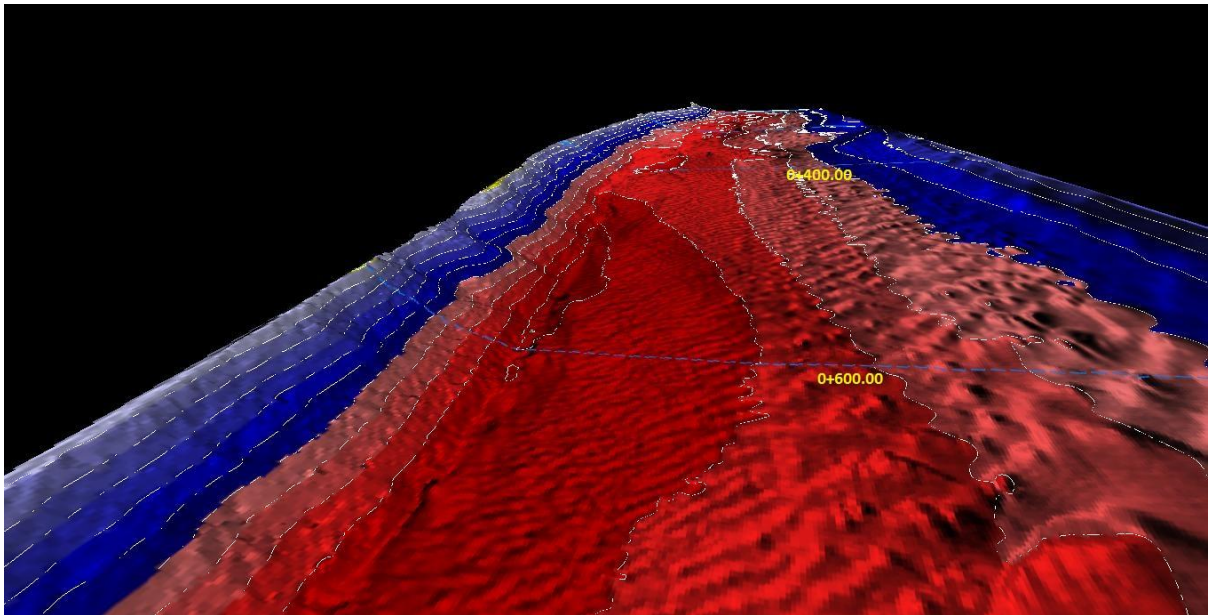
Figure 8-56 3D view of underwater launched geobag slope

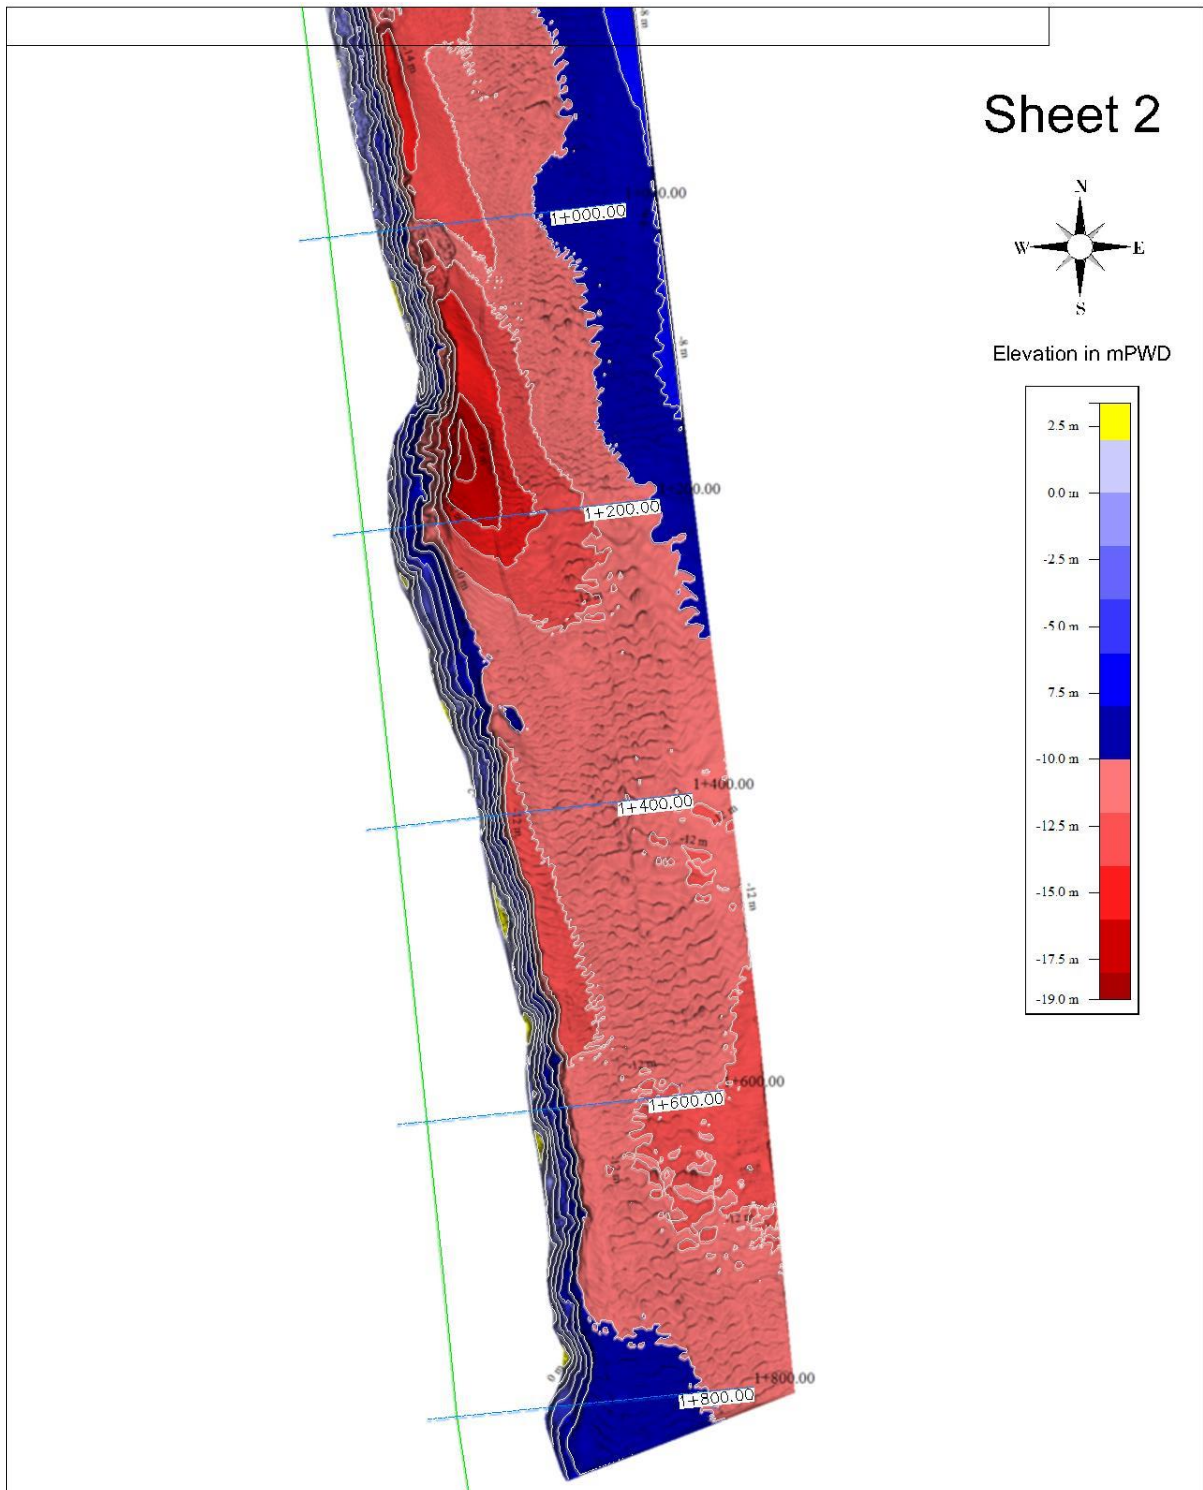
At km 1+200, an inner bend formed. One slip circle observed there. Rest of the location has a 1V:2H launched slope.

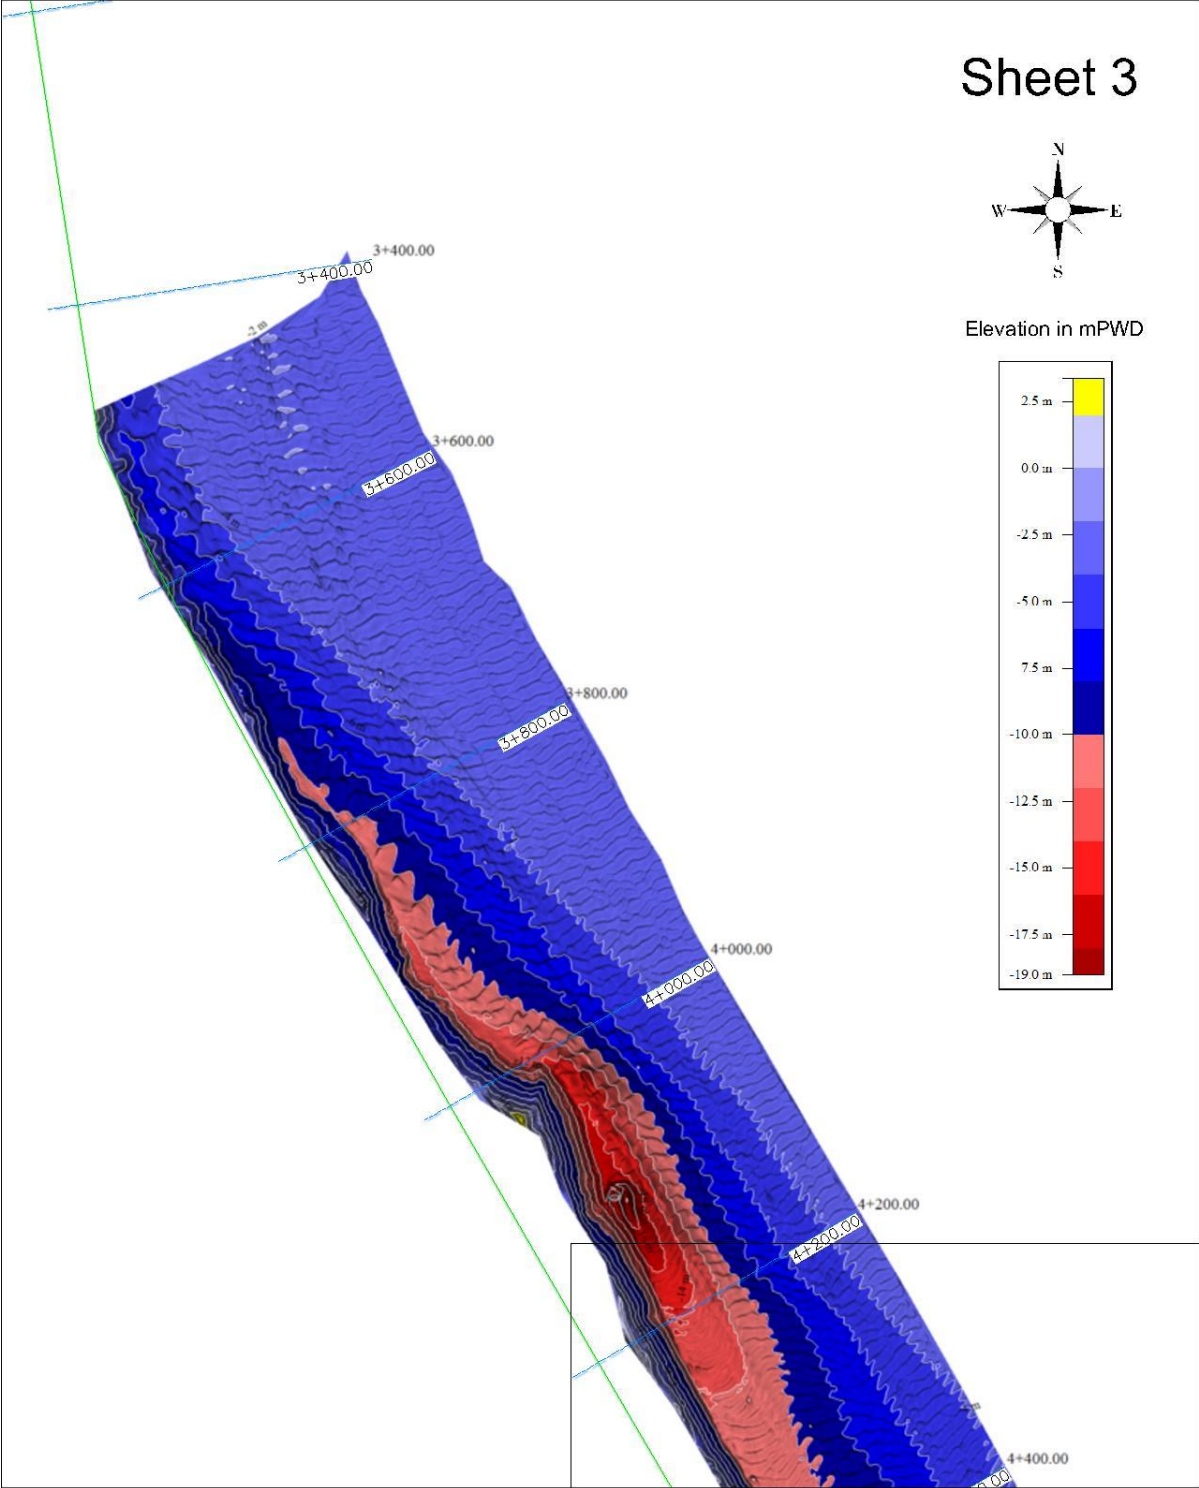
Most of the location from km 3+400 to 4+000 is sedimented. Sand dunes can be seen. From km 4+000 to 4+400, 1V:2H launched slope observed. No underwater erosion observed here.

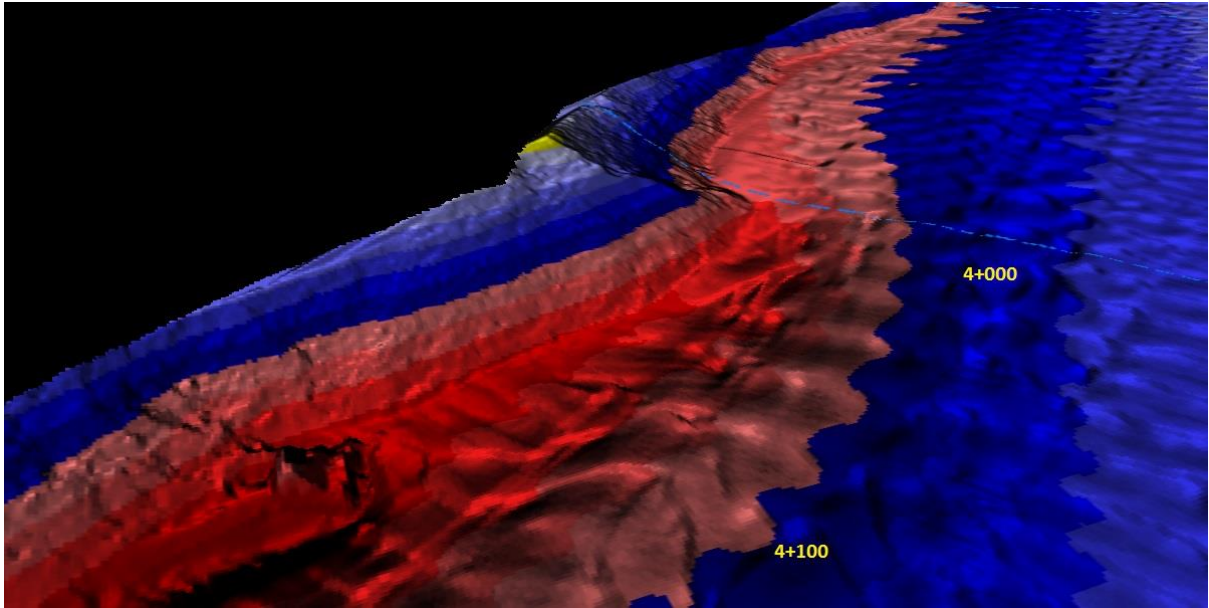
Figure 8-58 Underwater launched slope at km 4+100

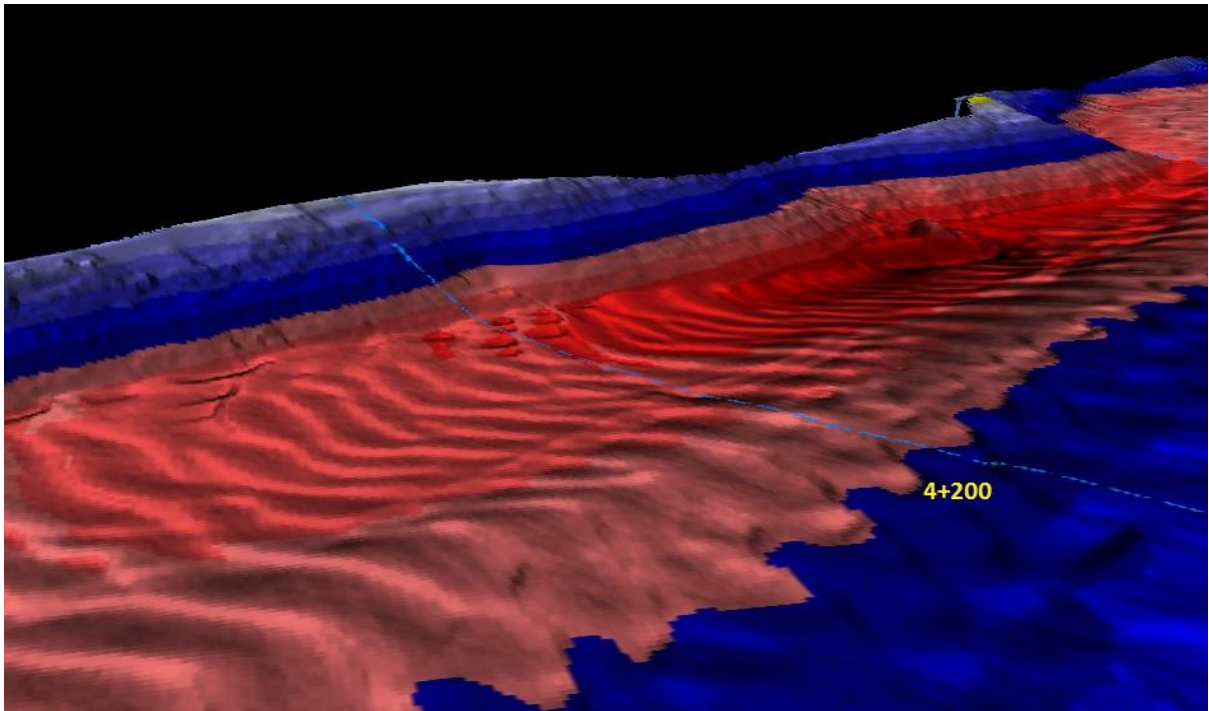
Figure 8-59 Underwater launched slope at km 4+200

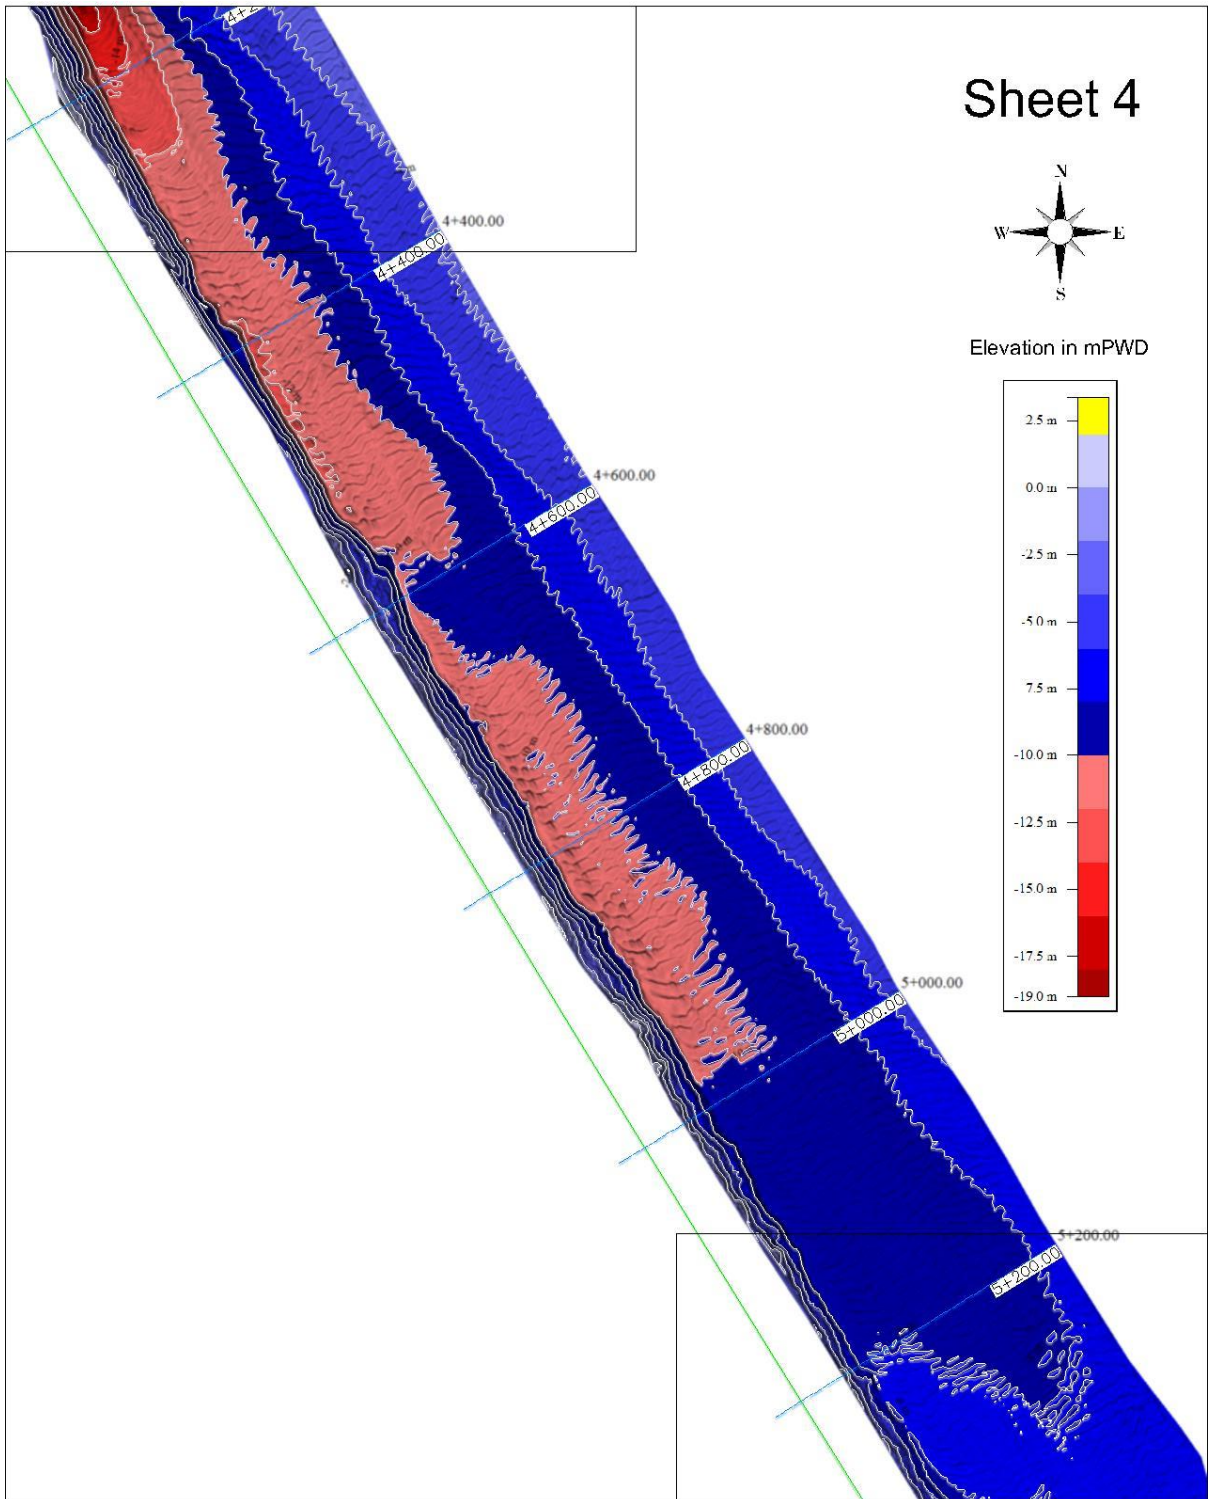
At this location no underwater erosion observed. 1V:2H launched slope observed.

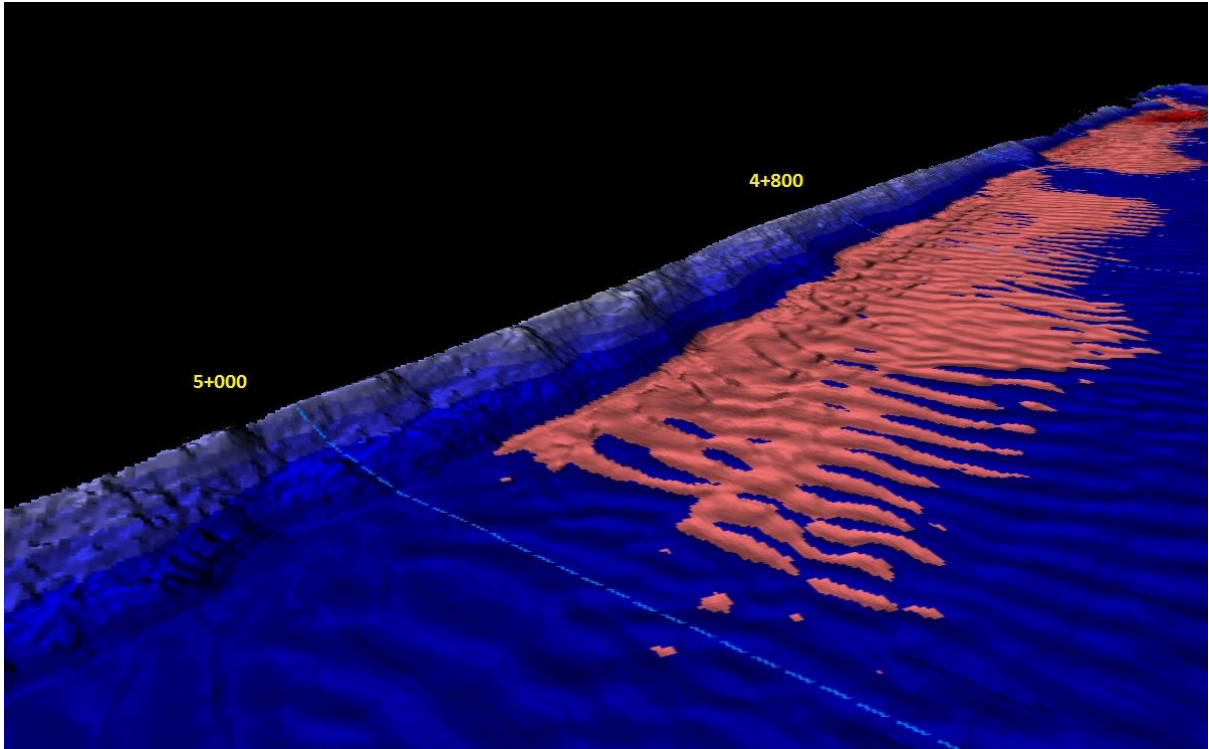
Figure 8-60 Underwater launched slope at km 5+000 to upstream

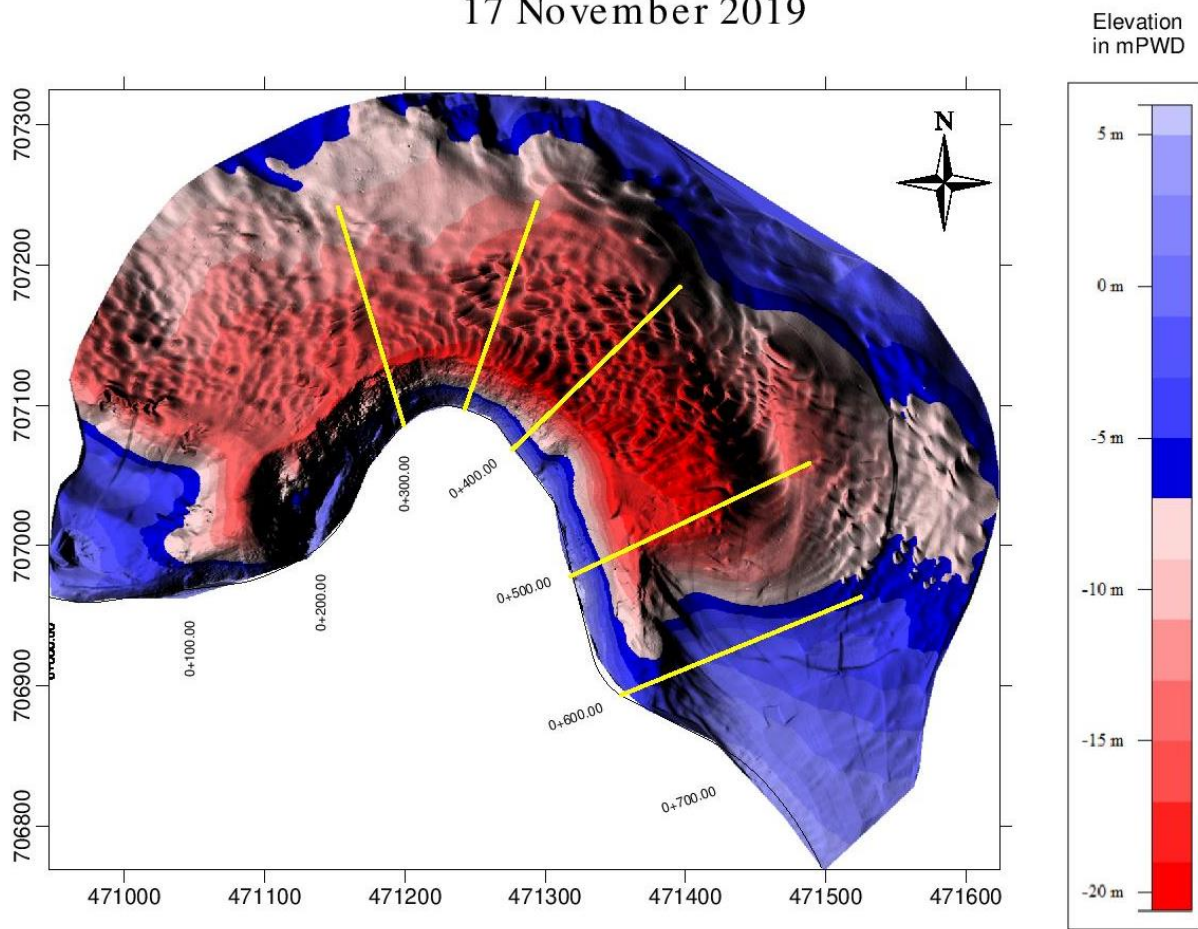
At Hardpoint site, there are variations in slopes in different places. Five representative cross-sections are shown below to show the different cross-section and different slope angle.

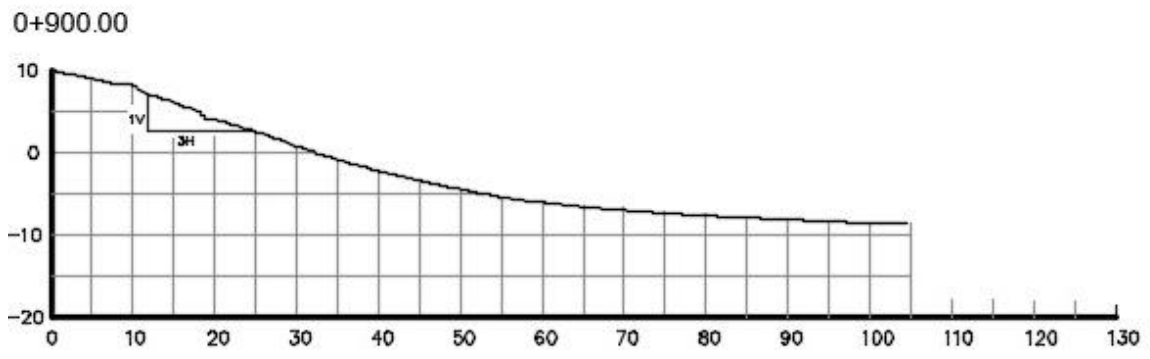
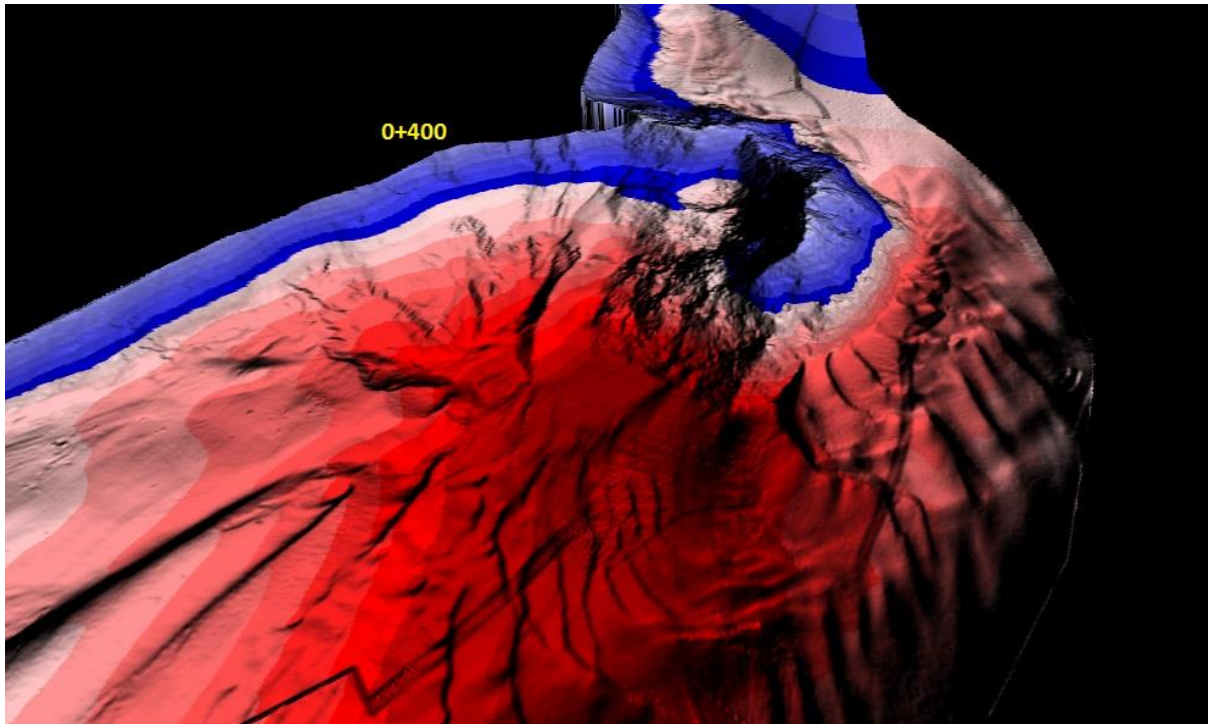
At Sirajganj cross bar 3 site upstream part is silted. At stn 0.4km there a heap of boulders that act like a spur and due to that downstream stn 0.5km was affected. Stn 0.6km shows launched stone covered slope. From stn 0.7km to downstream there sedimentation observed. Below some cross section was provided. The yellow line in the plan view represents the cross section line.

Figure 8-63 Underwater scour due to heap of boulders at km 0+400
